## 1 LTI – ankle injury caused during lifting operations

## 2 Lifting complex loads - offloading third party equipment

### 3 Dropped object - unexpected release of spool

**4 NOPSEMA: person injured in chain hoist incident**

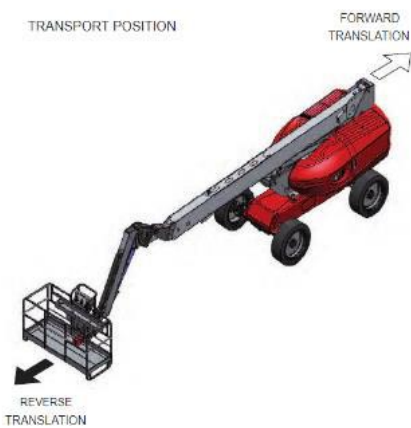
*Extract from operations manual*

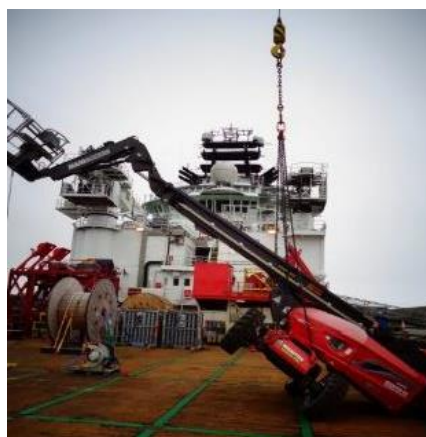
*Cherry picker incorrectly rigged*

- Inadequate handover, inadequate communication:
  - The cherry picker had been lifted on board by vessel personnel who had subsequently crew changed out before the maintenance works were finished;
  - The initial lift detail and information was not effectively communicated to the oncoming team;
  - When the cherry picker was brought on board, the lift plan took no account of the condition of the unit or the correct rigging required to lift it safely.
- The information in the cherry picker operations manual did not address how to safely lift such a unit;
- The rigging arrangement for the unit created a clash with the lift points and the counterweight. This led the lifting team to consider that the correct set up for the lift required the boom to be placed at a 90° offset therefore removing the clash.

- Specific to lifting cherry pickers:
  - Develop a specific lift plan for cherry pickers. The lift plans should be readily available and refer to specific guidance from the manufacturer's manual;

- Ensure correct documentation including operations manuals and information relating to safe lifting operations is available from third-party plant and equipment vendors;
- Require dedicated and certified rigging to accompany the rental;
- Discuss this issue with logistics and supply chain personnel and with port agents and suppliers, to safeguard the provision of equipment, information and documentation relating to the hire of plant and equipment.
- Where crew changes may impact operations, plans should be in place to support effective handover of key information such as lift plans;
- Lifting requirements, particularly for complex objects, should be thoroughly understood and confirmed by all persons involved;
- Management and supervisors should continue to support “Stop the Job” with their teams.

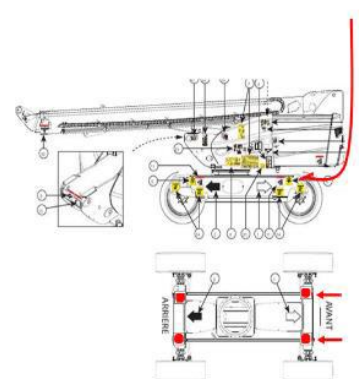
*Correct rigging arrangements*

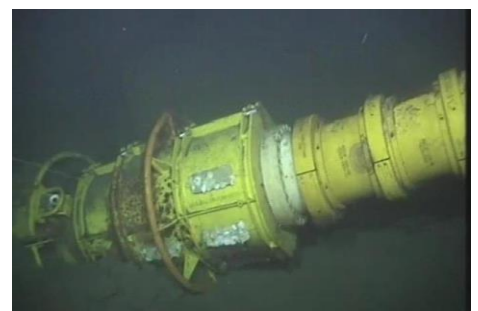
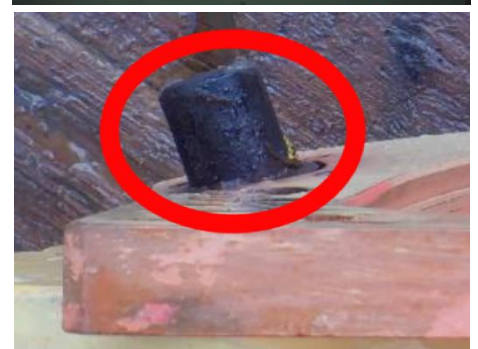
- “Stop knobs” were not retracted resulting in significant unplanned forces being applied to the yoke structure causing yoke integrity failure and subsequent failure to secure the load (spool);
- Third-party written procedures for installation and commissioning of the third-party subsea equipment were not followed and were not completed;
- Company personnel had limited expertise with the use of the tooling used and relied on heavily on the third-party contractor to confirm that all steps in the commissioning procedure were completed;

- There was a misunderstanding in verbal communications in that company personnel thought that the “stop knobs” had been retracted, but they had not been retracted;
- By design the main Yoke pins were the weak points in the lifting configuration.

- Ensure that tooling design arranges for clear visual indicators on the tooling; and that the fail-safe design of their tooling has been considered;
- Reiterate to third-party contractors the importance of following tasks as per procedure;
- Check and carefully verify the competency, experience, and training of third-party contractor personnel;
- Check to ensure that there is no overlap or duplication between third-party contractor procedures and company procedures;
- In task planning, consider further detail, checking and verification for areas that may be unfamiliar;
- Ensure that risk assessments cover the interfaces or gaps between third-party contractor equipment and procedures, and company equipment and procedures.

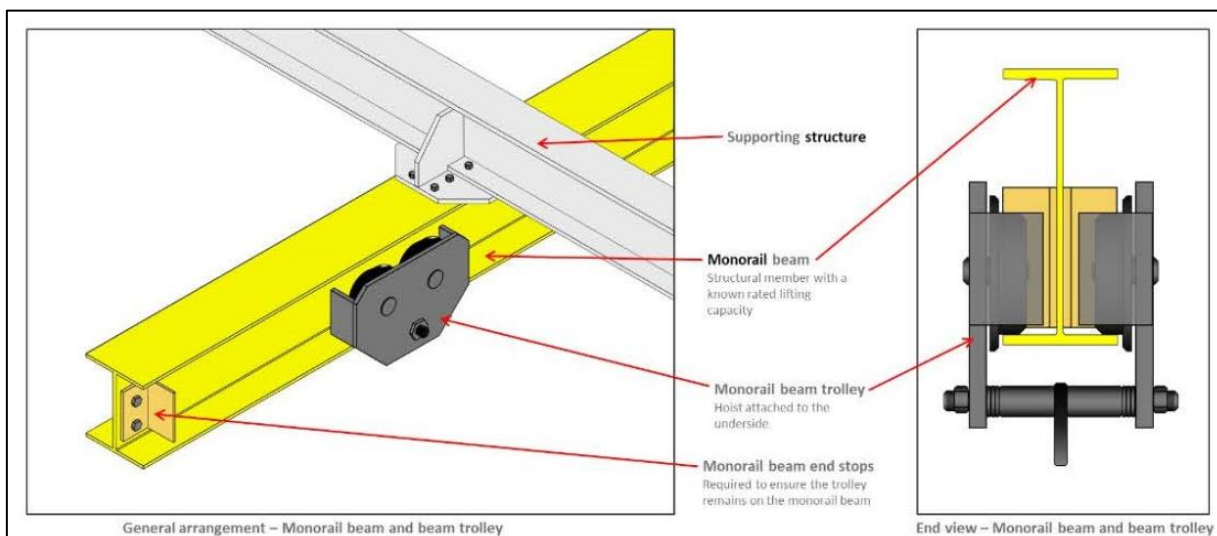
The incident involved a monorail hoist dropping a 500kg piping spool (including ancillaries) when its beam trolley, chain hoist and suspended load overran the end-stop.

- The monorail hoist was not fit for purpose, specifically the monorail end stops and beam trolley width;
- The beam trolley had been modified outside of management of change processes;
- The lift plan was not followed, resulting in unsafe operation of the monorail hoist.

- Monorails, including their end stops and attachment to supporting structures, must be designed, installed, and inspected in accordance with the requirements of the relevant standards by a competent person;
- Serially produced lifting equipment, including monorail beam trolleys, must not be modified from the original equipment manufacturer design;
- Appropriate lifting equipment must be selected for use for the specific lifting application;
- Monorail hoist systems are designed for the vertical lifting/lowering and lateral transfer of loads. Monorail hoists must not be used for dragging loads and non-vertical lifting as it may result in a failure of the monorail beam/beam trolley/end stops and/or the dropping of the load.

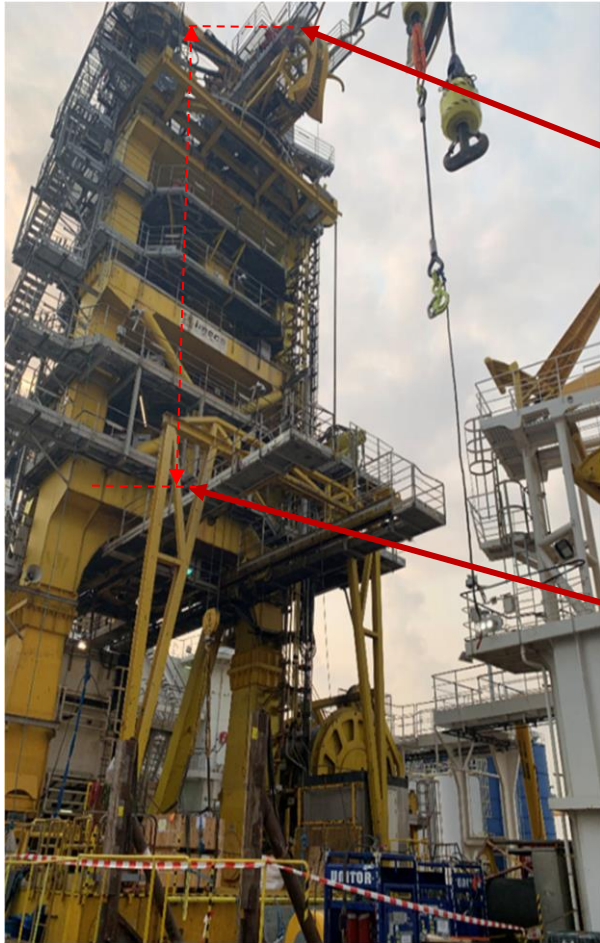
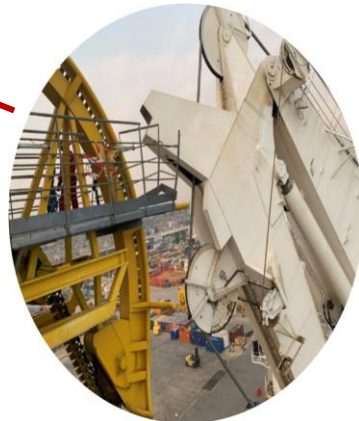
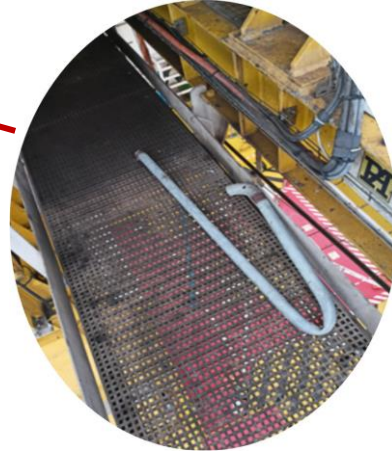
A crane made contact with a pipelay tower handrail during a routine lifting operation, resulting in a serious dropped object event. There were no injuries. The incident occurred during repositioning of a chain link clump weight on the main deck using a 250T crane whip line. The boom rest landing section on the boom knuckle came into contact with the top gutter walkway guardrails on the pipelay tower. A section of the rail (approx. 1.2 m and 5.5kg) broke off and fell approximately 22m to a walkway below.

- There was a lapse in concentration due to distractions during the operation;
- The banksman was primarily focused on the load and its travel path rather than on the crane itself;
- The crane operator’s view was obstructed by the knuckle boom;
- The crew were new to the vessel:
  - There was a lack of awareness of possible clash points and were not highlighted in the deck induction;
  - The crew were not familiar with the vessel set-up when working in close proximity to tower;
- There was an unidentified hazard (i.e. deck structure clash points);
- There were no engineering controls to warn the crane operator of close proximity to a structure.

- **Are we out of the line of fire?** Discuss what key controls you have in place to remove yourself and your team members from the potential line of fire;
- Ensure drop zones are identified for any potential clash points when performing lifting operations in close proximity to other structures or equipment;
- Ensure there is a robust and effective barrier management process used to manage all drop zones;
- Ensure all potential crane collision points are identified and included in worksite inductions, toolbox talks and risk assessments;
- Where applicable, ensure additional 'spotters' are used to assist the banksman.
