IMCA Safety Flashes summarise key safety matters and incidents, allowing lessons to be more easily learnt for the benefit of all. The effectiveness of the IMCA Safety Flash system depends on Members sharing information and so avoiding repeat incidents. Please consider adding safetyreports@imca-int.com to your internal distribution list for safety alerts or manually submitting information on incidents you consider may be relevant. All information is anonymised or sanitised, as appropriate.

2 MSF: Hand Injury Sustained During Routine Checks

3 Electrician suffered flash burn to hand

4 Failure of in-service saturation bailout bottle

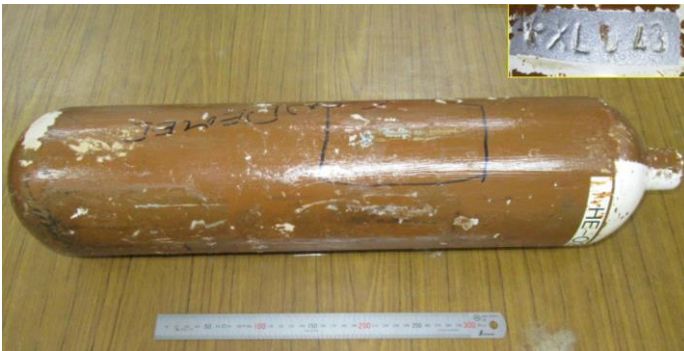
Upon recovery to deck, the bailout bottle was found to have 3 pin holes on the side wall hidden by a locking clasp. Saturation diving operations were suspended and all bailout bottles from the same manufacture of the same type were taken out of service and quarantined.

Leaking cylinder

A through-wall defect 42mm long approx. was observed, with 3 small leak paths.

- Verify that third-party procedures are fit for purpose and followed;
- Improve receipt inspection and storage of bailout bottles to ensure they are dried and sealed.

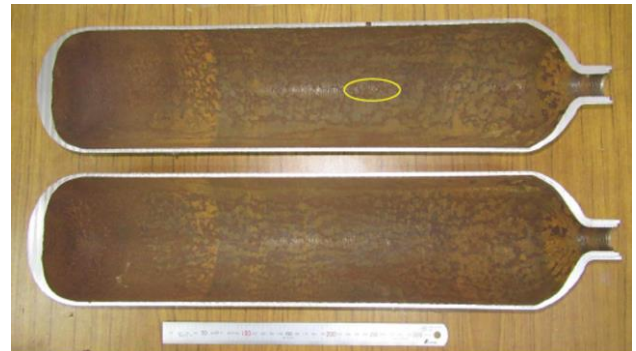
Internal surface of cylinder, showing corrosion over entire surface. Leak location circled.

- The primary factor was water/moisture on the internal surface of the cylinder, promoting corrosion. High levels of chlorides and possibly produced hydrogen may have led to the Stress Corrosion (SCC) and/or Hydrogen Stress Cracking (HSC) mechanisms;
- The root cause was suspected to be third-party testing and/or unsuitable long-term storage.

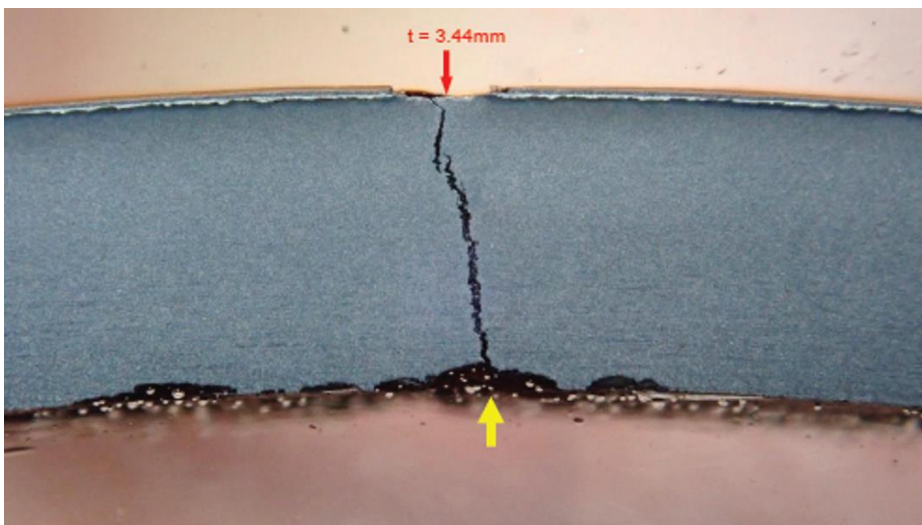
A cross-section through the cylinder wall at the leak location showing a through-thickness crack. The cylinder suffered internal corrosion at the crack location, with a measured remaining wall thickness of 3.44mm.

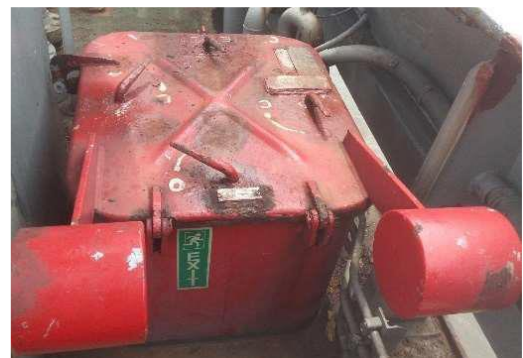
It was discovered, during an inspection onboard, that the emergency escape hatch leading from the steering gear compartment to the main deck walkway on the starboard side, was rusted shut, stuck and could not be opened.

- The crew were not familiar with the importance of this emergency escape hatch;
- There was a poor maintenance culture;
- Onboard responsibility for safety was neglected.

Escape hatch rusted closed

- Check that all emergency escape hatches and fire doors are always free from obstacles and/or obstruction;
- Add routine inspection of emergency escape hatches to planned maintenance system;
- Ensure hinges are greased and maintained properly.

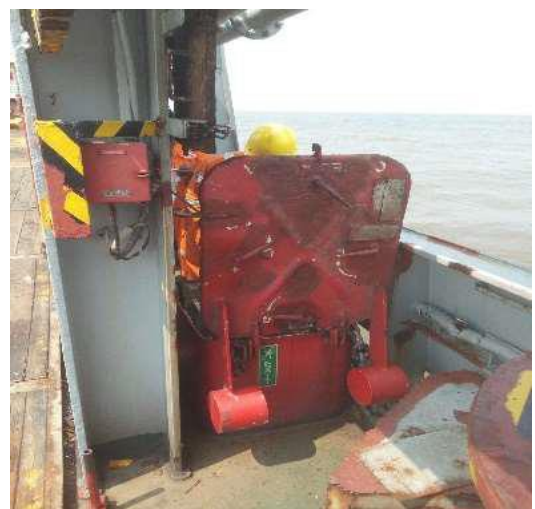
Escape hatch made free after greasing
