1 Serious incident: topsides started swinging during lifting

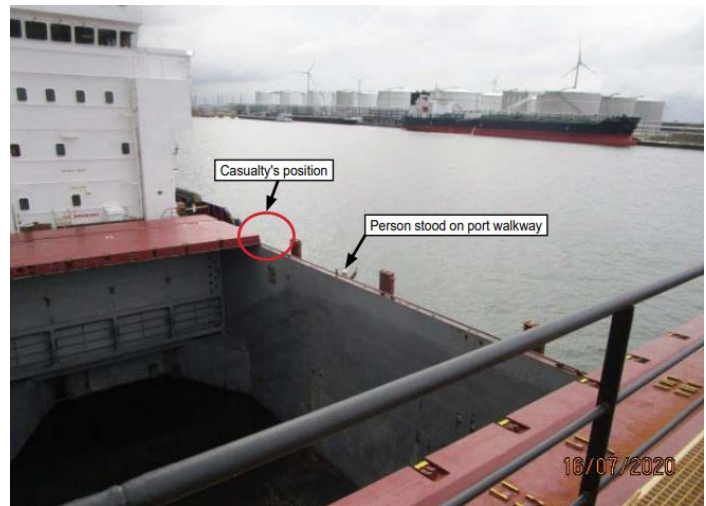
A crewman was fatally crushed when he became trapped between the vessel's gantry crane and a cargo hatch cover. No one saw the crewman position himself between the moving gantry crane and the hatch cover, but his likely intent was to assess the progress being made by his team working in the hold.

- The crewman was fatally crushed between the gantry crane and the hatch cover because he placed himself in the path of the moving crane and the crane did not stop;
- The crewman almost certainly knew the gantry crane was moving but was probably confident that he could achieve his objective and move out of its path;
- The ship's gantry crane operator did not stop the crane because he did not know the crewman was in the way.

- The chief officer did not have a full view of the crane's path from his control position;
- Contrary to the vessel's documented procedures, a second crew member was not used to act as a lookout or banksman;
- The hatch cover lifting operation was not properly planned, adequately supervised, or executed in a safe manner;
- Communication between the ship's crew and port crew was poor and the safety culture demonstrated by both was weak.

- Made it mandatory that there be a second person to act as safety sentry during the operation of cranes, gantry cranes or hatch cover machinery;
- Reviewed its safety procedures for such operations;
- Issued a safety instruction card, defining the role of safety lookout for all crane operations.

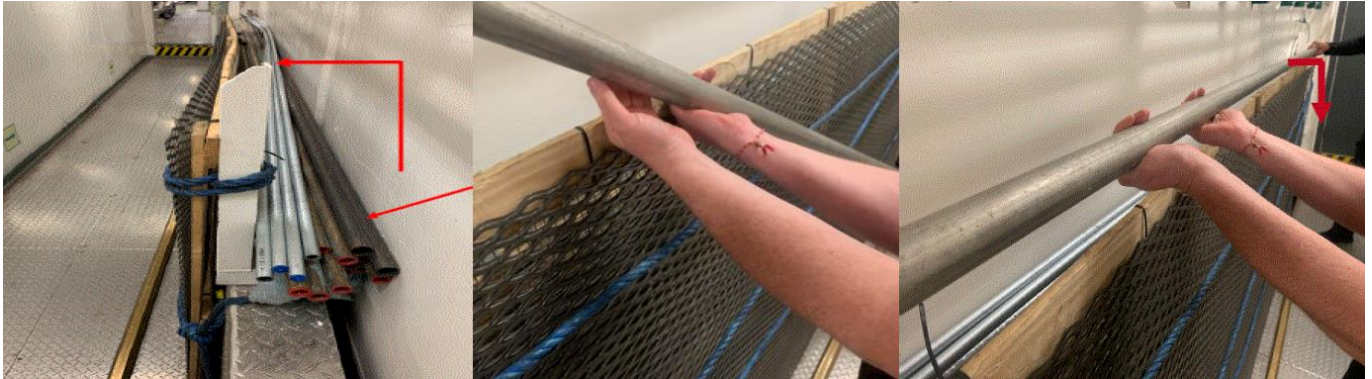
A crewman on a vessel suffered laceration on three fingers of the left hand while attempting to remove brass bar from the storage rack. The injury caused an LTI.

He was removing a brass bar (3m long, 47kg weight, 46 mm dia.) from the storage rack. The brass bar was lying behind a wooden frame and behind two pieces of expanded metal mesh sheets. Working alone, the injured person lifted the bar in stages to remove it from its storage. He first lifted the forward end of the bar which suddenly slipped, forcing his left hand downwards and against sharp edges on the steel wire mesh which, ripping into the skin under the weight of the bar, caused the injury.

- The injured person did not risk assess the job correctly, and misjudged the weight of the brass bar (47kg);
- The injured person did not ask for help in moving the bar, deciding to work alone;
- The injured person was not wearing safety gloves during this job.

- Check and re-assess the suitability of storage for materials and equipment;
 - Consider the adequacy of access, egress, lighting, ergonomics, stability influences such as weather and wind, lighting, and ergonomics;
- If lone working cannot be avoided wherever possible, ensure that when persons are working alone, this is adequately covered by Task Risk Assessments (TRA);
- **Wear gloves for work like this!** The wearing of task specific Personal Protective Equipment (PPE) should be noted in the risk assessment, and reinforced at toolbox talks.

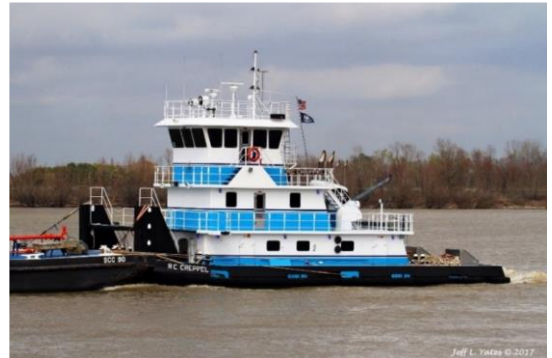
One towing vessel was moving 40 barges upriver, and another was moving two barges downriver, when they collided. As a result, one of the towing vessels capsized. Minutes later, a third vessel going upriver made contact with the some of the barges being towed. All 42 barges from both tows broke free and were later recovered.

One of the four members of the crew of the capsized vessel was rescued; the remaining three were never recovered and are presumed dead. The accident resulted in the release of about 8,000 gallons (US) of diesel fuel into the river and sulphuric acid vapours into the atmosphere, and property damage to three vessels and 11 barges, costing an estimated US\$3.8 million.

- The two pilots' **insufficient radio communication** before meeting in a bend of the river;
- **Not broadcasting accurate AIS information** regarding tow size.

- **Ensuring adequate communications** – whilst this incident is about communications as an aspect of seamanship, the same principles apply to communications between:
 - Shifts at shift change time;
 - Crews at crew handover time;
 - Departments within the vessel – bridge team, lifting personnel etc.,
 - Departments within a company – project, crewing, human resources, engineering etc.,
 - Client and contractor, and contractor and sub-contractor.
- **Up to date information** – ensuring that all appropriate and up to date information is available to all stakeholders, is likewise a lesson applicable not only to the bridge operation but to all. To do so helps to alleviate possible misinterpretation and enhances situational awareness.
