IMCA Safety Flashes summarise key safety matters and incidents, allowing lessons to be more easily learnt for the benefit of all. The effectiveness of the IMCA Safety Flash system depends on Members sharing information and so avoiding repeat incidents. Please consider adding safetyreports@imca-int.com to your internal distribution list for safety alerts or manually submitting information on incidents you consider may be relevant. All information is anonymised or sanitised, as appropriate.

1 Portable electrical equipment – serious fire in the accommodation

2 Rope under tension parted on deck

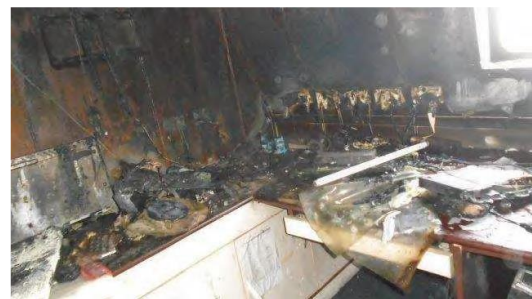
It was noted that first appearances showed the bedroom of the cabin to be completely damaged. The damage in the day room was much less. This had given the initial impression that the fire had originated from the bedroom. However investigation revealed that the fire had actually started from the day room.

Further investigation showed that the fire was caused by an electric kettle in the day room which had been left on while the occupant was not in the cabin. **There is a very high probability that the kettle cut-off safety switch did not operate.** This led to the overheating and caused smouldering eventual catching fire of the kettle handle and all the subsequent fire.

Burnt out day room of cabin

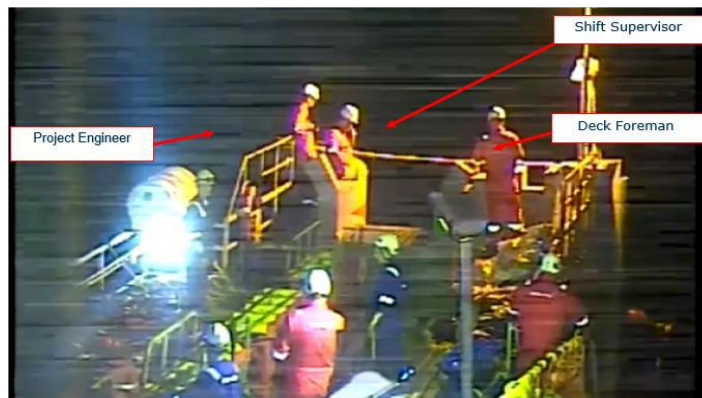
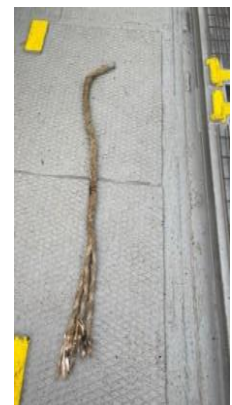
The Shift Supervisor, positioned at the top of the chute platform, noticed a polypropylene rope was attached to the rigging which was not part of the approved rigging arrangement. The polypropylene rope suddenly came under tension, parted, recoiled and struck the Shift Supervisor’s helmet. The helmet shell separated from the inside webbing. No-one was harmed.

- Nine persons were on the cable lay vessel deck at the time, all neglecting the ‘Line of Fire’ Life Saving Rule;
- The crew on the workboat did not follow the company approved rigging arrangement;
- There was no supervision on the workboat to ensure the approved procedure was followed;
- There was a language barrier; the workboat crew only had minimal English.

- Follow the Life-Saving Rules; **do not place yourself in the line of fire;**
- Ensure better close collaboration between third-party vessels:
 - Confirm that procedures have been reviewed by crews
 - Ensure they attend Hazard Identification and Risk Analysis (HIRA) meetings
 - Ensure that they are fully familiar with the task plan on site.
- Ensure adequate levels of supervision for the task in hand;
- Where appropriate, ensure bilingual documentation is available for key documents and that a translator is available who is familiar with the task.

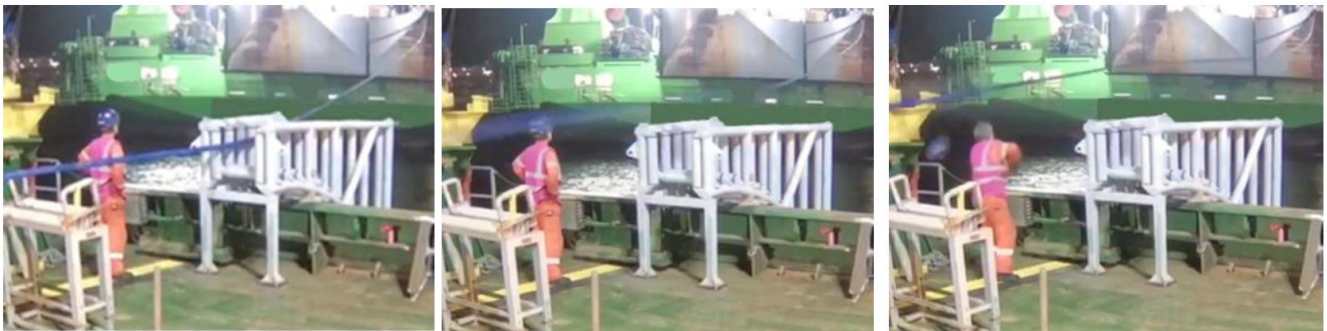
Whilst a messenger rope (a mooring line) was being pulled across from a cable vessel to a barge, a crew member was standing near the chute to visually monitor the operation. Due to the height difference between vessel and barge, the messenger rope crept up as the pull tension increased, until it reached the top of the chute wall and exited the chute. Due to the angle between vessel and barge, the rope violently shot sideways, striking the helmet of the crewmember, knocking his helmet off his head. Had the rope been 10 cm lower (or the crewmember have been 10 cm taller), he would have been hit on the head with potentially very serious (if not fatal) consequences.

Stills from CCTV footage of the actual occurrence, showing the rope striking the crew members' helmet.

- There was a difference between spooling speeds on each cable tank – they were not synchronised. This allowed tension to build up and caused the “climbing up” of the rope in the chute;

- Speak up! Dare to call an **ALL STOP**;
- There was nothing to stop the rope exiting the chute;
 - Our contractor has modified all their chutes, adding a bar across the top to totally enclose the chutes during similar operations – safety by design.

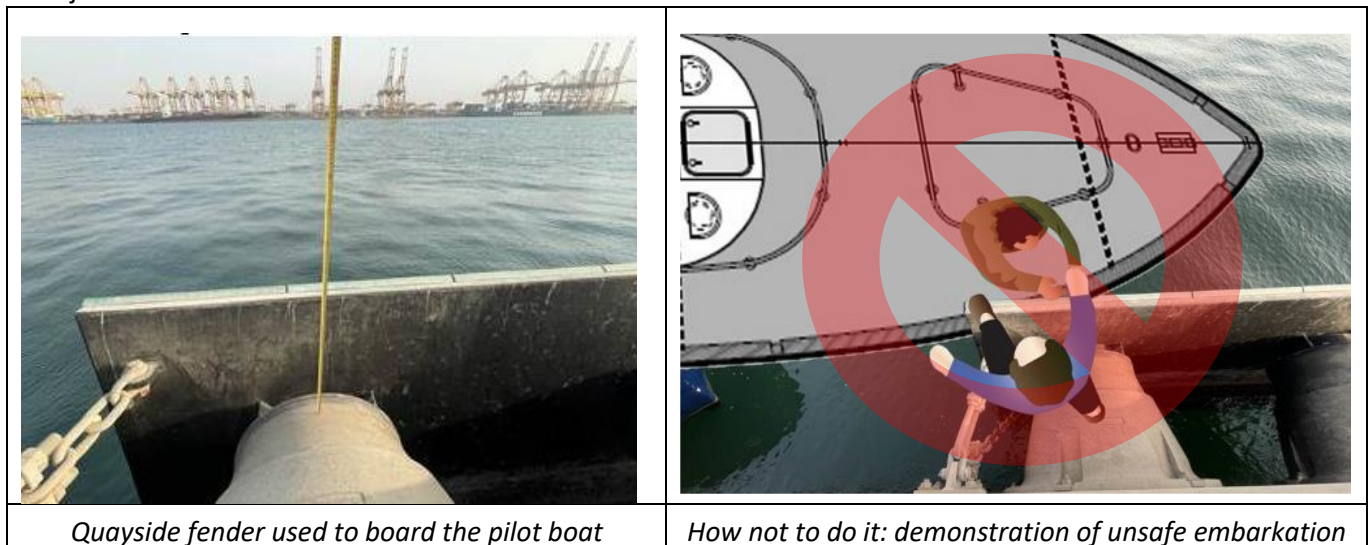
After completing a standard diving activity for underwater hull cleaning on a pilot boat, the diver used the quayside fender to embark from the jetty to the pilot boat. In so doing, his right foot slipped, resulting in an uncontrolled movement. The Diving Supervisor, assisting his safe embarkation onboard the forward deck, also lost his balance, resulting in both of them jumping into the water away from the fender and vessel. Their lifejackets inflated immediately, and both swam towards the quay ladder, located a few meters away. No injuries were sustained.

- There was no suitable means of access/egress to or from the pilot boat;
- Complacency – “task seen as routine”;
- They ought have stopped the job but they didn’t: Stop Work authority was not exercised.

- Find a safe means of access/egress arrangements at temporary locations;
- Re-emphasise importance of Stop work authority as an obligation and responsibility.

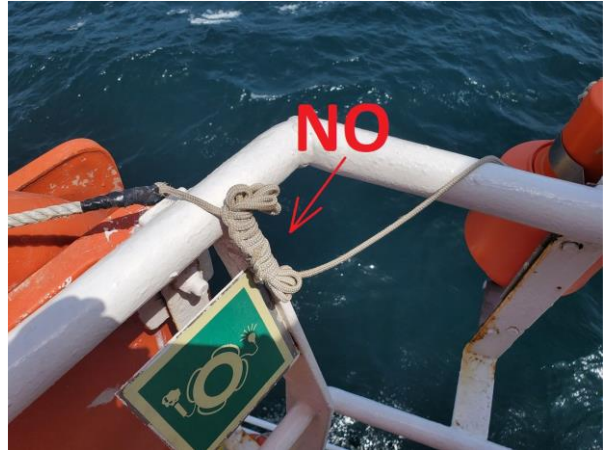
If the lanyard is shortened, the MOB beacon may fail to activate, or, if it were activated, the person who fell overboard may find themselves in the potentially hazardous situation of being too close to the heavily smoking MOB beacon while handling the life buoy.

- There was a lack of understanding of how these Life Buoys operate, as well as failure to perceive relevant hazards;
- There was improper/incomplete inspection of Life Saving Appliances onboard.

- Check length of similar lanyards attached to MOB beacons; the correct length will be prescribed in the manufacturer's manual. It should be long enough to allow the life buoy to gain a good inertia after being thrown, before releasing the MOB beacon from its cradle;
- Include check of MOB beacon in planned maintenance schedule.
