1 NTSB: The sinking of the *El Faro* – an illustrated digest

2 Unexpected movement of conductor during diver dredging operations

3 Defective embarkation ladder quarantined – a reminder

4 USCG: Corrosion causing structural failure on accommodation ladders

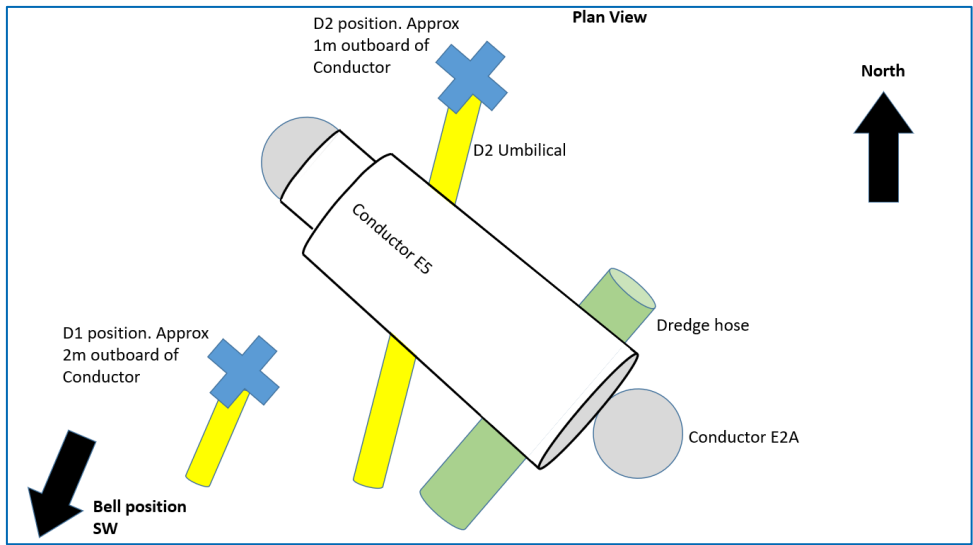
Divers were conducting dredging operations in preparation for an external cut of a conductor (E5 in the diagram below) using a diamond wire saw. Due to seabed conditions, this was one of a number of dives dedicated to making conditions suitable for the conductor cutting. As the divers continued dredging, the conductor moved unexpectedly and came to rest against an adjacent conductor (E2 in the diagram below).

Diver 2's umbilical was found to be in free span between the two conductors. As a precaution, the decision was made to secure the conductor to the vessel crane and manoeuvre the vessel to allow the umbilical to be released. This was conducted successfully, and the divers recovered to bell with no injury nor damage to umbilical.

- **Immediate Cause** - Conductor toppled at a severance point due to displacement of surrounding seabed and grout during dredging operations;

- **Underlying Causes** - assumption that the conductor was stable, due to:
 - Information relating to the task (an incomplete sub-surface cut) had not been highlighted during client work pack compilation
 - Unclear datum measurement with respect to the as-found mudline and potential scouring.
- **Root Cause** – the vessel team did not have all the relevant information they needed, to complete a suitable Management of Change to move from internal to external cutting of the conductor.

- Change to methodology for diver work around conductors, so that they are restrained with rigging prior to any dredging operations;
- Ensure suitable verification of data by client during onshore project preparation phase;
- Refine and update existing engineering best practice and risk assessment for cutting operations;
- Ensure management of change procedure provides suitable guidance on process for evaluating and approving change request in line with agreed risk level.

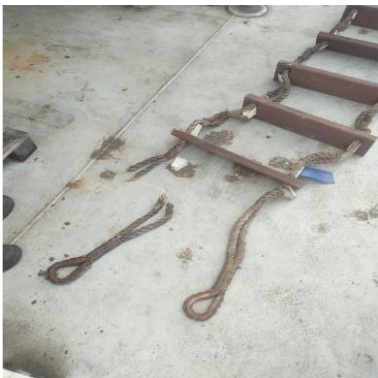
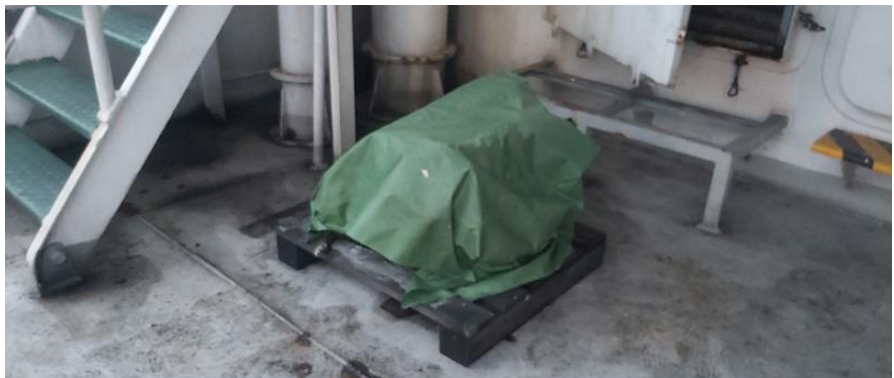
During routine inspection of the port side embarkation ladder on a vessel operating in a tropical environment, it was observed that the embarkation ladder rope has become very weak and snapped, when pulled apart by hands. This could likely have led to a man overboard situation had the ladder been used.

- The protective canvas cover was inadequate, not providing adequate protection for the ladder;
- The crew had a poor culture of routine inspection;
- Exposure to seawater and sunlight (actinic degradation).

- Pilot ladders and other ladders should be appropriately and carefully stored, checked regularly as part of a planned maintenance system, and defective ladders removed from service immediately.

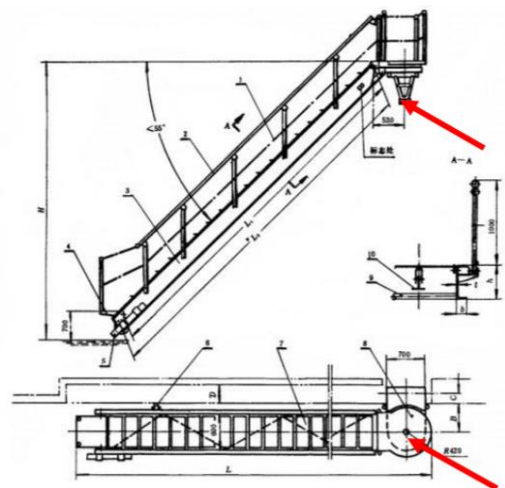
Pin location on the Accommodation Ladder Turntable

The USCG reported that *“a recent marine casualty resulting in an injury of a crewmember onboard a foreign freight vessel brought to light a potentially dangerous situation involving the **turntable pin on accommodation ladders**. Currently, there are no established timelines or requirements to replace turntable pins. Without proper and periodic examination and replacement, corrosion can ultimately lead to structural failure.”*

The USCG noted multiple foreign (not American) flagged vessels had accommodation ladder turntable pins in service for more than 20 years without replacement. Guidelines on the maintenance of accommodation ladders is contained within 74 SOLAS (14) II-1/3-9, MSC.1/Circ. 1331, and 74 SOLAS (14) III/20.7.2; however, none of the aforementioned references include maintenance guidelines for the turntable pins.

The USCG notes that while the turntable pin may seem like a minor component, its failure can cause significant harm to all persons utilizing the accommodation ladder. In this instance, the vessel’s crew was in the process of stowing the accommodation ladder when the turntable pin failed. As a result, a crewmember who was on the accommodation ladder at the time fell approximately 30 feet and sustained serious injuries.

- Maintain the turntable pins;
- Periodically inspect the condition of the turntable pins and replace them when necessary;
- Revise accommodation ladder maintenance plans to include turntable pins.

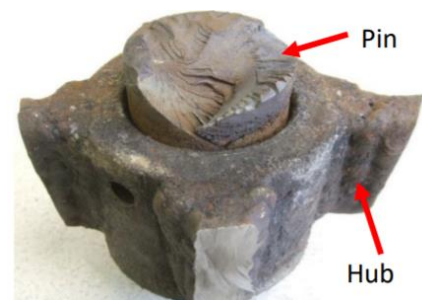
Accommodation ladder connection pin with severe corrosion over the pin's fracture surface & sidewall and on the surface of the hub.

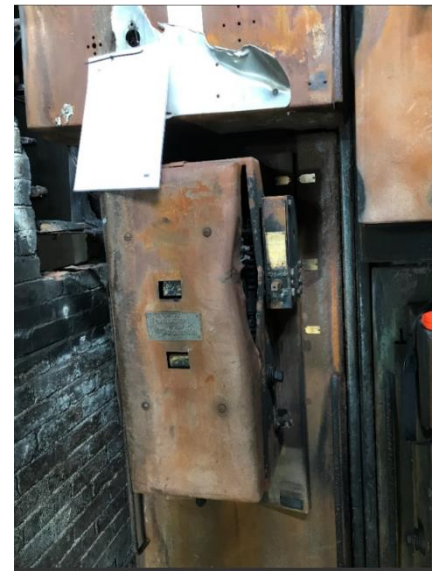
There was a catastrophic failure and explosion of a HV circuit breaker leading to a fire which could have resulted in fatal injuries.

The HSE report noted that *“maintenance of HV and LV circuit breakers typically involves both the cleaning and lubricating of the operating mechanism. The HSE investigation found that the **same physical product was used for both maintenance activities, but evidence shows the product was in fact only suitable for cleaning and NOT lubrication.** This situation may have arisen because of the availability of different products, (for different purposes), within the same product range, or changes to the products composition over time whilst retaining the original name. It is essential that the correct product is used for each task.”*

- 'stiction' in the failed circuit breaker may have been a result of an incorrect aerosol based multi-purpose lubricant being used on the circuit breaker;
- Independent forensic analysis showed that the multipurpose lubricant used during the maintenance of the failed circuit breaker prior to the incident, evaporated by 75% of its original weight within 2 weeks of application. **The analysis concluded that for this reason, multi-purpose lubricants containing solvents (e.g. white spirit) are unsuitable for use as a lubricant of this type of HV and LV switchgear.**

Photograph of the HV circuit breaker taken after the catastrophic failure, which resulted in fire and explosion within the substation.

- Review maintenance procedures associated with cleaning and lubrication of HV and LV circuit breakers;
- Check that the maintenance procedure ensures that the manufacturer instructions on cleaning and lubrication of the circuit breaker mechanism are followed at appropriate intervals, including the selection and application of the correctly specified lubricants (typically this will be two separate types of product).
