1 De-Rusting Incident Resulting In Eye Injury

2 MSF: Eye Injury Whilst Opening Paint Tin Lid

3 Hand pinched between cable and cable roller frame

4 Failure of first stage regulator low pressure (LP) blanking cap

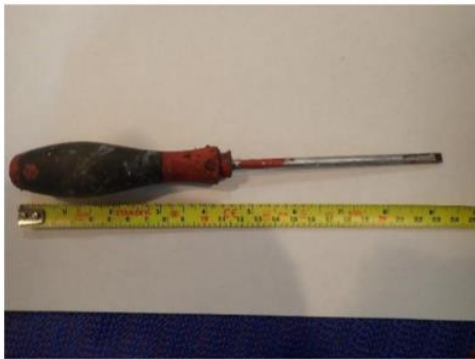
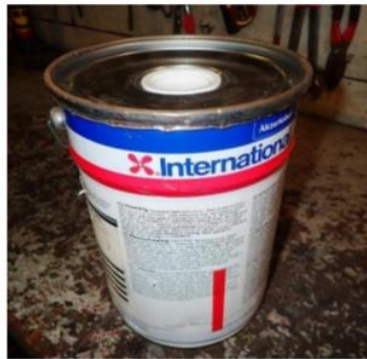
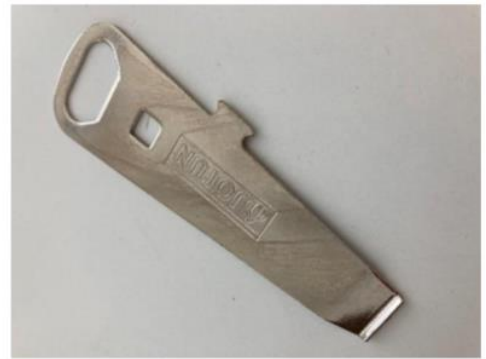
- There was no defined tool or recommendation for opening this type of paint tin lid;
- The Risk Assessment in place did not capture the task of removing the paint tin lid as a hazard;
- By design, the paint tin lid was rounded and tight fitting, which was also deemed a contributing factor as the screwdriver required force to separate the paint tin lid from the tin itself. Given that the screwdriver used was of the long-handled type, it was also considered difficult to control.

- Purchase of a safer alternative in the form of a specific paint tin opening tool (see images) was agreed, with the use of screwdrivers prohibited for the task.

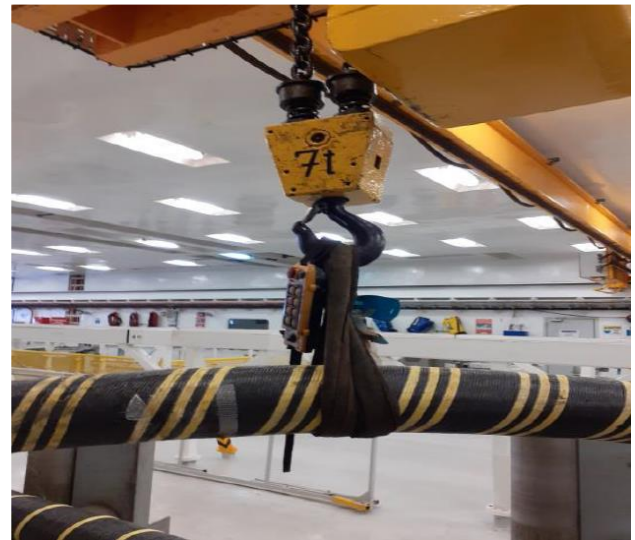
A person got their hand trapped between the cable and an upright steel frame post of the roller table, leading to a hand injury. After completion of testing of the cable, the cable was to be placed back on the roller table. Due to the limitation of the deck gantry crane, the cable end had to be lifted by approximately 10cm to clear the vertical cable roller post. When lowering the cable, the injured person's hand was pinched between the frame post and the cable, causing a laceration to his hand even through his protective glove.

Cable lifted with the deck gantry crane to place the cable back on the roller table

- Follow the “Life-saving Rules” and never place yourself in the line of fire;
- Have a “hazard hunt”: take a close look at injury risk from contact with pinch points, entrapment or other line of fire hazards;
- Ensure everyone fully understands what is going to happen - conduct a worksite risk assessment review;
- Where appropriate perform a last-minute risk assessment.

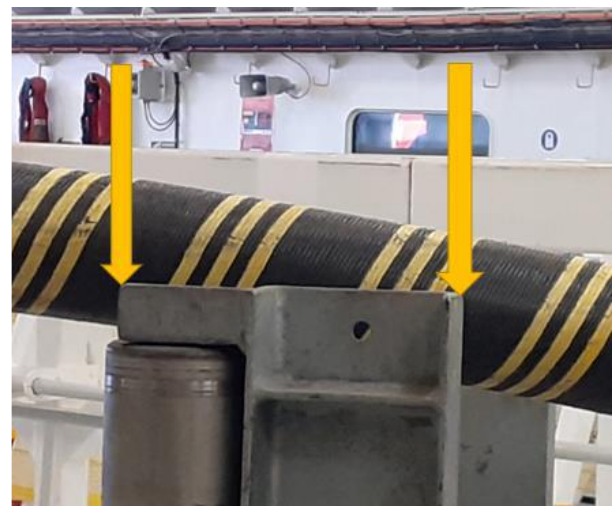
- The Task Risk Assessment covering the set-up for the testing of cable did not include the movement of the cable end, and so the related hazards were not highlighted;
- **The operation was considered a routine task** (IMCA emphasis) during cable load out and there was no Toolbox Talk specific to this task. Hazards were covered in the daily shift tool box talk;
- The pinch points on the cable highway were insufficiently marked;
- The injured person was the Supervisor – or acting as such - and supported the work by actively putting his hand onto the cable;
- **“Stop the Job” authority** was not used to tighten the rigging arrangement and/or move the rigging to a better place so that the cable could have been lifted over the post with the gantry crane.

Pinch points on the frame post

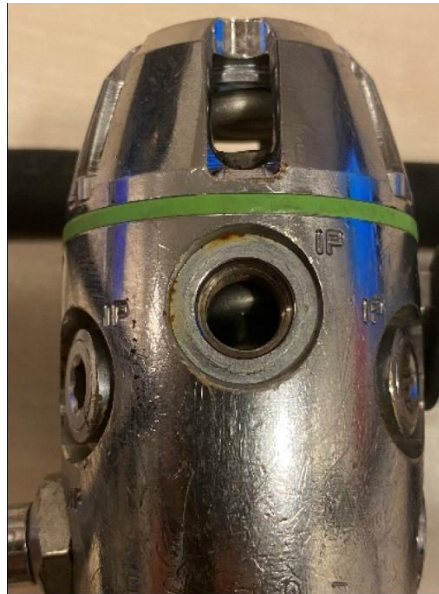
During a dive, a leak was noted coming from the first stage of diver #2's regulator on the bail out bottle. Further inspection identified that the low-pressure port blanking cap was found to have failed. The dive was terminated, the divers recovered safely, and the regulator was removed from service.

Regulator with 1st stage with low pressure port identified

- Immediate actions:
 - Manufacturers recommendations
 - O-rings to be replaced at each service or every two years
 - Confirm torque settings of 2N to be applied to all blanking caps
 - Diving Contractors actions
 - Replace all blanking caps and O-rings on existing in service 1st stage regulators;
 - Update work orders to confirm torque settings of 2N to be applied to all blanking caps;
- Further actions:
 - Release as IMCA safety flash;
 - Identify and assess condition of all 1st stage regulators that have been in service in excess of 10 years for possible replacement.

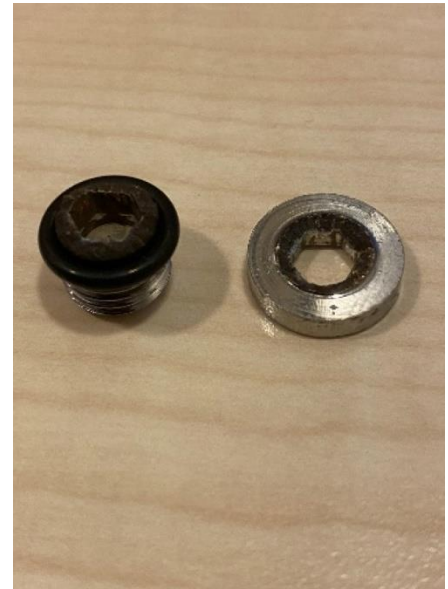
During the investigation of the regulator there were no signs of damage to the body or any of the associated hoses, fittings or the gauge. The regulator was within its recommended annual service period.

The two pieces of the failed blanking plug

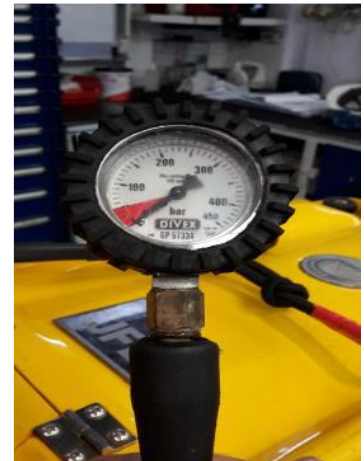
- Immediate Cause - failure of thread
- Underlying Cause - impact load placed on thread connection during use
 - Dive technical examination by subject matter experts concluded that the thread failed due to dynamic damage, likely caused by being bumped, knocked or stood on during use.

Area where gauge failed

- All COBRA and bail out gauges inspected and replaced as necessary;
- Planned Maintenance System updated to include monthly inspection of contents gauge, inclusive of gauge being removed from the HP hose to check integrity of fittings;
- Third-party inspection of failed gauge;
- Improved traceability through all contents gauges being serialized units.
