## 1 Shackle failure during over-boarding of pennant wire and ballast chain

## 2 MSF: Dropped object during cargo discharge operations

### 3 MOB: person fell into water during gangway installation

## 5 Fuel oil hose burst during bunkering

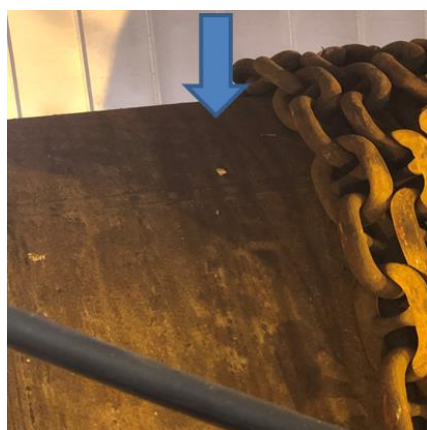
*Breaking point location of shackle on drum*

- Evidence suggested that during the over-boarding of the chain, the nut on the shackle pin became lodged behind the stud piece of the chain link whilst wrapped on the winch drum.
  - When tension was applied on this section of the chain the links straightened and caused the nut of the shackle to be forced off along with the stud piece.
  - The resultant shock may have then forced the pin out of the shackle and allowed the chain to part;
  - At the point of shackle failure, the chain on the winch drum became loose and whipped towards the special handling winch causing multiple impact damage to surrounding equipment;

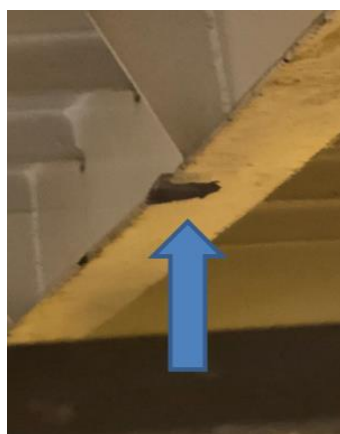
*Impact damage from flying chain directly above*

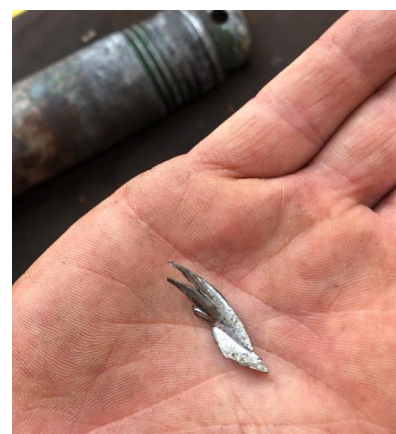
*Sheared piece of metal from shackle pin – found close to the winch where the beam was damaged*

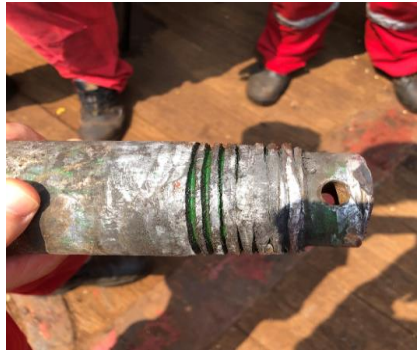
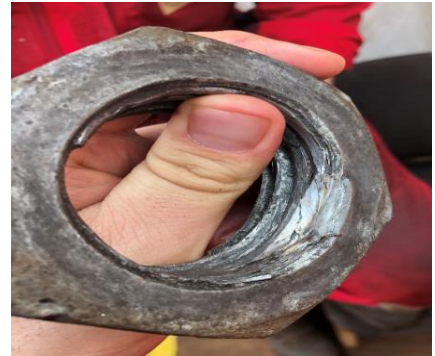
- The chain was connected with 35t shackles which have multiple edges that can be caught or trapped inside other equipment, especially the nuts.

*Pictures of damaged shackle nut and pin – shackle nut located STB side of winch near walkway and shackle pin found at the back of the winch. (Clear indication the shackle was side loaded)*

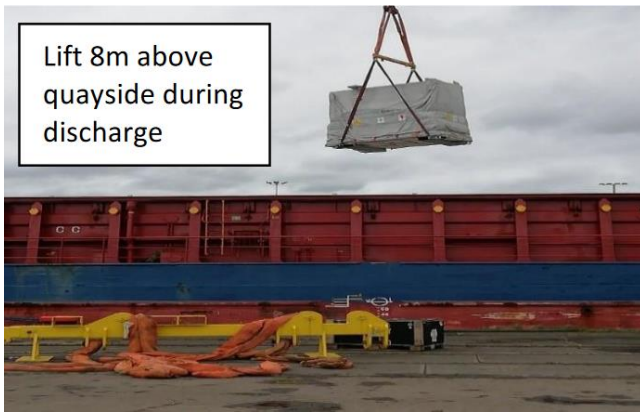
Lift 8m above quayside during discharge

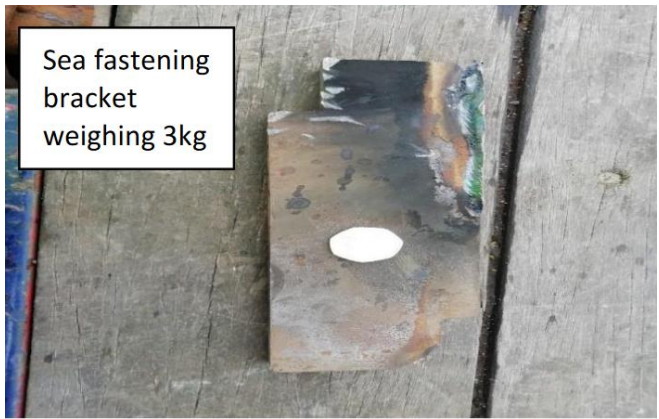
A cargo ship loaded with cargo for the renewables sector was being discharged using a mobile shore crane when a sea fastening bracket weighing about 3 kg fell out of a forklift pocket from a generator that was being offloaded and landed onto a trailer on the quayside.

Sea fastening bracket weighing 3kg

- The importance of dropped object sweeps was reiterated to the crew.
- IMCA notes that there may be a lesson here in terms of additional vigilance when doing repetitive work. 320 sea fastenings, and two were missed.

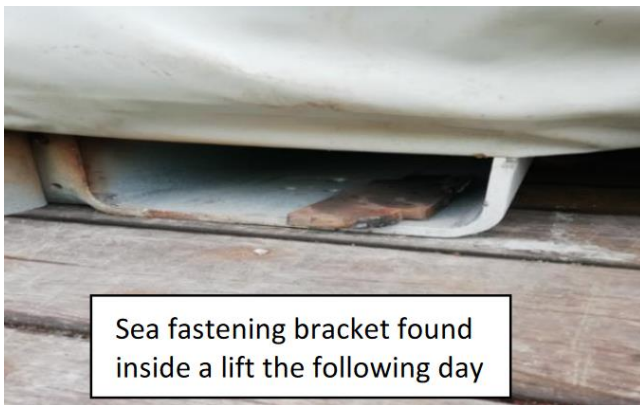
Sea fastening bracket found inside a lift the following day

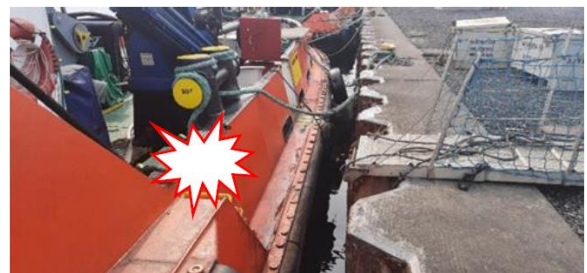
AB2 attempted to lift the gangway (see photo) but was unable to heave it high enough to release the trapped foot. He then stepped aside with the gangway and at that moment he lost his footing and slipped and fell into the water.

Area where crew member fell into water

- Use Toolbox Talks, even for the most ordinary or everyday operation;
- Ensure better communication between bridge and deck at all times, not just when installing gangways;
- Check onboard arrangements for manual handling of gangways, including development of Risk Assessment
- Ensure sufficient supervised and properly rested crew are available for the job.

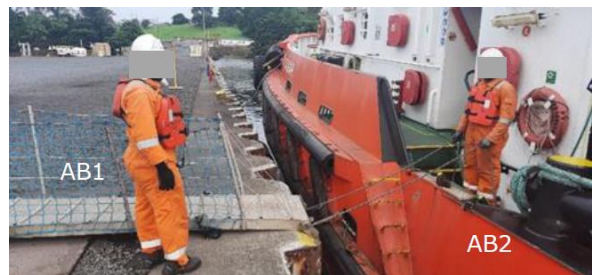
One crew person (AB1) went ashore to pass the gangway ropes to a second person (AB2) on the vessel. AB2 began to pull the ropes without informing AB1, and as a result AB1's foot became trapped under the gangway. AB1 could not pick up the gangway from the midway position to release his foot because the only item for lifting in this position was the net and rope which runs through the stanchions. So he asked AB2, on the vessel, to pick up the gangway from the vessel to release his foot.

Position of ABs during installation

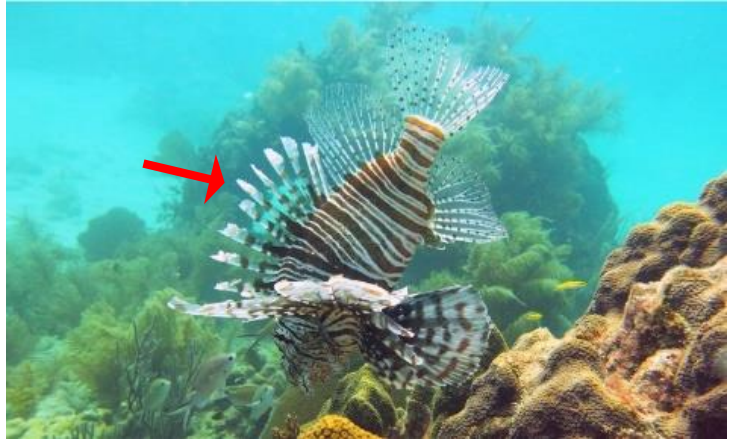
A diver suffered a finger injury from a Lionfish fin ray. The incident occurred during diving operations, when the diver went to pick up some tooling and the Lionfish came close to the diver. The diver tried to push the fish away, and in doing so his right thumb was pricked by one of the fin rays of the fish. The diver was recovered to the bell; on closer inspection there was a slight bleeding and small piece of the fin ray lodged in thumb. The bell was recovered to surface, where the medic assessed the injury and treated with a wash, dressing and pain killer.

*A Lionfish (Fin Ray highlighted)*

- Review of gloves worn by divers to ensure suitability for protection against venomous fish in that region;
- Refresher training with dive team on venomous fish hazard and update of risk assessment;
- Additional controls implemented for remainder of project:
  - Every Dive team briefing included risk of venomous fish;
  - Dive Supervisor monitor video feed and warn of any Lionfish in vicinity;
  - Divers increased buddy watching in water to warn of fish in vicinity.

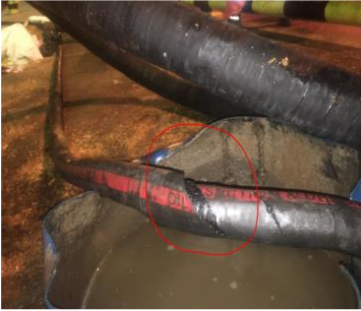
During bunkering a vessel in port, a 2" fuel oil hose burst. The hose burst as the fuel transfer rate was increased at the start of the operation. Around 30-50 litres of fuel oil were spilled on the jetty. Owing to the quick reactions of the Master and crew, no fuel went overboard.

Our member notes that this is a preliminary cause and investigation is ongoing. The reason for the failure has yet to be confirmed; the hose had recently undergone a third-party test and certification.

*Section of the hose that failed*

- Inspect cargo hose stowage and consider whether those that are stowed in a coiled position, need to be moved or changed in position more frequently so as to avoid damage / kinks in the same location.

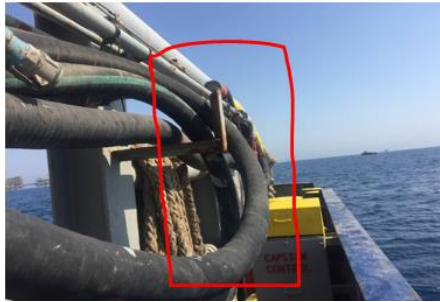
*Stowage of hoses in coiled position due to long lengths*

A suggestion raised was that the fuel oil hose had been damaged over long periods of time by being stowed in an improper coiled position due to its length (longer than the deck stowing location).

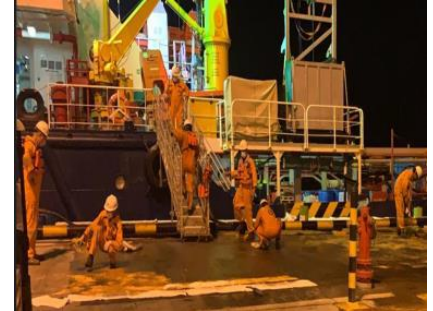
*Crew immediate response in containing the spill*
