1 USCG: Unexpected heavy weather dangers

2 Dropped object: dislodged flex-joint laydown tool component

3 H₂S detected in a bilge tank

4 Use of damaged electrical equipment by dock workers

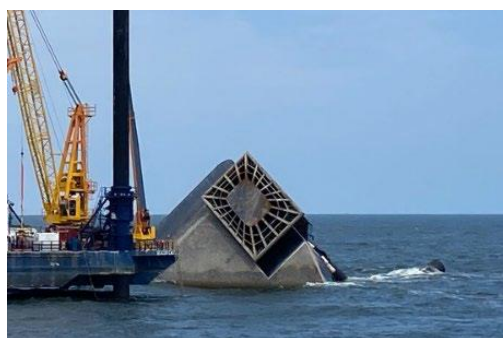
The capsized lift boat SEACOR POWER

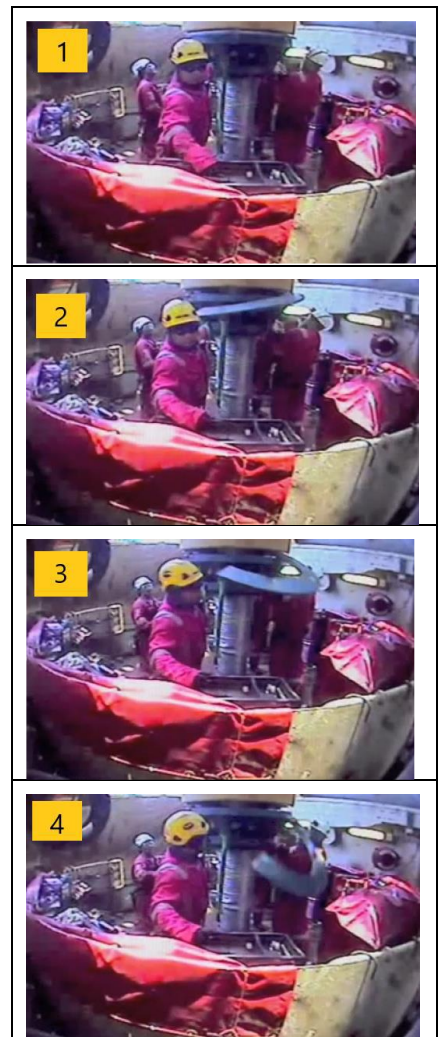
During removal of the anti-rotation/laydown tool from a Flex-Joint, a load-ring half plate, weighing 85kg, was inadvertently dislodged and dropped about 1.8m to deck.

Crew on a J-Lay Tower were removing the anti-rotation device/laydown. The tower was tilted to 5 degrees at the time of the incident. A team of riggers and technicians proceeded to remove the half plates, which form part of the laydown tool. After the load ring securing plate was removed and the final jacking bolt had been loosened, one load ring element slid out of the assembly and dropped down onto deck.

- Procedures not followed:
 - The removal of the load ring plates did not follow the approved procedure. The task plan included the manufacturer's procedure which described the correct way to do it, which required eye bolts and rigging to remove the section of the laydown tool using a crane;
 - The task of removing the load ring half plates manually/by hand was deemed to be faster and required less steps than the approved procedure;
 - The risk associated with the removal of the heavy load rings by hand instead of using a crane was not assessed.

- **Follow the instructions; keep to the procedures!!**
- Any planned changes to the task plan or procedure should require a Management of Change process to be conducted to assess the risks from the change, apply the appropriate controls and gain authorization to proceed;
- If unsure of the correct method to execute a task, or the associated risks, personnel should always speak to their supervisor before attempting the task – don't be afraid to **STOP THE JOB**.

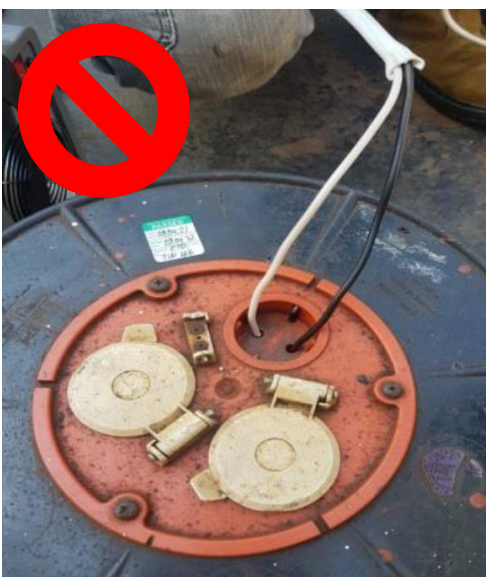
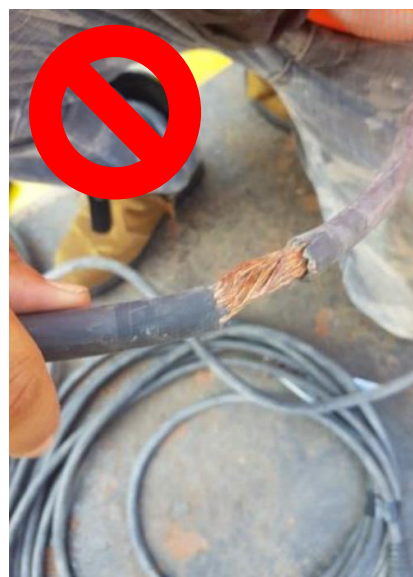
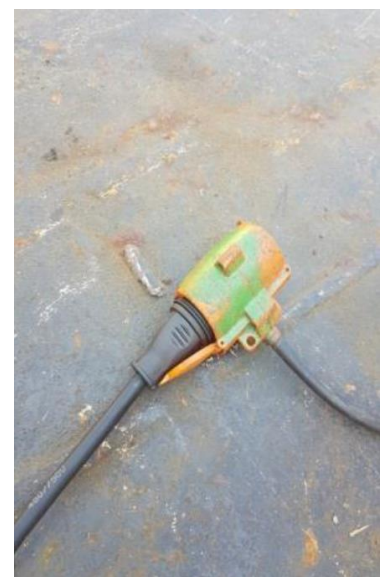
Third-party crew working on a vessel being demobilised were observed using damaged electrical equipment. Third-party welders were preparing to weld the anchor sea-fastening onto the main deck aft. Vessel crew noticed that the electric cable of the welding machine was connected to the electric cord extension without a plug, and the cable cover was damaged.

Our member notes that the third-party workers did not bring the proper tools for the job, nor did they carry out visual inspection of electrical equipment.

The job was immediately stopped. The vessel ETO repaired the damaged wiring and installed an appropriate plug – illustrated in the third photograph on the right below.

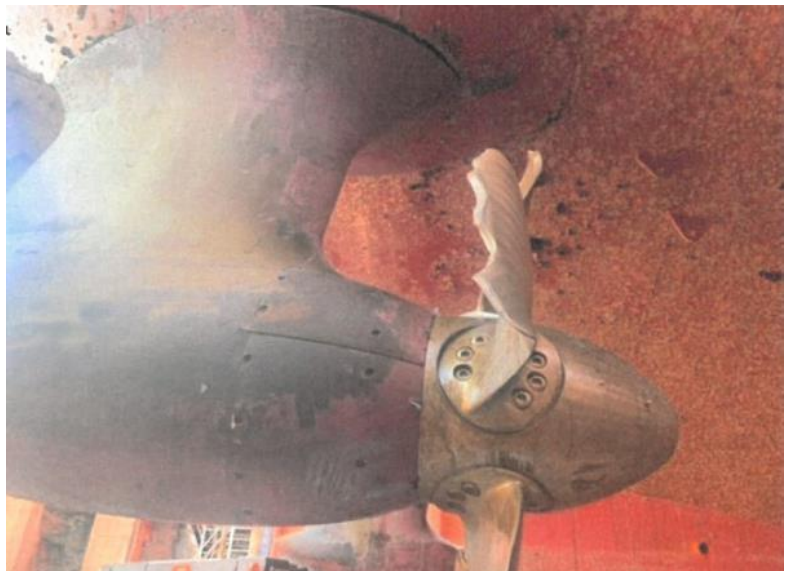
When the vessel passed the safety depth contour, she ran aground, resulting in major hull damage and damage to the propulsion system. There was a leak of hydraulic oil which was limited to approx. 40 litres. The vessel re-floated herself and returned immediately to port. The vessel had to be dry-docked as a result of the damage.

- The settings on the ECDIS were such that critical information was not being displayed;
- The vessel's passage plan was not approved in advance and used a route unvalidated in the ECDIS;
- The officer on watch opted to pass the vessel ahead on their port side.

- The route was not validated in the ECDIS system nor verified before departure;
- Information that could and should have been displayed in ECDIS – that is, “All Dangers” - was not selected;
- The bridge crew did not properly understand safety depth contours and the implications for the vessel of crossing them.

- Ensured that correct and appropriate ECDIS settings are part of voyage plan checklists;
- Updated bridge personnel training on ECDIS
- Ensured deeper and fuller understanding of “safety depth contours” and the implications for vessels.
