The following case studies and observations have been compiled from information received by IMCA. All vessel, client, and operational data has been removed from the narrative to ensure anonymity. Case studies are not intended as guidance on the safe conduct of operations, but rather to assist vessel managers, DP operators and DP technical crew in appropriately determining how to safely conduct their own operations. Any queries should be directed to IMCA at dpreports@imca-int.com. Members and non-members alike are welcome to contact IMCA if they have experienced DP events which can be shared anonymously with the DP industry.

1 Action Error – Was an ASOG in place?

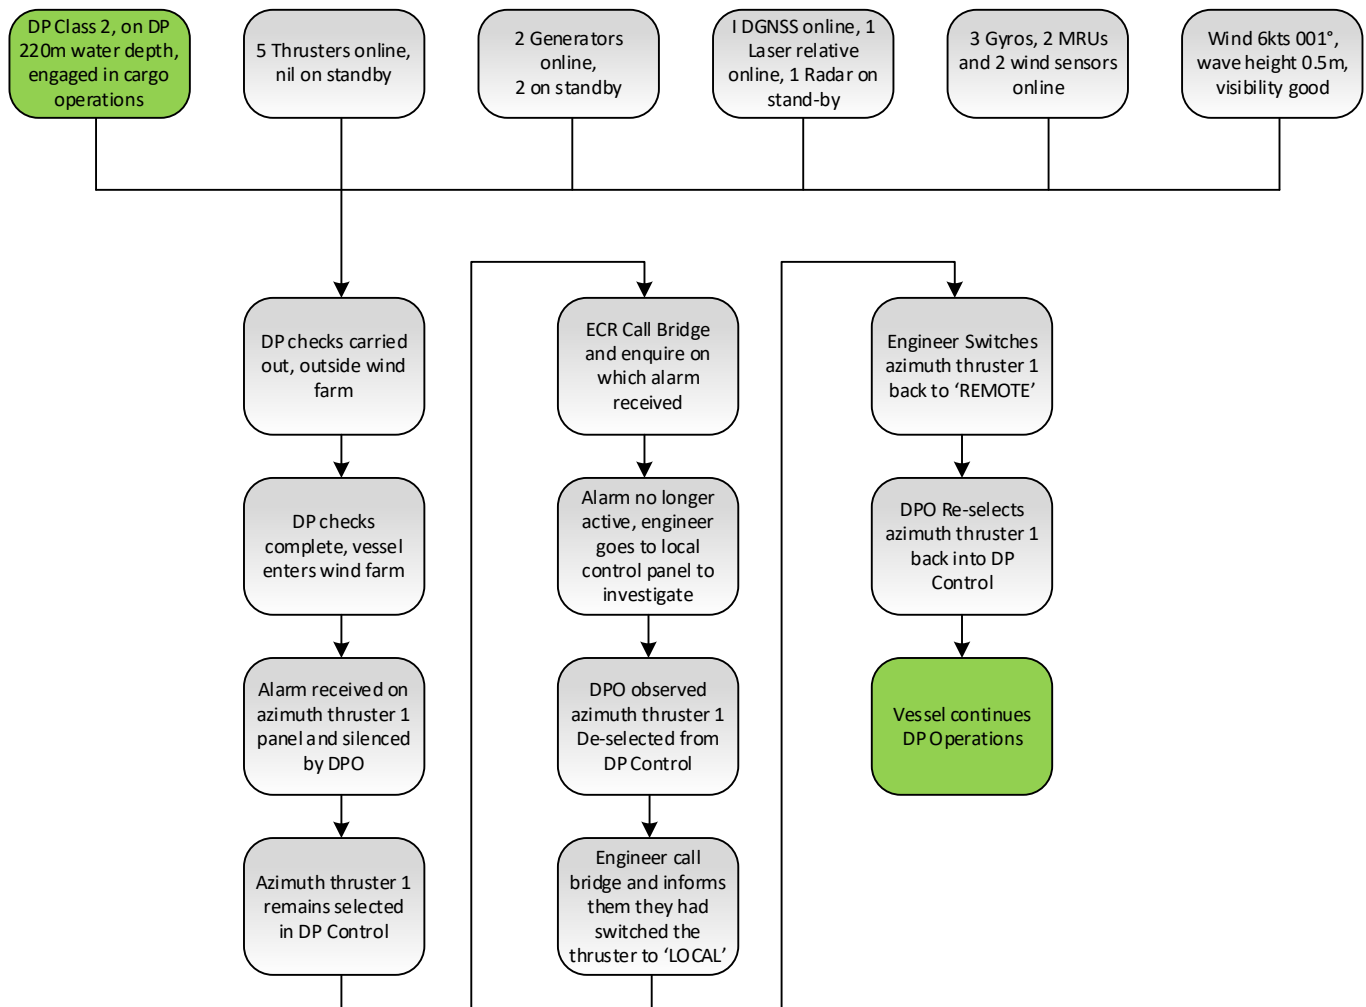
This was a simple case of Key DP personnel not being included in the ASOG process, the ASOG should clearly indicate how critical machinery should be treated whilst carrying out the industrial mission of the vessel. If intrusive fault finding is required, then a change of status would/should be required. The engineer did not consider the consequences of taking the thruster into local control.

This event highlights the need for good operational planning and a detailed accurate ASOG. IMCA M 220 Guidance on operational activity planning, contains guidance on this subject.

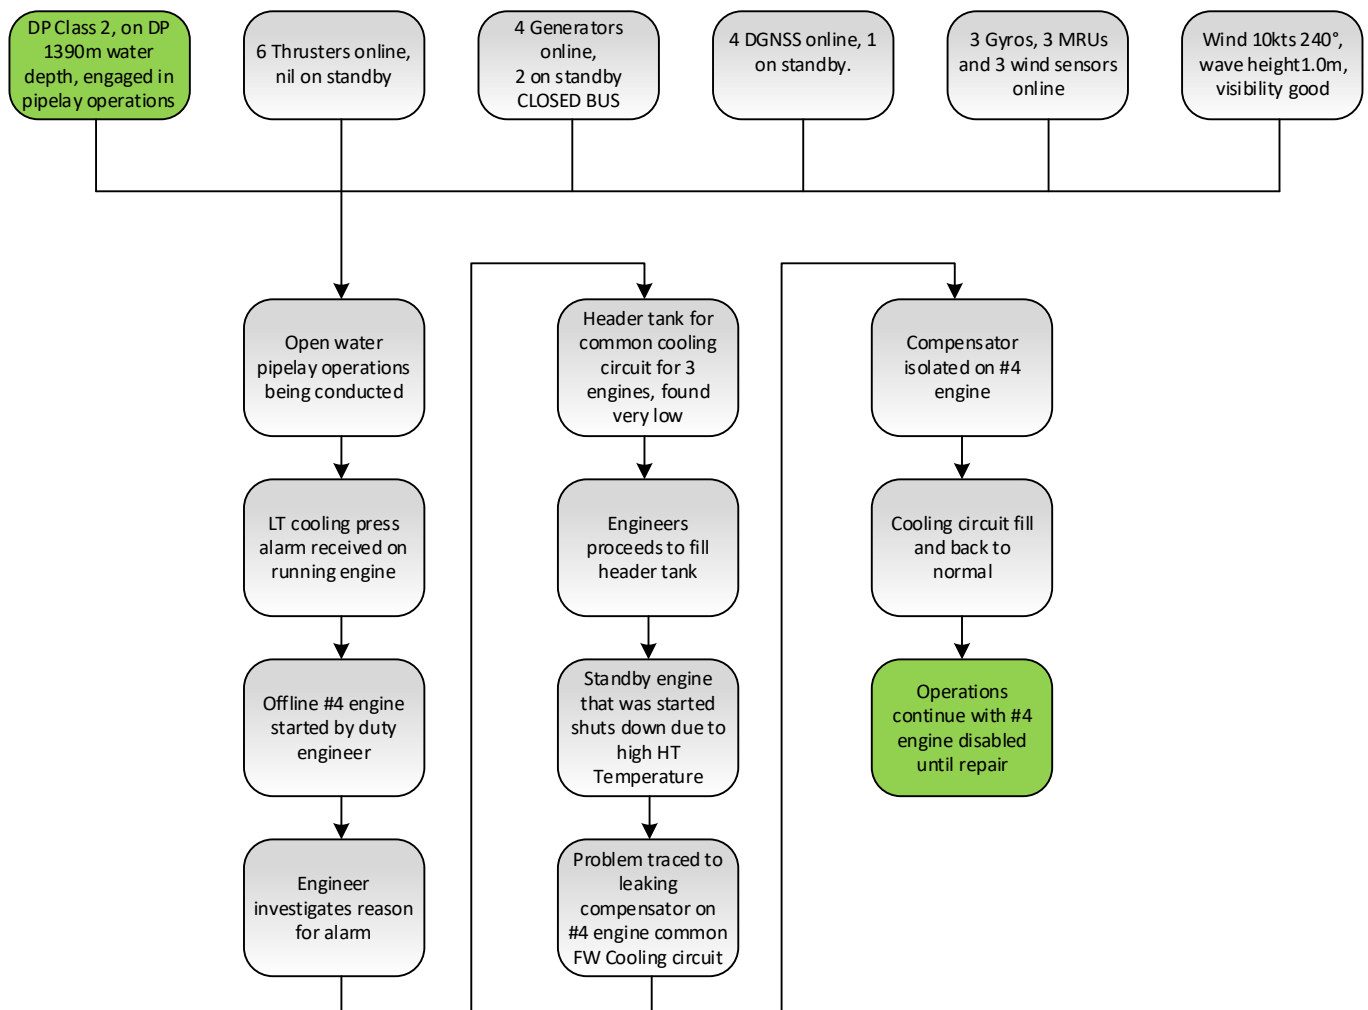
This is a positive report which highlights how familiarity of Key DP Personnel with the vessels Critical DP systems can lead to a successful outcome following a failure, which in this case had the potential to remove one redundant group.

The report highlights the importance of the detection elements of the DP system, and the requirements for periodic testing, such as low-level alarms and pressure transducers.

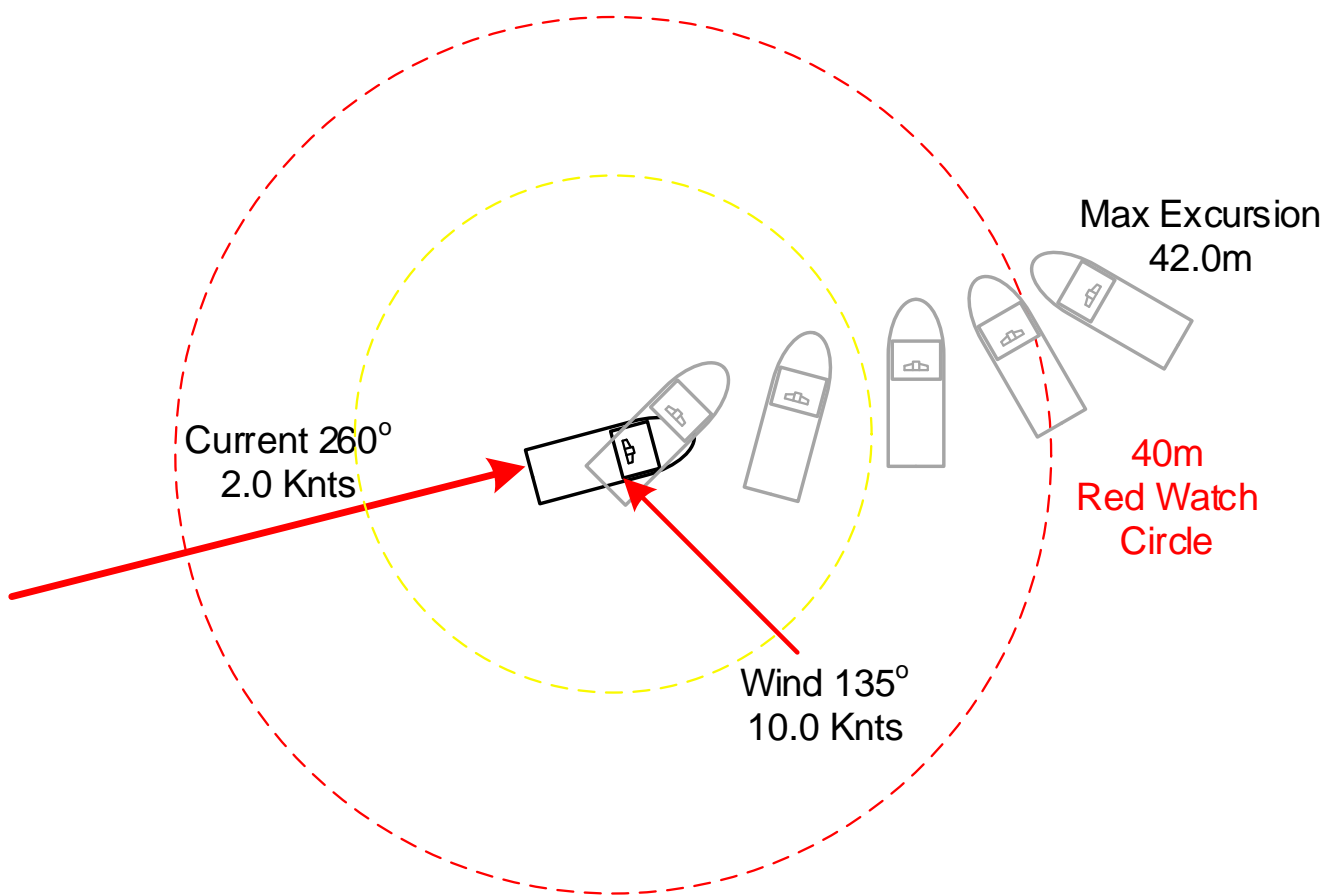
Figure 2 Track of vessel during Heading change

As the heading change was executed, the bow thrusters ramped up to 100% and at 35° into the turn the vessel was already approaching the Yellow watch circle. Gains were adjusted in order to prioritise the heading. When the vessel was abeam of the current, the vessel speed was 0.7knts easterly and increasing, the vessel continued to move off the original position. By 35m off position, the speed of travel was seen to be decreasing. Upon reaching the Red watch circle the speed easterly was at 0.30knts and reducing.

The vessel passed through the Red watch circle and exceeded it by 2m before the vessel started to step back in and return to the original position.

- The decision making process - The parameters around the decision to make the move were not clear from the event report in terms of adherence to ASOG/WSOG, with regards the monitoring of environmental conditions and overall timing of the move.
- The environmental conditions at the time and prior to executing heading change.
- The power of the thrusters were unable to counter the environmental conditions which caused the vessel to breach the Red watch circle.

This event highlights the need for good operational planning and a detailed accurate ASOG/WSOG. Planning needs to include when DP vessels are operating in an increasing environmental condition or close to the fringes of the vessel's capability. Considerations should include:

- a. What are my safe limits for heading or position moves and are these detailed in the ASOG/WSOG?
- b. What are my limits for safe disconnection (or time to terminate) in the case of being unable to maintain position / heading while also considering post worst case failure capability?
- c. Key personnel involved in the decision-making process.
- d. What are my limits for emergency disconnection in the event of loss of position?
- e. What was the Rate of Turn and acceleration values? This may have contributed to the rapid increase of thrust.

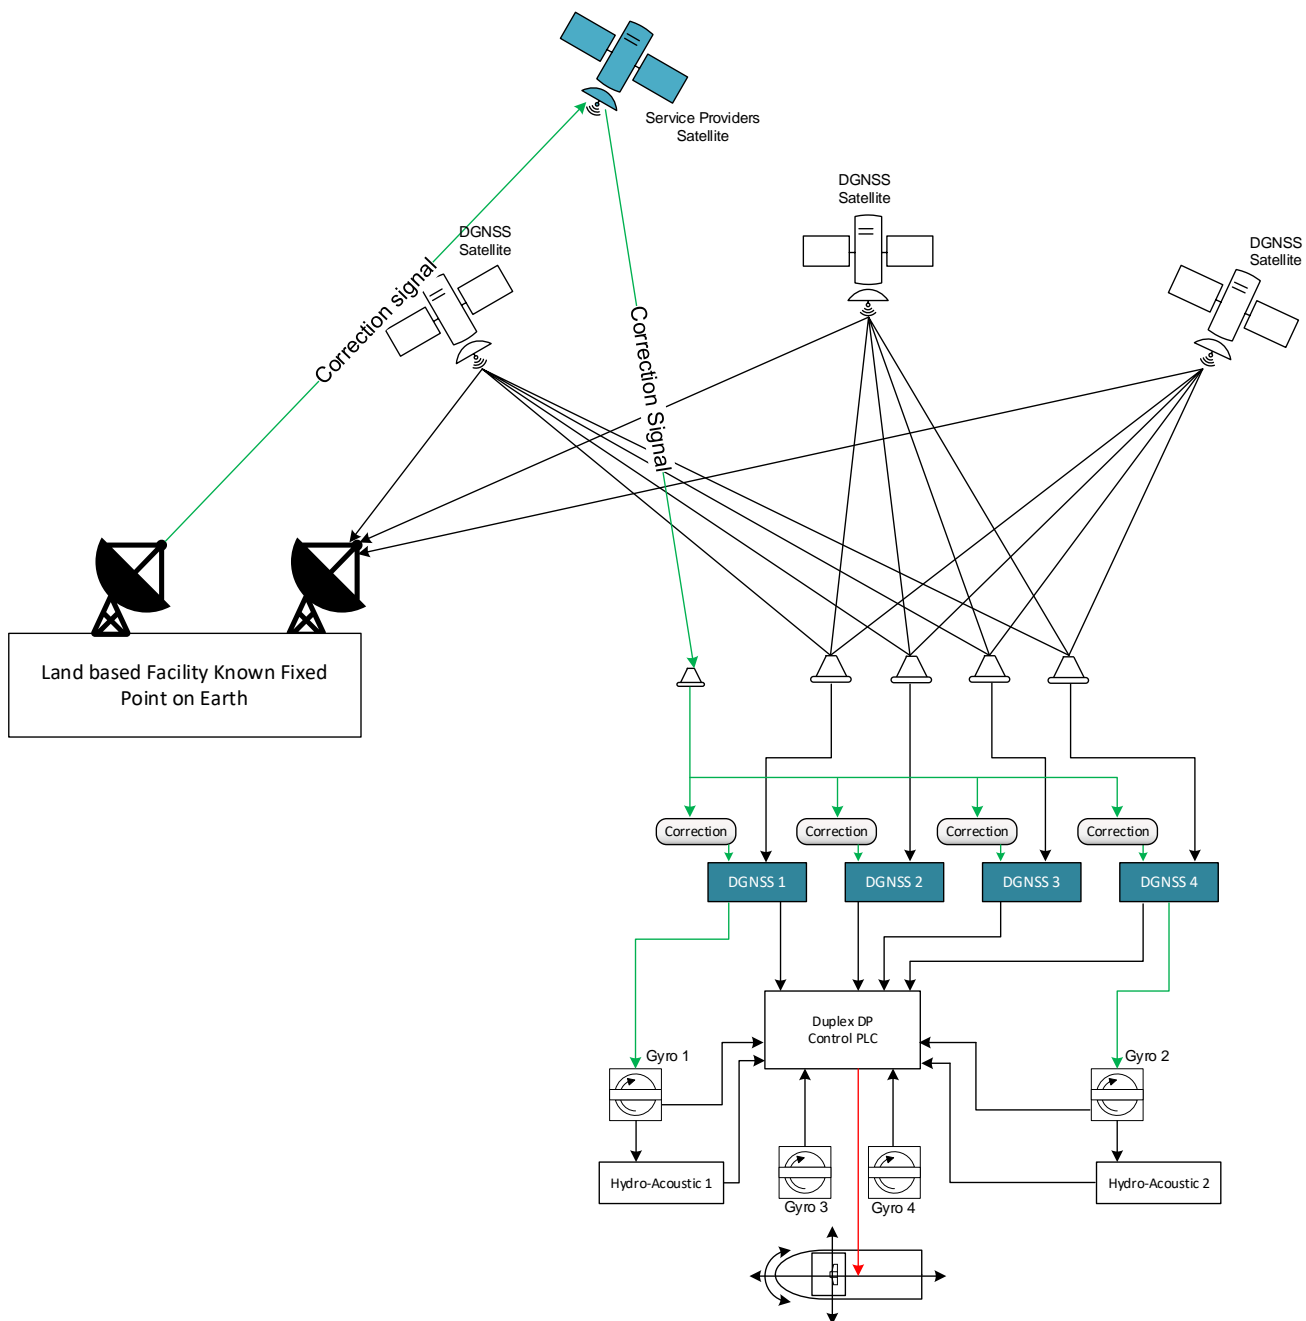
Figure 3 DGNS Correction configuration Prior to Failure

- The correction signal suppliers satellite signal was reported as failed for 1hr 3mins.
- All four of the DGNSS modulators (signal correction modules) were locked onto a single source.

- Failure of the single correction source led to the loss of DGNSS and prompted the DP Control to reject all four DGNSS PRSs.
- Both Gyros 1 & 2 took automatic updates from the DGNSS for latitude & speed correction.

- Upon failure of both Gyro's 1&2 both Hydro-acoustic PRS units were subsequently rejected from DP Control.
 - During the calibration by the Survey team, both Hydro-acoustic systems were connected to Gyros 1 & 2 with auto speed and latitude, instead of Gyro's 3 & 4 with manual speed and latitude setting. In this way, after satellite primary reference loss, it additionally resulted in the loss of the Hydro-acoustic position references.

- A common mode failure had been introduced.

- 5 It is not recommended that the Gyros take an automatic latitude & speed signal, it is recommended for DP vessels that latitude & speed be entered manually – Reference: IMCA M 252 4.6 *Operational Consideration Summary*. Also see **NOTE below**.
