Loosening of COBRA Handle Manifold – JFD Guidance Note

COBRA Bailout System

COBRA Guidance Note

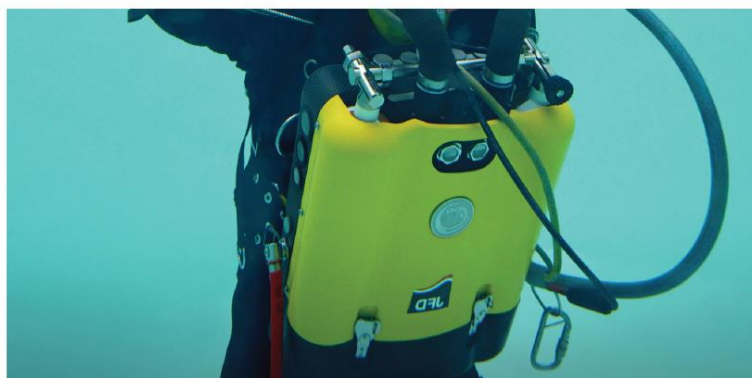
JFD have had reports of the Handle Manifold becoming loose within the Activation Assembly on the Helmet

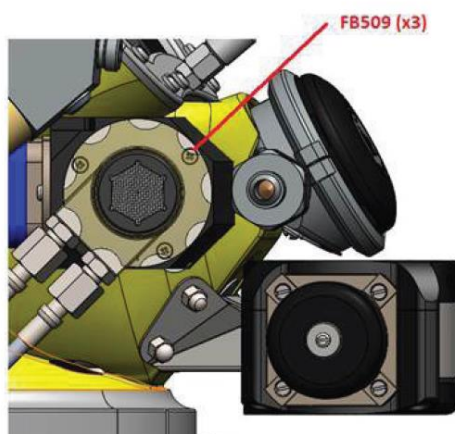
Handle Manifold becoming loose

After repeated use, the M3 countersunk screws (pt. no. FB509) used to secure the Handle Manifold can loosen and occasionally unscrew completely, leaving the Handle Manifold insufficiently secured into the Mouthpiece Housing on the helmet.

The general torque stated in the COBRA manual for an M3 screw in a Tappex insert is insufficient in this location. These 3 screws (pt. no. FB509) should be tightened to 8 inch-pounds. Additionally, Loctite 222 should be applied to the countersink area of the screw only. It is important that the Loctite is not applied to the thread of the screw, as this may cause slackening of the insert when the screw is removed.

It can also be advantageous to remove the Activation Handle to allow improved access to these screws.

The torque of 3 inch-pounds for M3 screws remains appropriate for other locations on the COBRA set.
