1 Cyber-security – malicious spoofing and phishing

2 Watch your hands!! person injured while using an angle grinder

3 UK HSE: Employee in shipyard killed by falling steel post

4 UHMPE pull-in rope damaged during mooring connection to buoy

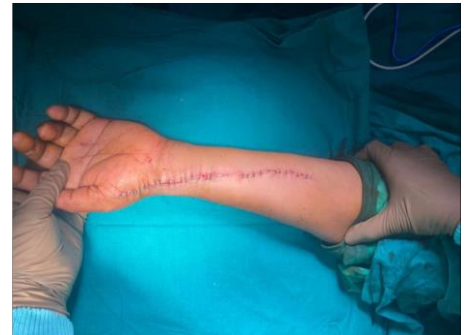
A member of the crew was badly injured whilst cutting a piece of wood using an angle grinder fitted with a cutting blade. He was cutting dunnage for a new washing machine. The vessel rolled and the injured person lost control of the grinder, such that it caught his left arm causing a deep laceration from his left thumb to his elbow.

- He was using a hand-operated power tool in rough weather;
- He was using a wood cutting disc in an angle grinder;
- He started work with no job hazard analysis nor a toolbox talk;
- There was no guard on the grinder nor an automatic “dead man” switch cut-off;
- The wood he was cutting was not supported nor held firm, but just placed on deck. The injured person was using his left hand to hold the job still whilst applying the spinning blade with his right hand.

- Improper handling of hand tools;
- Human Element - poor perception of risk and inadequate supervision;
- The sea conditions - not directly responsible but remaining part of the chain of causation of the event.

- Risk assessment and toolbox talk before starting work – no matter how routine the job;
- Correct and proper management of hand tools
 - Use the right tool for the right job, use guards; use “dead man” switches.
- When using powered tools, ensure the job is secured and cannot move before starting work;
- Appropriate supervision of crew – in this case the chief engineer was unaware that the injured person was doing this work.

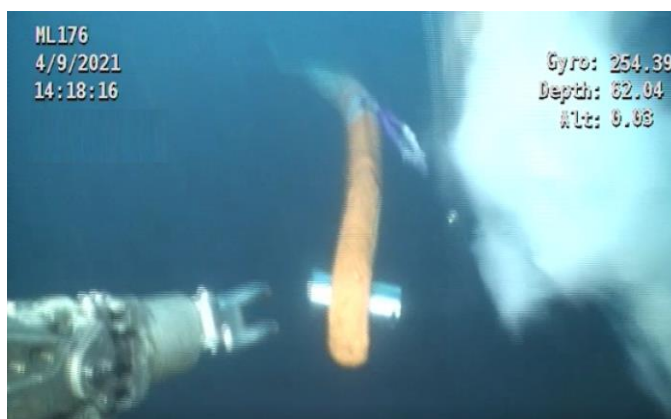
A synthetic pull-in rope used in a subsea mooring operation was violently pulled out of the control of an ROV. The ROV was pulling the thimble side of the rope away from a submerged turret production (STP) buoy when it lost control of the pull-in rope, causing damage to its 7-function arm. The pull-in rope was slowly paying out from a special handling winch, in combination with a capstan to overcome the friction on the full rope over the vessel deck.

Another ROV witnessed the sheave spinning very fast and the pull-in rope spooling off towards the surface, and that the thimble was stuck between the sheave and the buoy.

Slack on the pulling rope built up subsea, creating a catenary close to the vessel's port side propellor. A combination of the sea current, pulling force of the vessel thrusters and wash from the propulsion of another nearby vessel caused the pull rope to be ripped out of the hand of the ROV, and the other end went into the propellor which cut and damaged the rope.

- Immediate causes
 - High sea current (2.8 knots) at time of incident combined with subsea conditions and the effects (wash) of nearby propulsion systems;

- There was insufficient monitoring of the pull-in rope catenary as it went over the vessel stern rollers;
 - The vessel was in an unfavourable heading with respect to the direction of the current.

- Underlying causes
 - The friction acting on the rope from the steel deck, was higher than anticipated;
 - The synthetic (UHMPE) pull-in rope was (too) light;

- The task plan did not appropriately address the environmental conditions subsea;
 - The supplier providing the mooring system confirmed that they did not consider environmental conditions during the design of the equipment.

- Root cause - Ineffective assessment and control of the impact the subsea environmental conditions would have on the pull-in rope during the operation, including design limitations.

- The installation procedure and task plan for this work were amended, particularly with regard to the impact the subsea environmental conditions would have.

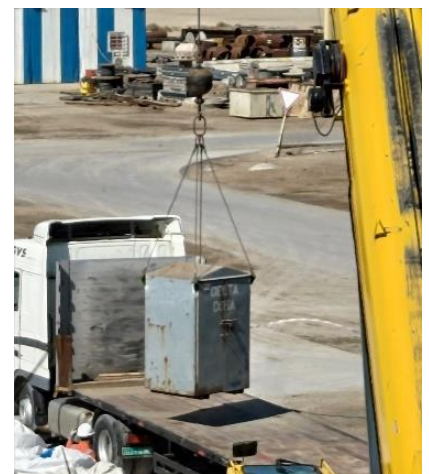
During third-party cargo operations from the dock to the vessel it was noticed that the lift was being conducted using a wire set with no colour code and the cargo/metal box had no valid certification marks. The Second Officer immediately **stopped the work** and asked the client's lifting supervisor to provide relevant assurance on lifting gear and cargo certification. No evidence was provided, and so the cargo was left on the quay and quarantined afterward.

- **KNOW** the lifting requirements and colour coding systems in use on your vessel and by your company's clients;
- **INSPECT** lifting equipment before activities start to ensure that all requirements are met;
- **EMPOWER** any person on the crew to **stop the job** if it is unsafe.
