COBRA Bailout System: Leakage at the Joint Between the Y-piece and the Interface Block - JFD Guidance Note

COBRA Guidance Note

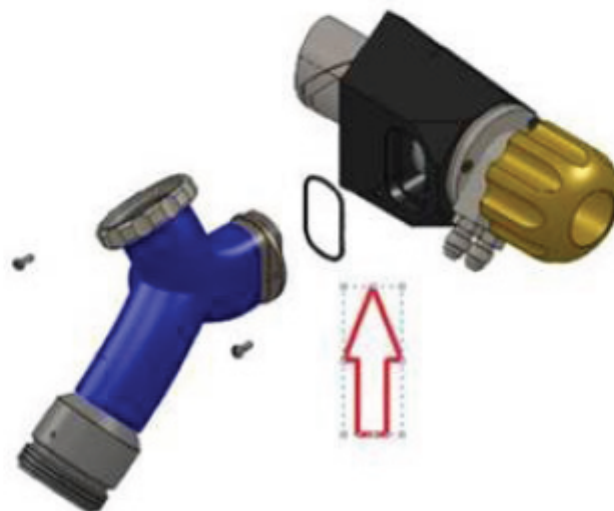
The joint between the Y-piece and the Interface block on the COBRA helmet uses an o-ring seal. Additionally, the joint is coated with silicone RTV as a back-up measure. Although this joint has performed satisfactorily, there have been occasional reports of gas leakage in this area, especially if the helmet receives a knock or impact. The potential for leakage is increased because the spigot and bore are not circular, therefore any twisting at the joint tends to pull the o-ring away from part of the bore causing leakage.

Any time this leakage has been observed, it has been minor and the positive pressure in the COBRA set has prevented water ingress.

Figure 1 - Joint between the Y-piece and interface block with o-ring seal

A replacement o-ring has been identified, that has a larger cross section but a smaller internal diameter. This increased volume of sealing material fills the joint more fully, preventing any leak even if the Y-piece is substantially manipulated. It is not necessary or recommended to use silicone RTV in conjunction with this new seal.

To fit the new seal, disconnect the helmet hose from the Y-piece and remove the clamp holding the Y-piece to the helmet. Remove the two screws fixing the Y-piece to the interface block. Withdraw the Y-piece, discard the o-ring and clean all silicone from the bore and the spigot.

Stretch the new o-ring over the spigot, lubricate and refit the Y-piece to the interface block, pulling the items together using the fixing screws. Refit the other parts, remembering to seal the clamp screws with silicone RTV where they pass through the helmet shell.

Replacement o-ring part number RN0813-7. These will be made available to users on request.
