## 1 Equipment on quay damaged when vessel started listing

## 2 UK HSE: Offshore crane boom hoist failures

### 3 Cargo shifted during heavy weather

**4 NTSB: Engine Failure leads to fire aboard offshore supply vessel**

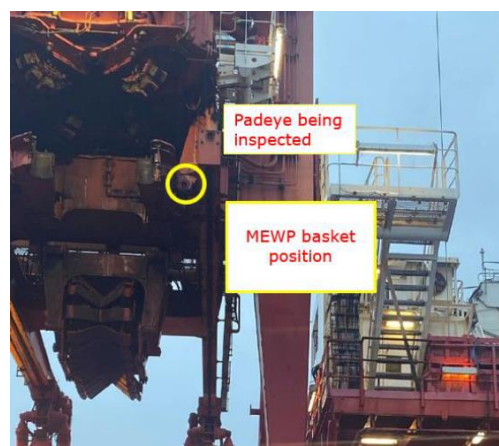
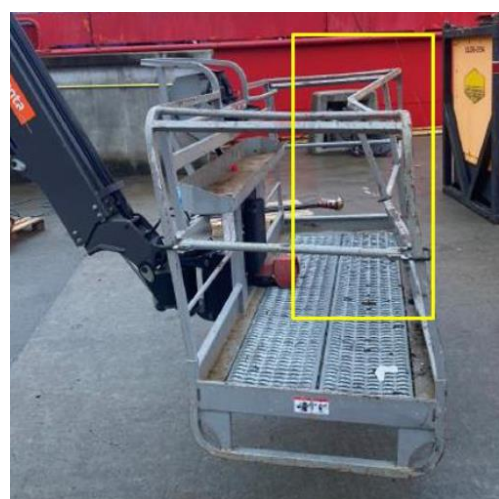
During the inspection of two pad eyes on a Tilttable Lay System (TLS) using a “cherry picker” or mobile elevated work platform on the quayside, the vessel slowly listed, causing the pipelay tower to come into contact with the work basket on the cherry picker. The hand rail on the work basket was damaged.

Uncontrolled simultaneous operations: during the pad eye inspection the vessel was observed to slowly list towards the quayside due to a vessel crane movement;

- Ensure Permit to Work is required for **non-routine** hazardous Working at Height tasks i.e. for tasks where routine established procedures are not in place and in use. Worksite management should be responsible for determining on a case by case basis when a Permit to Work is required for working at height tasks.
- Review and update Task Risk Assessments to include potential for vessel movement and communication of SIMOPS activities;
- Ensure that all work that can be impacted by deck activities, is highlighted and discussed at cross-departmental TBTs;
- Have an effectively practiced and drilled plan for emergency rescue when anyone is working at height;
- If unsure of the correct method to execute a task, or the associated risks, **STOP the JOB** and ASK!

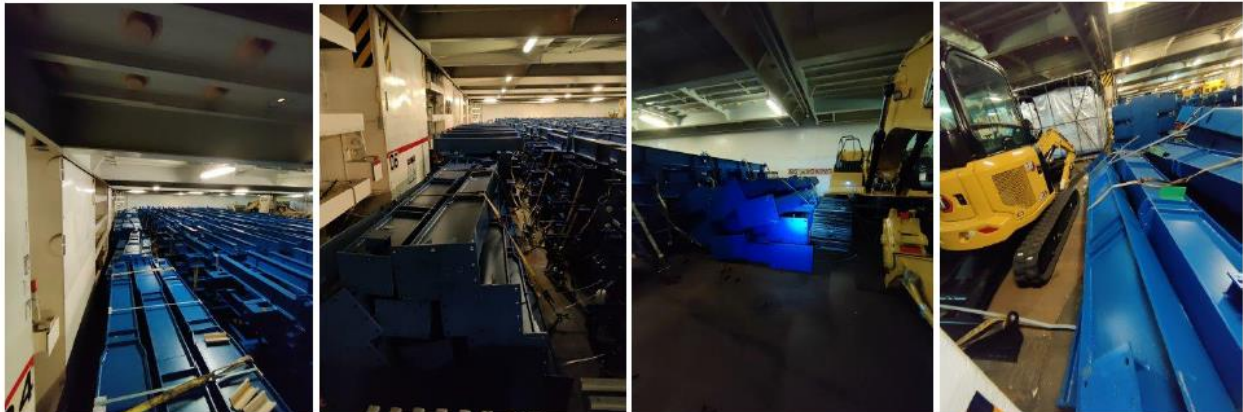
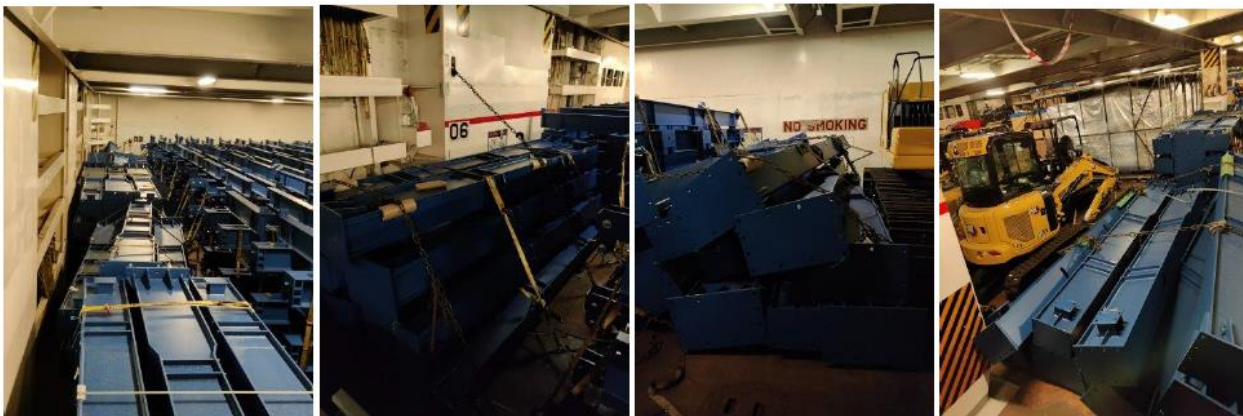
Cargo broke loose in heavy seas on a vessel in transit. Moderate to heavy rolling caused strapping holding stacks of cargo (metal beams) to break, causing the stacks to collapse. Seven stacks collapsed or shifted, and a further three stacks moved to a lesser degree. There was no structural damage to the vessel or to other cargo. The vessel altered course and the collapsed / shifted stacks were re-secured with extra chain lashings.

*Showing stacks of beams having shifted*

- Immediate cause
  - The beam stacks (each over 9000kg and length: 4.5 m x width: 1.7 m x height: 1.9 m) were not loaded or lashed as per the Code of Safe Practice for Cargo Stowage and Securing (CSS code) for such cargo;
- Causal factors
  - Inadequate communication – there was ineffective communication between vessel and charterers;
  - Inadequate supervision – there was misjudgement of vessel movement and external force (wind, wave, and swells),
  - Lack of experience in loading / lashing such type of cargo at the Port of Loading.

- Further training on proper/effective lashing and securing of cargo;
- Discussion end education on need for vigilance and close supervision when loading;
- Additional lashings to be in place in certain weather conditions.

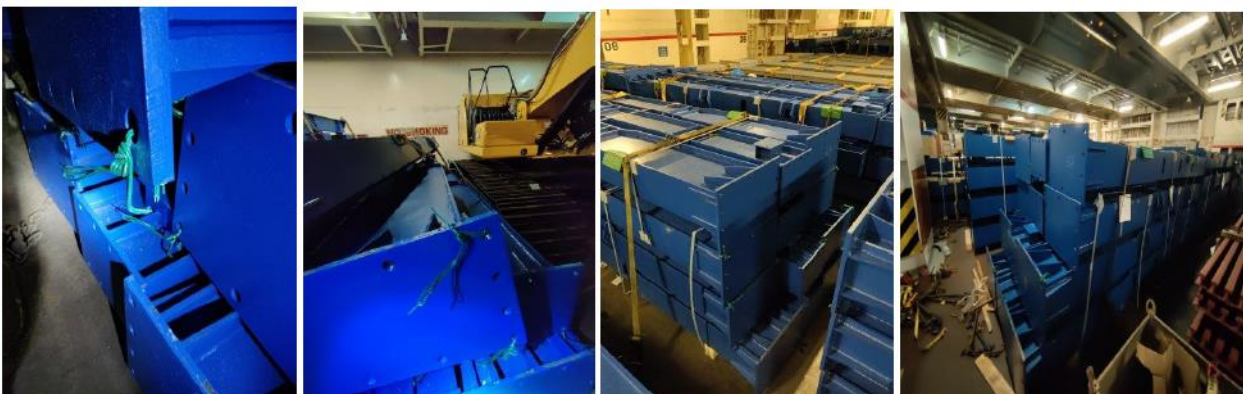
Beams tied with thin metal ties

Broken metal ties

Metal to Metal contact

Beams shifted after rolling

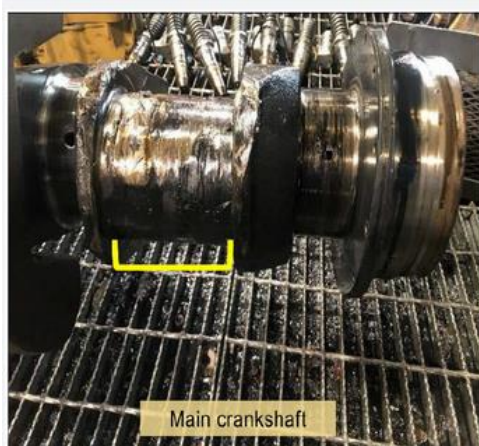
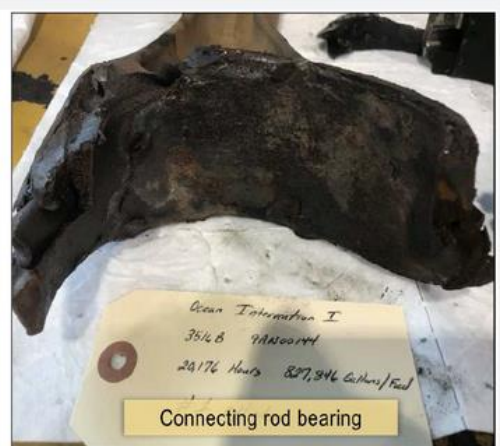
Crew on a OSV at anchor were troubleshooting speed variation issues related to two of the engines driving the vessel’s generators. This involved replacement and calibration of several electrical components and multiple engine restarts. When later carrying the vessel’s electrical load, one of these two engines suffered catastrophic mechanical failure. A cylinder connecting rod was ejected through the engine crankcase while the engine was running. The ejection of the connecting rod allowed atomized oil to be released from the engine and ignite, starting a fire in the engine room.

The NTSB determined the probable cause of the diesel generator engine failure was a cylinder's connecting rod bearing adhering to the crankshaft. In short – it seized up. This led to the ejection of the connecting rod and catastrophic damage to the engine.

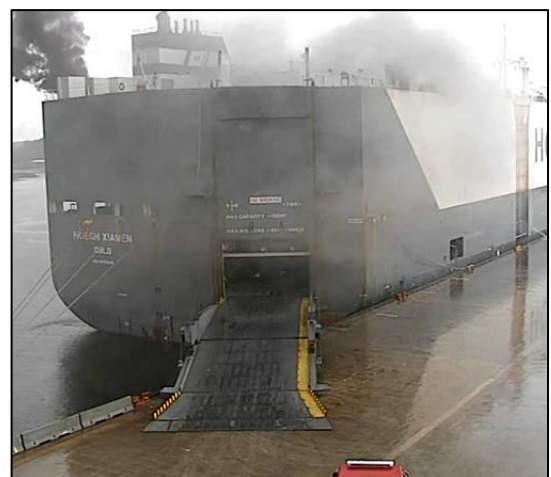
An electrical fault from an improperly disconnected battery in a used vehicle led to a fire aboard the vehicle carrier *Höegh Xiamen* at Jacksonville, Fla., in June 2020. Nine firefighters were injured tackling the blaze, which took over a week to put out. The vessel and its entire cargo (over two thousand used cars) were effectively destroyed.

The NTSB determined the probable cause of the fire was ineffective oversight of the loading crew, which did not identify that the charterer's vehicle battery securement procedures were not being followed. This resulted in an electrical fault from an improperly disconnected battery in a used vehicle;

- Improved oversight and training of personnel involved in loading and in dealing with batteries and potentially hazardous cargo;
- Revision of procedures for the reactivation of fire detection systems after loading;
- Ensuring emergency contact information is immediately available for bridge teams.
