IMCA Safety Flashes summarise key safety matters and incidents, allowing lessons to be more easily learnt for the benefit of all. The effectiveness of the IMCA Safety Flash system depends on Members sharing information and so avoiding repeat incidents. Please consider adding safetyreports@imca-int.com to your internal distribution list for safety alerts or manually submitting information on incidents you consider may be relevant. All information is anonymised or sanitised, as appropriate.

1 Permit to Work and Isolation procedure not followed

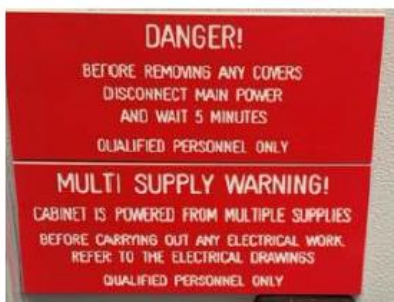
An electrician installed fuses on a 930V DC electrical system while the system was live. Under deck carousels were mechanically and electrically isolated as a precaution for maintenance work. Several other important vessel systems were powered from the same drive cabinet. The electrical isolation was conducted by removing the fuses for the carousel drive unit.

Signage on
cabinet door

- There was no Permit To Work (PTW) in place to control, communicate and co-ordinate the activities;
- Persons holding several different roles within the work team failed to understand and apply the company-required level of controls for electrical works and isolations – the isolations were incorrectly applied;
- The vessel Standard Operating Procedures (SOP) for work on the equipment powered by this drive cabinet did not consider the isolations as long-term with a requirement to protect several people working in the area;
- Procedures were not followed: the security of the electrical cabinet was not in accordance with company procedures; the electrician did not lock and tag the cabinet while the fuses were removed;

- Review of procedures, work instructions, task risk assessments etc. with regard to Permit to Work and electrical isolations;
- Review of Toolbox Talks to ensure they cover all aspects of the work including PTW and isolations;
- Check that the system you are going to work on **is isolated** – **BEFORE** you start work;
- Follow the instructions and warnings signs posted in the workplace. If in doubt, ask!

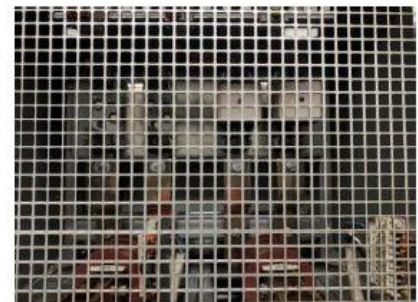
Open cabinet
with fuses on top

Fuses behind
protective mesh

When the fuses were originally removed, the vessel was in port and none of the other vessel systems driven from this same drive cabinet were powered up. The electrician isolated the power to the entire drive cabinet by isolating the breakers and removing the fuses. The electrician then left the fuses at the bottom of the cabinet. Tags were not applied, and the cabinet was left unlocked. On completion of the maintenance work another electrician re-installed the fuses, believing the power to the cabinet was isolated. He opened the cabinet, removed the protective mesh, and installed the fuses using a fuse insertion tool rated to 1000V. When inserting the second fuse, an arc flash occurred, and the fuse blew. The electrician was not injured.

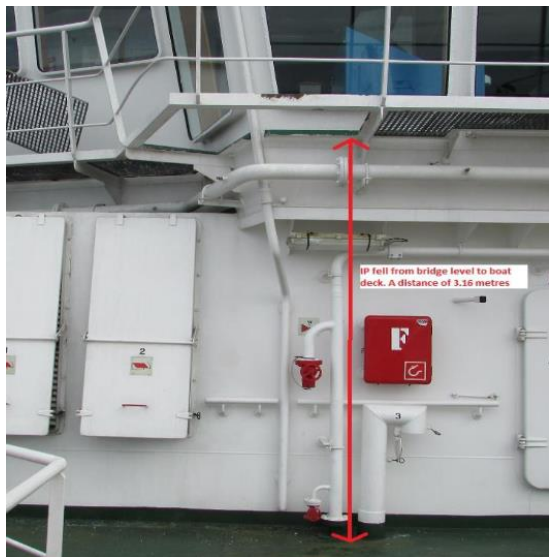
- Control of Work and Permit to Work Systems weren’t correctly and effectively implemented on board;
- There was a lack of situational awareness and risk perception, a lack of awareness of SIMOPS, and inadequate communications between deck personnel in charge and deck crew;
- There were no barriers or signage in the area of the incident. A fall hazard was introduced by removing the bridge gantry gratings.

- More effective and thorough toolbox talks and pre-task risk assessment, particularly for non-routine tasks;
- More thorough approach to SIMOPS:
 - During scope of work planning, identify any combined operations and any additional hazards introduced by the SIMOPS. **Can SIMOPS be avoided, and tasks executed at different times?**
 - Assess the relevant level of risk associated with the SIMOPS.
 - Are the planned control measures enough to keep things safe? If not, identify additional risk reduction measures and update the relevant risk assessments.
 - Whatever happens, make sure a record is kept so the same mistake doesn't happen again - provide input to the Permit to Work / Control of Work process and "embed" any changes identified.

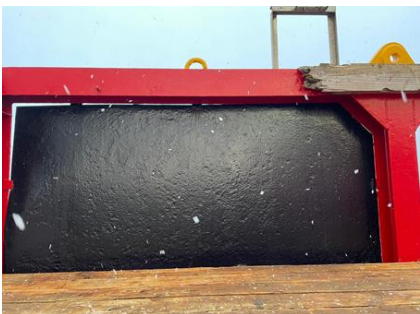
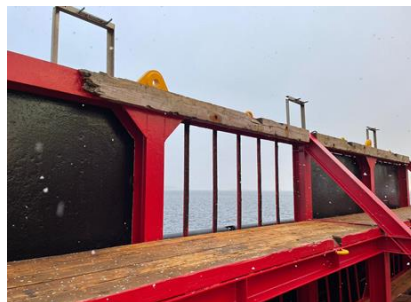
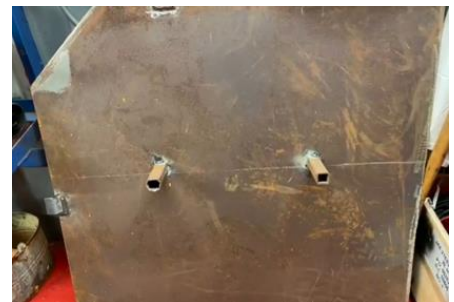
Heavy weather had caused damage to welded plates on deck. While manually handling the plate back into position with another crew member, the injured person suffered a pinch injury to his finger which was trapped between the plate and frame. Following a medical review, the vessel headed into port to permit further diagnosis at hospital. An X-ray showed a distal fracture to the tip of the finger and the wound required stitches.

- The design of the plate did not allow for safe manual handling;
- The installation of the plate had a permanent risk of finger entrapment;
- The risk assessments and toolbox talk used were generic in content and not task specific;
- The JSA used was for hot work only and did not include manual handling at all.

- Safety by design: the plate was subsequently modified to have a pair of temporary handles to keep fingers away from the pinch points;
- Magnetic lifting handles sourced as a long term solution;
- Take care with generic risk assessments – ensure they are either modified to suit the task, or use a dynamic risk assessment or toolbox talk specifically for a full and thorough review of the task.
- If the task is slow, uncomfortable or inconvenient, can we use the toolbox talk or JSA to better define and understand these areas of risk? Can we remove the risk or reduce its likelihood or severity?
