IMCA Safety Flashes summarise key safety matters and incidents, allowing lessons to be more easily learnt for the benefit of all. The effectiveness of the IMCA Safety Flash system depends on Members sharing information and so avoiding repeat incidents. Please consider adding safetyreports@imca-int.com to your internal distribution list for safety alerts or manually submitting information on incidents you consider may be relevant. All information is anonymised or sanitised, as appropriate.

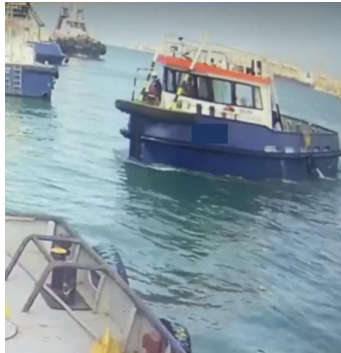
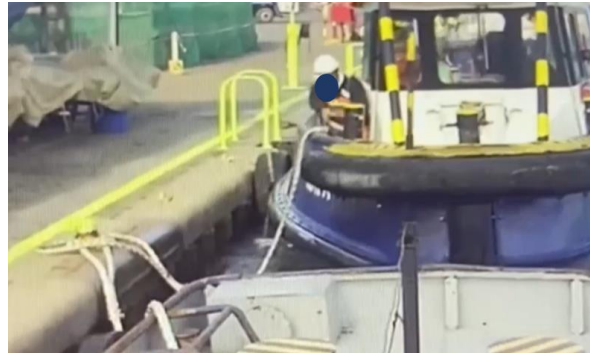
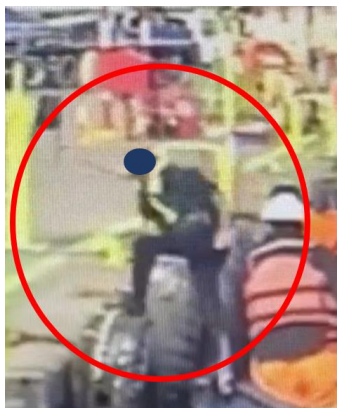
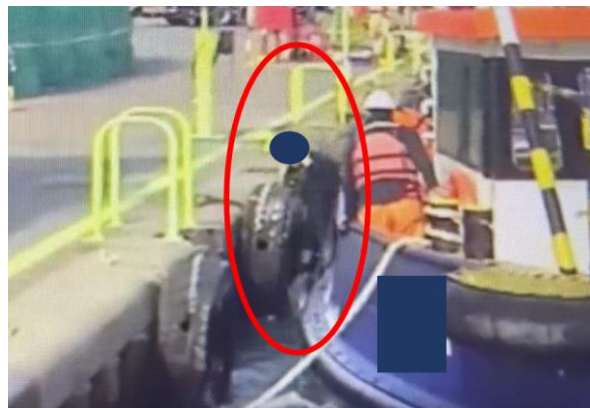
After completing work, a small mooring (pilot) boat returned to the jetty. The AB began to secure the forward spring line of the mooring boat. The pilot being transferred on the mooring boat attempted to disembark by jumping across the quayside fender before the vessel, missed the fender and fell into the water between the mooring boat and the jetty.

- The pilot attempted to disembark the vessel before the vessel was fully and securely moored;
- He was not wearing a helmet and very nearly hit his head on the jetty in the fall; had this occurred the incident may have resulted in a serious injury;
- Falling between the vessel and the quayside, he was fortunate not to be crushed;
- He was lucky: it was noted afterwards that his lifejacket had not been correctly secured; had it slipped off on impact with the water it would have failed to keep him above water.

- No one should disembark from any vessel until the vessel is completely alongside and securely moored;
- For vessels without gangways, a mandatory “buddy system” during personnel transfer was implemented, whereby another crew member on the shore side supports the crew member transferring from the vessel. Life jackets to be secured and correctly fastened before embarking/disembarking;
- For vessels with gangways, gangways should be securely fastened, and safety nets installed. After installation checks should be conducted to ensure it is secured safely, and the gangway controlled at all times.

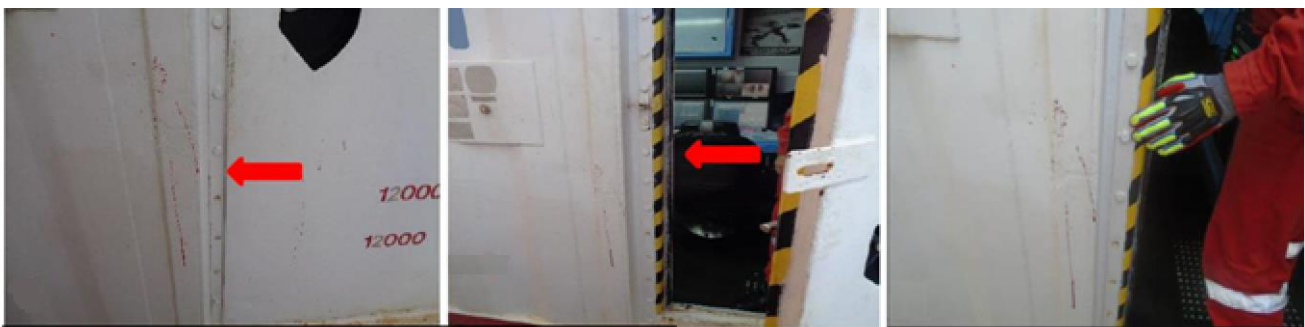
Image 1 - ROV Control Van door frame

An ROV operator suffered a serious injury, after their finger was pinched between the door frame of an ROV control van and the door as it swung closed. The ROV operator was returning to the work area after lunch and made his way to the ROV control van to speak with the supervisor. He opened the door outwards and rested his left hand on door frame as he moved his body inside the control van. The door swung closed, resulting in the door pinching his left index finger against the door frame. He automatically moved his hand away on impact which caused a laceration injury to the fingertip that required a medivac and reconstructive surgery.

- The spring device mechanism to control the speed at which the door closed was faulty and had not been repaired. The ROV team had not identified this hazard nor corrected it before the incident;
- There was a lack of situational awareness in that the ROV operator left his hand in the line of fire;
- The induction/familiarization process had not been effective in identifying hazards associated with the work area;
- This was the first day of the trip for the ROV operator; he had two months experience on the vessel.

- Ensure that such doors (in this case, to ROV control vans) are fitted with a functioning spring device mechanism to control the speed at which the door closes;
- Ensure these door closing spring device mechanisms are included in the planned maintenance system, and subject to regular inspection;
- Ensure there is suitable induction / familiarization process on site, to safely integrate new workers, and provide them with mentoring and effective supervision.

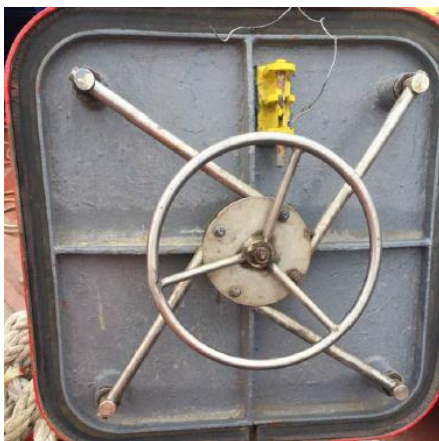
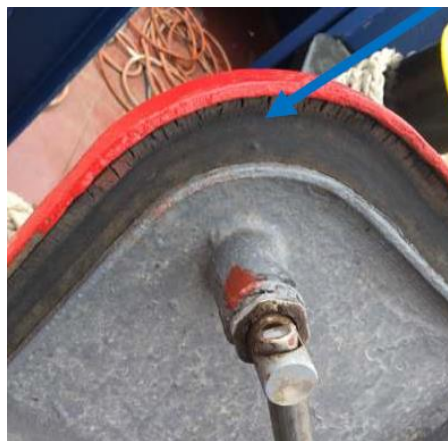
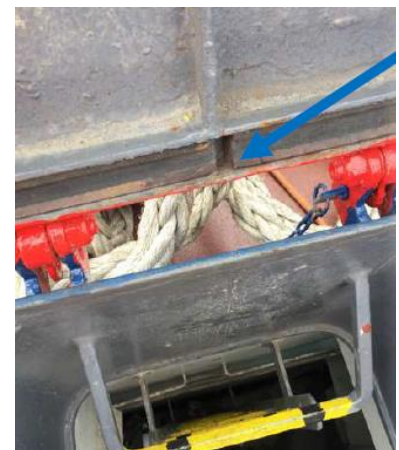
During an inspection of a vessel as a part of the 5-yearly docking, deteriorated seals were found on a number of hatches.

Preliminary investigation was conducted and after crew feedback, it was revealed that the crew had observed this unsafe condition some while ago, ordered and received new seals, but had continued to operate with no action, waiting for docking in order to replace deteriorated seals etc.

Hatch seals perform a vital role in a wide variety of marine applications. The hatch seal ensures that no liquid or gas is able to enter the vessel. After a period of use seals can deteriorate and become worn which reduces potential sealing properties. In this case, there was the risk of potential seawater leakage to the engine room had no action been taken.

- Lack of risk perception and lack of timely action by vessel crew after identifying deteriorated seals - continuing to operate in an unsafe condition, considering waiting until the vessel was docked.

- *"If it isn't broken, don't fix it"* is a call to inaction – if something needs dealing with, deal with it now, not later.
