## 1 MAIB: Unexploded ordnance - subsea explosion causes injury and damage

The UK Marine Accident Investigation Branch (MAIB) has published its [Accident Report 1/2022](#) into a subsea explosion which damaged crab potting vessel *Galwad-Y-Mor* on 15 December 2020.

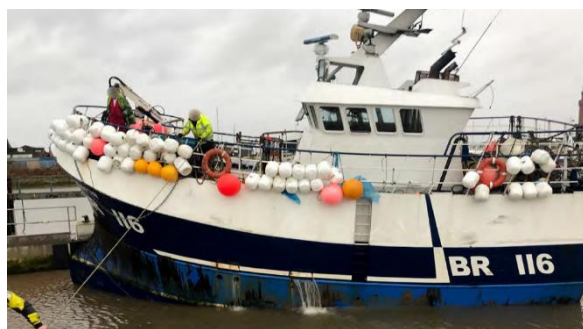
A 15m crab potting vessel was hauling pots in the North Sea approximately 22 miles north-east of Cromer. The crabbing gear disturbed a 250kg unexploded WWII bomb, which went off on the seabed 30m below the vessel. The ensuing explosion caused a shock wave that threw the boat about, resulting in significant injuries to five of the seven crew and major damage to the vessel's hull and machinery.

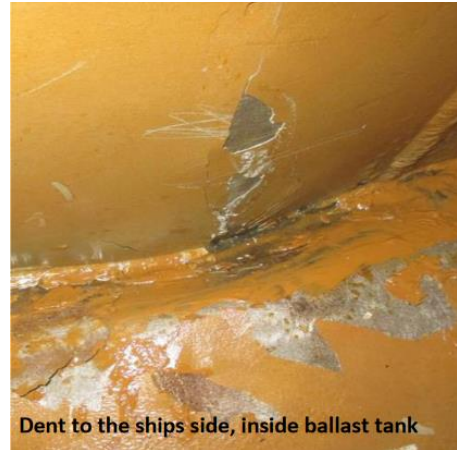
The 1st Officer rushed to the manoeuvring station attempting to stop forward movement of the vessel. The 1st Officer intended to switch steering from autopilot to hand steering. However, emergency steering was accidentally switched into instead. This caused the 1st Officer to lose control of the vessel and the forward movement was not arrested. The Master, who was called to the bridge, managed to turn the vessel to port, however the proximity to the installation and the vessel momentum resulted in the starboard side of the vessel contacting the installation. The vessel hull was dented but not holed. The installation was undamaged.

It is deemed likely that the 1st Officer would have been able to steer or stop the vessel if he had not accidentally set the vessel into emergency steering.

- Review and adjust existing procedures, enhanced training sessions. The vessel owner made the following improvement suggestions:
  - Ensure that all emergency switches do not have multiple functions;
  - Update of the existing navigational audit checklist;
  - Clarification of the lookout's duties in bridge procedure;
  - Emergency scenario training sessions to be implemented.
- Suggested discussion points to accompany this safety alert:
  - Could this have happened on your vessel?
  - What do you have in place to avoid a similar incident?
  - Installations should not be used as waypoints when passage planning;
  - Don't allow yourself or others to become distracted on watch, maintain situational awareness at all times;
  - Know how to operate manual and emergency control changeovers.
