The following case studies and observations have been compiled from information received by IMCA. All vessel, client, and operational data has been removed from the narrative to ensure anonymity. Case studies are not intended as guidance on the safe conduct of operations, but rather to assist vessel managers, DP operators and DP technical crew in appropriately determining how to safely conduct their own operations. Any queries should be directed to IMCA at [dpreports@imca-int.com](mailto:dpreports@imca-int.com). Members and non-members alike are welcome to contact IMCA if they have experienced DP events which can be shared anonymously with the DP industry.

## 1 Case Study – Masking of PRSs – SIMOPS

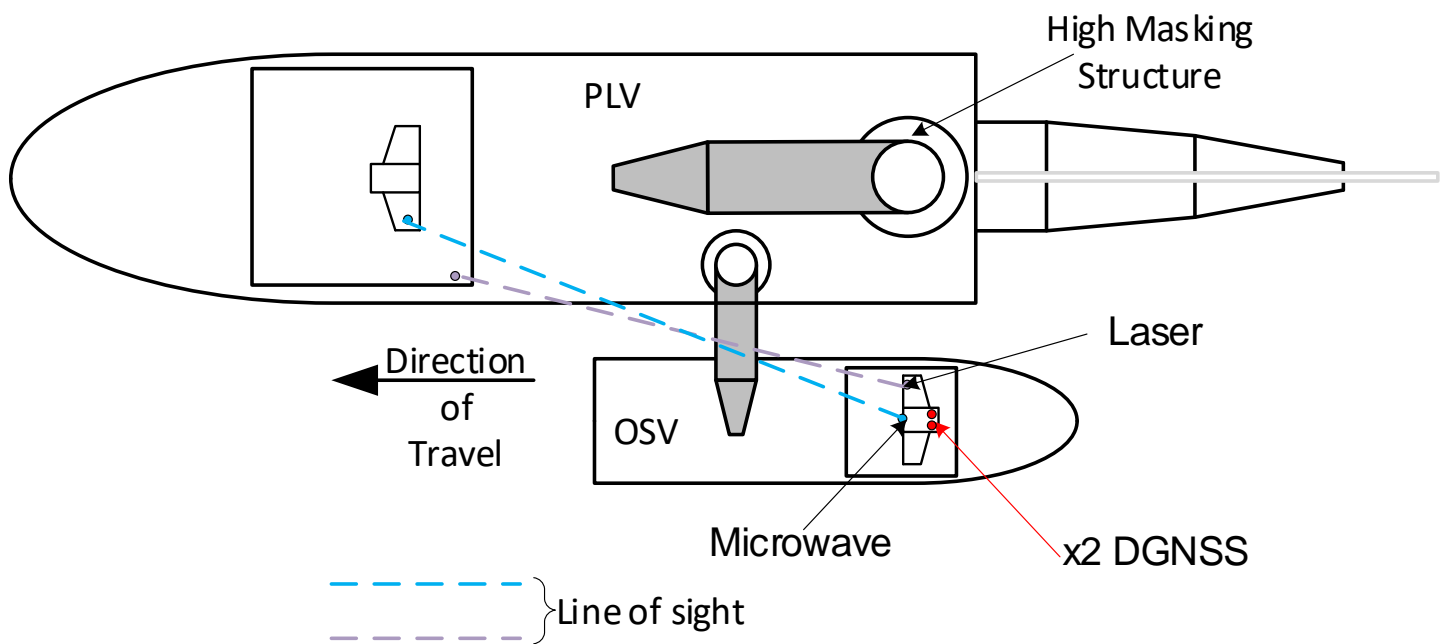
As the Pipelay Vessel's crane hoisted the cargo off the deck of the OSV, it was noted that the cargo would interrupt the laser and microwave signal causing loss of signal and therefore, weighting to fall, making DP Control solely reliant on the DGNSS.

With the Pipelay Vessel changing its heading and, the difference in speeds between the two vessels, the effect was to also mask the DGNSS. Alarms were generated and cancelled without assessment.

This happened during a 25m Simultaneous Operations (SIMOPS) move. The OSV failed to come to a stop at the set point and the thrusters were noted to be increasing in speed (starting to ramp up). The DPO took the action to remove the surge functionality to bring the vessel to rest and thereby taking the vessel out of auto station keeping. The total overshoot was 7m.

- The cargo lifts caused the line of sight to be broken for both the relative position references. An alarm was raised at the DP Operating Station and accepted by the DPO, in the knowledge that the DGNSS weighting would increase and compensate for the loss of the two relative units.

- The two vessels did not move at the same speed relative to each other. Not only did the main crane move relatively to the OSV, the whole pipelayer moved (hull, accommodation, deck equipment, mission equipment, etc). The blind sector was dynamic and was able to mask the satellite signal to the 2 DGNSS's located on the OSV, an alarm was raised which the DPO accepted.

- At the startup of this operation, the DPO on the OSV should make a concentrated effort to indicate the blind sector for the DGNSS satellites in the DGNSS equipment, via the HMI. This function is available in modern DGNSS equipment and should form part of the DP ops setup check list.

- The DP control system on the OSV could be equipped with a “Follow Target” function that allows the OSV to automatically follow both pipelayer's position and heading to prevent a mix of absolute and relative systems. If they do not have a “Follow Target” function, then they should use only Absolute PRS and make operator initiated position move together with the pipelayer.
- OEM Manuals & training should give advice to how best to manage PRS's within their system. This can be included into the DP Operations Manual.
- If possible, the OSV should be on the same heading as the pipelayer to give the relative systems better working conditions due to the crane.
- How detailed was the ASOG, was it being followed? From the details it would be reasonable to conclude that either an ASOG was not in place, or it was not being followed.

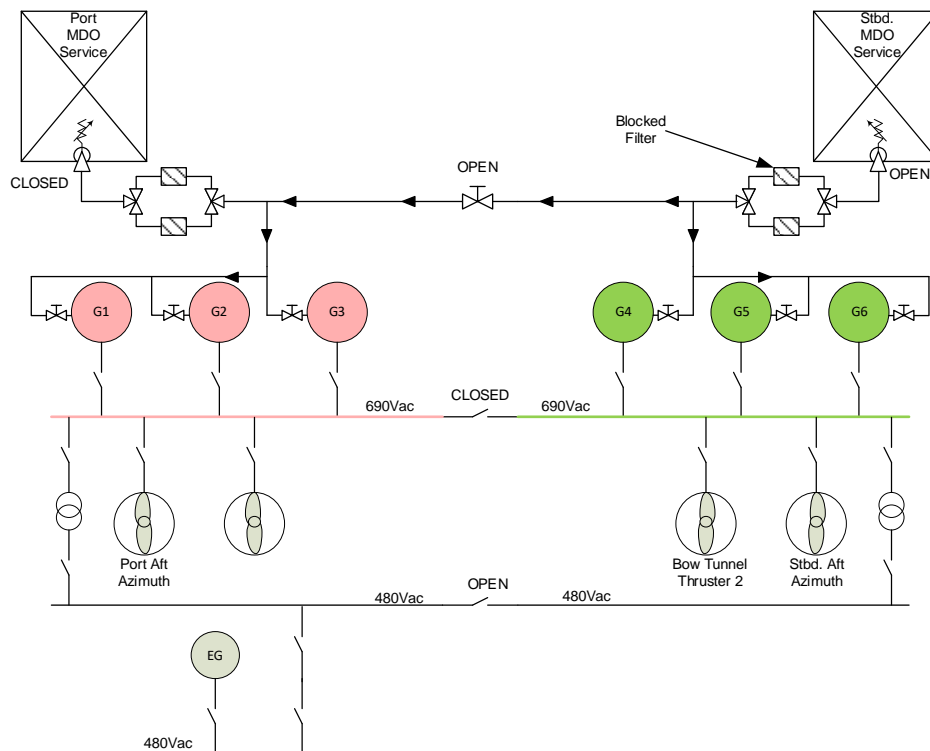
At around midday of the third day, the weather had increased slightly, and engine loading increased. Another generator was started and connected. Once connected, bus frequency alarms were activated and didn't clear. The frequency continued to fall to the level where all generator incomer breakers tripped along with the bus tie on under frequency and blacked out the vessel. The engines on standby auto started. It was apparent that all running engines were slowing down to the point they stopped.

The technical department immediately identified that the fuel supply filters were the immediate issue and changed them to the clean set-in order to restore a supply to the engines. In the meantime, the blocked set were being cleaned.

- The vessel was working in 'Task Activity Mode' (TAM) which allowed for the risks associated with closed bus operation. The ASOG accounted for TAM.
- The jeopardy was cross connecting the fuel system and removing the redundancy of supply by isolating the port service tank for inspection and cleaning.

It was decided to monitor the filters and change onto a clean set every hour. The port service tank was sealed and filled with clean fuel. Once filled and with the bus ties closed, the port engines were stopped. The fuel system was split, and the port engines were started and connected to the common bus. Once all checks had been made and the technical staff were happy, the bus tie was opened. The vessel was now on two independent redundancy systems.

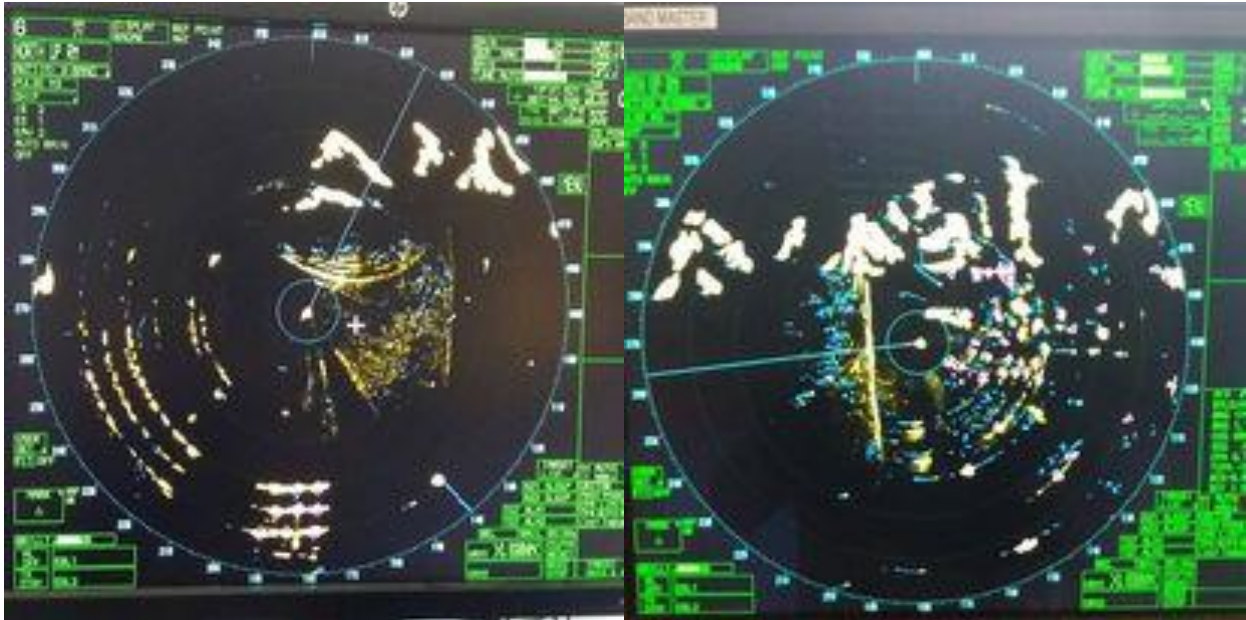
*Figure 4-1 Radar image of Soliton*

Figure 4-1 above shows how a Soliton can be shown on Radar. These waves can travel at 2 to 4 knots. This along with the physical effects of the waves can cause a sudden loss of position followed by severe ramp up of thrusters and generators.

In the case of DP vessels, there is insufficient time for the vessel mathematical model to update. The vessel may remain unstable in terms of position and heading for some time after, overshooting and hunting the set point values. At the same time, unreliable results will be obtained from subsea position references. Both taut wire and HPR systems will be degraded due to velocity of surface and subsea water with additional noise and aeration from thrusters.

Solitons are difficult to predict. IMCA recommends that the bridge crew research their geographic area of operation and be mindful that the vessel is susceptible to sudden increase of sea currents.
