1 Mooring near miss: Guide roller pin suffered material failure

3 NTSB: Dangerous engine failure – improper torquing

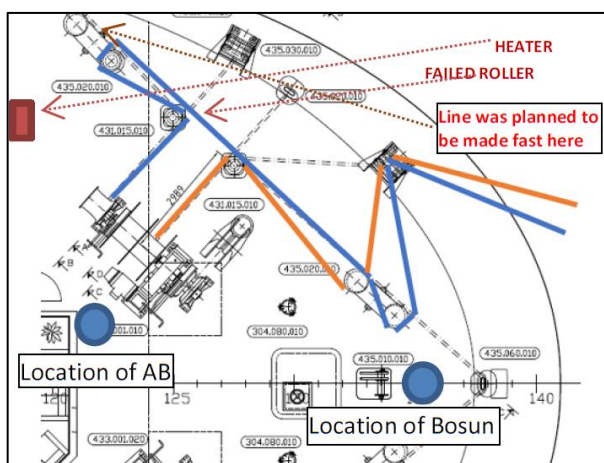
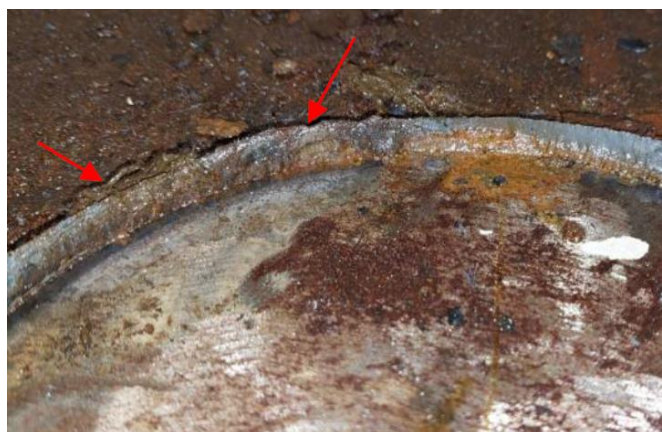
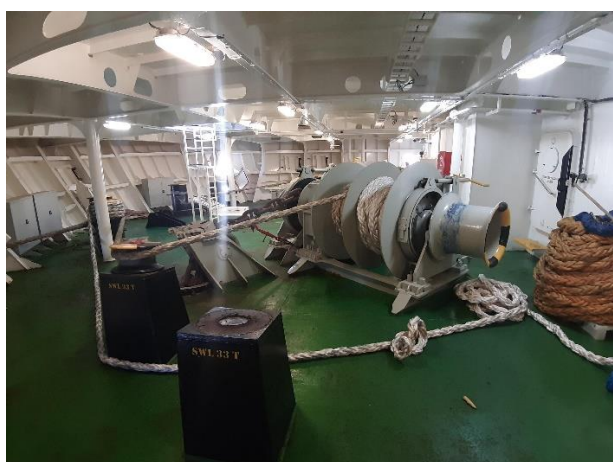
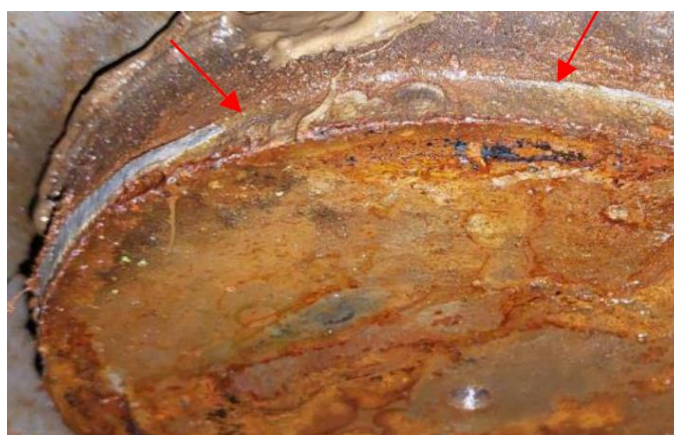
A deck stand guide roller pin suffered material failure at its foundation whilst a vessel was mooring. Weather, wind and tide conditions were gentle at the time of the incident and the vessel was being held in position using thrusters with no appreciable movement or excessive loads which could have contributed to this incident.

During mooring operations at the forward station when the 3rd head line (blue line in diagram below) was being heaved up using the warping head (the plan was to make it fast on a bollard to the aft of the failed roller) the deck stand roller pin parted from its base and hit a heater located just aft of this position.

There were no injuries. However, it is evident that any crew member standing in the line of fire of the damaged roller would have been seriously injured. The winch pulling force was 12 tonnes, the roller stand SWL was 33 tonnes.

- The mooring layout on this vessel was complicated and also did not follow accepted and recommended practice, which caused overloading of structures;
- The routing of the mooring line caused an increase of axial forces on the roller;
- On further investigation it was noticed that roller pin was already in the process of degradation and at least some part of the welded structure had already disengaged from the base. The roller had not been inspected thoroughly;
- Multiple turns over various fittings increase the complexity of the mooring systems and introduce additional hazards such as complex snap back zones and overloading of structures.

- Our member arranged to add to their Planned Maintenance System, dismantling and overhauling of deck stand guide rollers every third year;
- Ensure mooring plans use the most suitable and appropriate mooring arrangements;
- Avoid multiple turns which introduce complex snap back zones and additional hazards. Always discuss such risks as part of the daily planning and toolbox meeting;
- Be aware of your surroundings and of the line of fire.

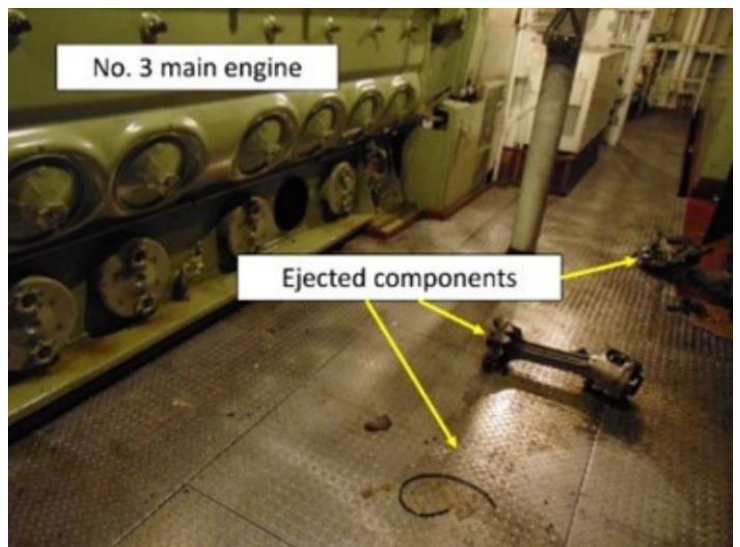
On April 22, while the vessel was conducting a post-maintenance sea trial in Puget Sound, the no. 3 main engine experienced a connecting rod assembly failure and ejected components that breached the crankcase, resulting in the ignition of hot pressurized gases that were released in the engine room.

NTSB investigation revealed that the probable cause of the mechanical failure of the no. 3 main engine was a connecting rod assembly that came loose and separated from the crankshaft **due to insufficient tightening** (torquing) of a lower basket bolt during the previous engine overhaul.

The NTSB notes that *“When installing fasteners, personnel should use a calibrated torque wrench, follow the manufacturer's recommended tightening guide and torque values, and verify that all required torque requirements have been completed. Under-torquing a fastener may cause excess vibration or allow the fastener to come loose, while over-torquing may lead to failure of the fastener or the machinery component being secured.”*
