## 1 MAIB Safety Digest 1/2022

## 2 USB power bank (Lithium battery) fire

### 3 USCG: Lithium battery fire

#### 4 UK HSE: worker died following fall from crane platform

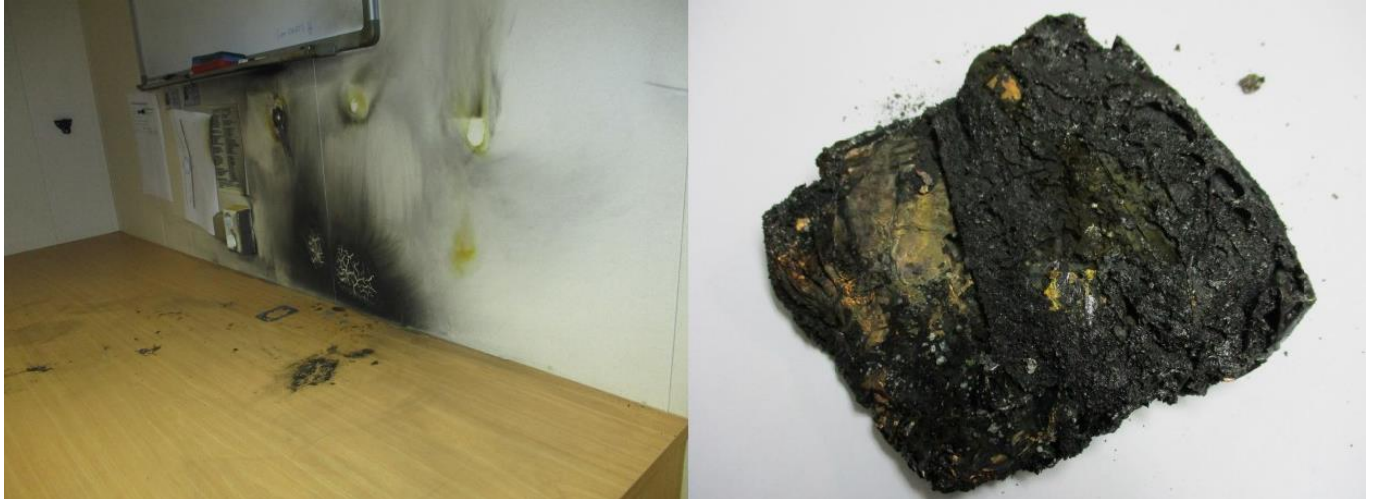
A crew member on a vessel was inside his cabin bedroom when he heard a popping sound in his dayroom. Upon investigating he noticed the USB battery bank (containing Lithium-polymer batteries) charging on the desk was on fire. He immediately smothered the power bank with nearby clothing to knock down the flames and at the same time disconnected the power bank from the mains. He then sprayed the clothing with water to remove heat and placed the whole lot in metal for removal from the room.

Damage was contained to the desk, adjacent bulkhead and deck where the battery bank rested after being extinguished. There were no injuries.

- The power bank was not supplied with an adaptor when purchased, leaving the buyer to match the adaptor plug with the unit for wall charging. In this case the adaptors did match the input and output requirements and the USB cord;

- The USB power bank was plugged into a 220V wall outlet for charging. A 240V-100V adapter (European to North American plug) was plugged into the wall outlet then a standard, North American style, USB charge adapter plugged into the 240V-100V adapter. A type 'C' charge cord was used from the North American style USB charge adapter to the power bank;

- The crew member had noted at 19:10 that the power bank was 97% charged and planned to wait for a full charge. At approximately 19:50, the crew member heard the popping sound and saw a flash of light and flames coming from the power bank;

- From the location of the burn pattern away from the outlet, the failure looked to be within the USB power bank itself and not in the receptacle or adaptor;

- There were no reported electrical or power interruptions in the ship supply or in the receptacle in which the unit was charging. Trends were normal and didn't show any interruptions. Power at the receptacle was reported by the chief engineer to be 237 V.

- Our member proposed to control how and when these devices are charged up (as distinct from a possibly unpopular blanket ban on them). Such battery/power banks should:
  - NEVER be left unattended when on charge;
  - Be unplugged as soon as they are fully charged.

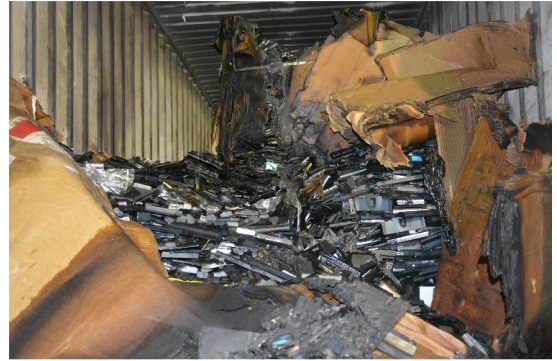
In August 2021 a container illegally loaded with discarded Lithium batteries caught fire while enroute to the Port of Virginia in the United States. The container was being transported to port with the intent that it would be shipped to China aboard a container ship. The batteries caught fire on the highway resulting in loss of the cargo, and significant damage to the shipping container.

Upon initial investigation, the fire department determined that the heat produced from the fire burned hot enough to burn or melt a hole through the freight container’s structure. In addition, the bill of lading listed “computer parts,” not Lithium batteries. This is a situation that made responding to the fire more challenging and could have been potentially catastrophic had the container caught fire after being loaded aboard the container ship.

Further investigation determined that the shipper had *failed to properly placard, label, mark and package the lithium batteries, class 9, UN 3480 and 3481*. The cause of fire was determined to be residual charge/full circuit, which led to a thermal increase.

- Ensure damaged/defective Lithium batteries are appropriately and properly packaged for disposal and/or recycling according to applicable legislation;
- Be aware of how to address additional marking requirements for Lithium batteries being transported and Lithium batteries that are damaged or defective, or being disposed of or recycled;
- Ensure that Lithium batteries prepared for transportation are protected against short circuit;
- Ensure that Lithium batteries are stored appropriately.

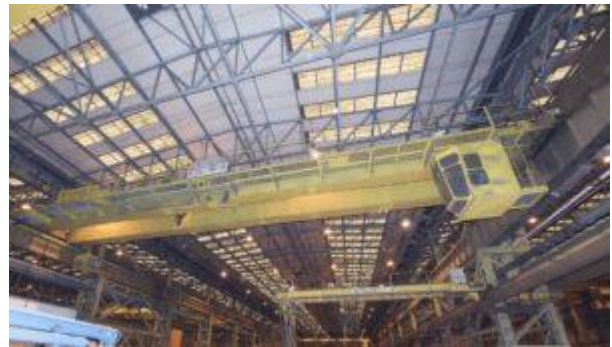
An electrician was repairing wiring that had been causing a short circuit on the lifting equipment of a large overhead gantry crane. As he was walking along the crane’s walkway, an access panel gave way beneath his feet, causing him to fall through to the ground below. He sustained fatal injuries and was pronounced dead at hospital.

HSE investigation found the company had failed to maintain the crane walkway’s access panels, which had been used to replace lighting fittings some months earlier. Also, the panel itself had been subject to weld repair, and there was no evidence of any steps being taken to ensure that the panel was safely replaced into the void and secured to ensure it did not fail.

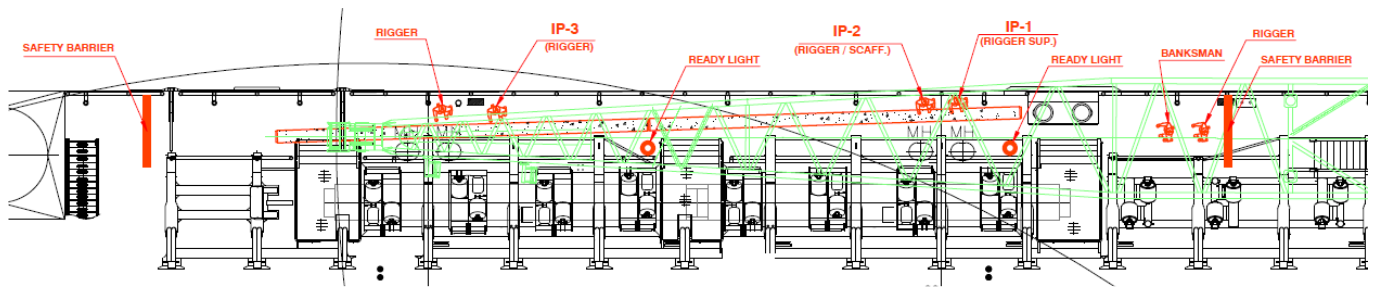
It was an established practice to lift two pipes at a time from the supply vessel, stabilize them against the conveyor bumper bars, then lower both pipes onto the conveyor. Riggers then step forward and disconnect one pipe from the crane, leaving the second pipe connected. The riggers then remove the end caps, soft slings, and rope rings from the first pipe. The second pipe is then raised, still resting against the bumper bars and the first pipe is transferred along the conveyor into the firing line. Once the first pipe has moved into the firing line, the second pipe is then lowered into the conveyor and the riggers repeat the preparation process. The riggers are expected to vacate the immediate area while the second pipe is raised and lowered.

On instruction from the banksman to lower the second pipe, it moved downward and away from the bumper bars. The pipe continued its horizontal motion, striking three riggers who were standing between the conveyor rollers and the vessel handrail. One rigger received a glancing blow. One rigger was momentarily impacted, and one rigger was caught between the suspended pipe and the handrail.

- The crane operator did not follow the banksman's instruction to lower but also introduced slew. The crane operator was new to the project crane operator position and this change in workload may have been a stressor.

- The rigging supervisor was directly involved in removing load rigging and protection and not in a stand-off position to oversee operations;
- No-one stopped the job: neither the banksman, supervisor nor crane operator, stopped the operation to ensure the line of fire zone was clear;

- The riggers remained in the line of fire during the movement of the second pipe section;
- The requirement to get out of the way while the pipe was raised was not specified in the task plan or the task risk assessment (TRA) but was discussed at the toolbox talk. Conflict was introduced through a verbal requirement reinforced in the toolbox talk to keep clear, whereas the task plan required riggers to be near the pipe to remove taglines;

- The repetitive nature of the operation, without any issues being experienced, may have reduced the risk perception of the potential line of fire hazard, making the riggers positions appear safe to them.

- Ensure that crane operation communications are clear, repeated and confirmed before load movements;
- Operations which have line of fire hazards should be checked to confirm the safe positioning of personnel is clearly defined, understood, and followed;
- Review zones where line of fire operations are regularly conducted. Confirm that where appropriate suitable barriers (permanent or temporary) are in place;
- Consider marking the deck as to identify no-go zones or restricted access;
- For repetitive work consider frequent toolbox talk sessions or introduce a pause to question the team to confirm they remain focused on the task and to reinforce the potential hazards and the controls to be maintained;
- Review repetitive high-risk tasks to confirm risk awareness is not decaying.
