1 Communications: LTI finger injury during lifting operations

2 COBRA System - Hose coupling cross threaded

3 Diver experienced an air flow restriction

4 Subsea transponder wire parted

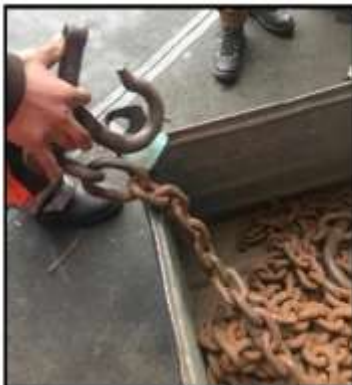
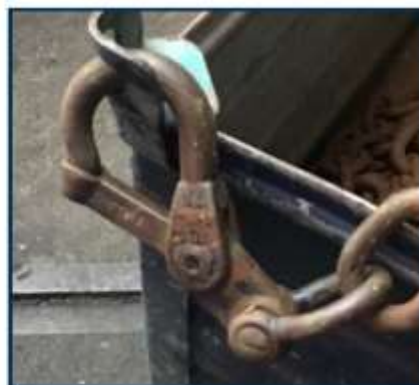
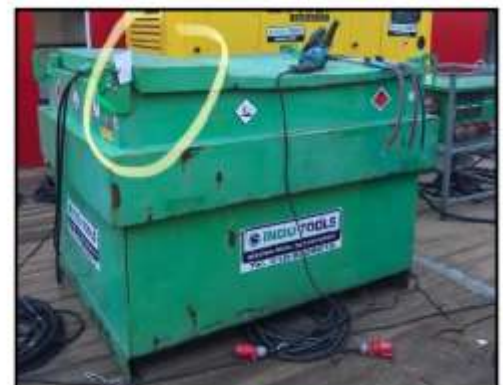
During demobilization lifting operations, a rigger's right ring finger was crushed between the crane hook and a lifting eye.

A vessel was demobilizing with a third party crane operator and banksman hired to perform lifting activities moving items on deck. A Toolbox Talk (TBT) was held before operations started. A container was being lifted from the vessel to the quay, using a quayside crane. The container was lifted and set down on the quay, and crew detached the rigging from the container lift points. Three of the hooks were loose and on top of the container and one hook was still attached to the container lifting eye, when the crane operator started hoisting. The rigger foreman's finger got jammed between the top of the hook and the top of the container lifting eye. His right ring finger was crushed between the hook and the lifting eye still attached. Surgery was required to amputate the fingertip.

- The injured person had his hands on the crane hook;
- Miscommunication: the third party crane operator thought the company rigger foreman gave the signal to hoist. However, both the company rigger foreman and lift supervisor assert that the hand signal to *lower* the load was given;
- Our members' investigation found that:
 - Roles, responsibilities, communication, and risks during lifting operations were not discussed during toolbox talk (TBT);
 - The toolbox talk was held in English and translated into another language for the third party crane operator who did not speak English;
 - There was inadequate lift planning;

- The banksman remained on the quayside during the lifting operations and had no view of the lift and did not take control; the company rigger foreman (the injured party) took over the role of banksman. The hand signal that was given remains unclear;
- The gloves worn by the rigging crew did not have the required impact rating;
- Demobilization was not included in the project management plans or project bridging document.

- Agree and understand roles, responsibilities, and communication protocols before starting work;
- Ensure that EVERYONE involved understands what is going on, and that they have confirmed that understanding back to you in a satisfactory way;
- Ensure there is a clear lift plan available for routine lifts;
- Ensure mobilization and demobilization activities are included and clearly defined in project documentation and corresponding risk assessments.

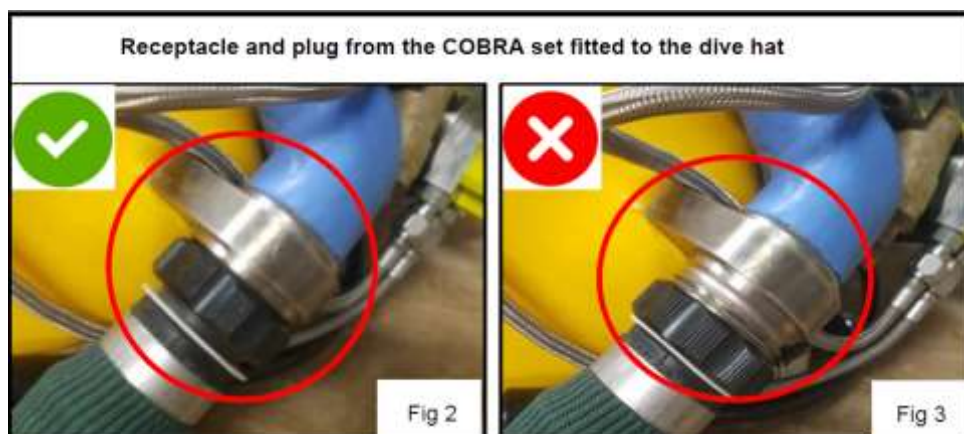
At the end of the dive, diver 1 returned to the bell, the bellman inspected the divers' hat and it was identified that the right-hand hose knurled retaining collar at the hat connection had been cross-threaded and not fully tightened. This resulted in the hose pulling free from the hat when the bellman lifted the hat clear of the divers head with the pulley system.

- In the work environment, there was a lack of alternative indication – no other indication that the coupling is fully engaged, other than visual and the Rotawink green indicator. There was poor access and equipment layout – the bellman has limited manoeuvrability within the bell when fitting the hose.
- With regard to human nature, there was an assumption that the Rotawink would remain red if the coupling was not properly engaged (cross threaded).

- Bellman and dive supervisor followed the pre-lockout checklist correctly and verified that the Rotawink indicator was green.
- The Rotawink (shown here) is a visual indicator that turns green when the system is pressurised and ready for use. Although coupling was cross threaded, the Rotawink remained green throughout the dive indicating that the system retained a positive pressure;
- Ensure awareness is provided on:
 - The potential for the coupling to be misaligned.
 - The Rotawink may still give a green indication when coupling is misaligned.
 - When correctly connected there must be no visible threads, as per **fig 2** above.
- Engaged with supplier to request a review of COBRA coupling mechanism to see if engineering solutions within existing pressure couplings can be used (i.e. HP gas spin fits).

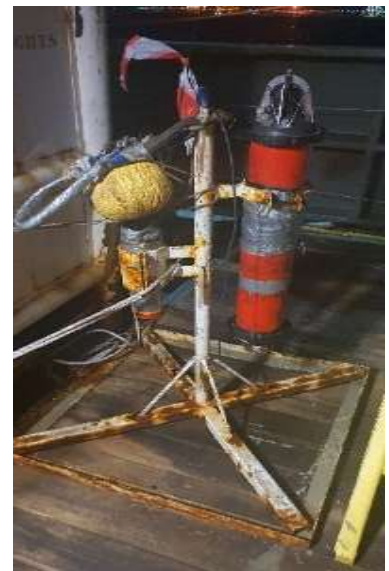
A tripod positioning transponder wire parted from the tripod framework whilst the vessel was repositioning and needed to re-plumb the transponder. No assets were close by at time of incident. Whilst coming up on the winch it was noticed that there was no weight on the wire; on recovery to the surface it was discovered that the 4mm diameter wire had parted approximately 1m from the tripod lifting eye. The lost tripod was subsequently recovered to deck by divers and the crane.

The equipment failure was caused by excessive wear and tear on equipment; the wire was corroded and was not replaced frequently enough.

- Replaced the damaged wire and conducted a performance test prior to use;
- Regular visual inspection prior to launch and during recovery now conducted;
- Replacement of the spool wire every 6 months added to the vessel PMS.

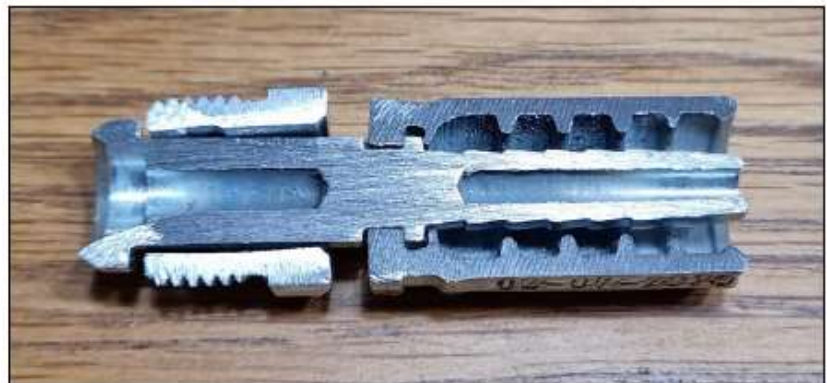
Investigation identified that one of the auxiliary engine room's CO₂ system pilot hoses was completely blocked. Subsequent examination and testing of the vessel's fixed fire extinguishing systems identified two other similarly blocked hoses. It was discovered that the pilot hose couplings had not been fully bored through during the manufacturing process. The testing process also identified several coupling leaks in the pilot lines.

Section through blocked CO₂ pilot hose coupling showing incomplete bore through the stem

- Ensure that crews are fully acquainted with the procedures for the manual activation of CO₂ fire extinguishing systems in the event of the pilot actuation system failing;
- The fire safety company did not identify that some of the hose assemblies were blocked and that there were leaks in the CO₂ system pilot lines;
- Neither the suppliers' quality assurance processes, nor onboard installation testing processes, identified that the hose couplings had not been fully bored through;
 - Amended procedures to incorporate a pneumatic flow test of the complete hose assemblies to verify that they are not blocked.
