IMCA Safety Flashes summarise key safety matters and incidents, allowing lessons to be more easily learnt for the benefit of all. The effectiveness of the IMCA Safety Flash system depends on members sharing information and so avoiding repeat incidents. Please consider adding safetyreports@imca-int.com to your internal distribution list for safety alerts or manually submitting information on incidents you consider may be relevant. All information is anonymised or sanitised, as appropriate.

1 Riggers injured while disconnecting rigging

2 Near miss: Floor Plate fell from Main Mast during storm

4 Maintenance and painting – two incidents

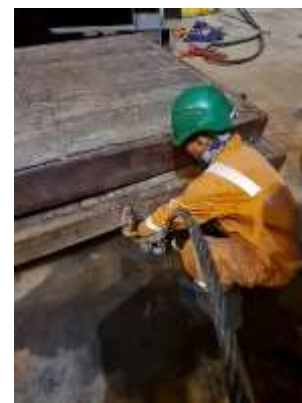
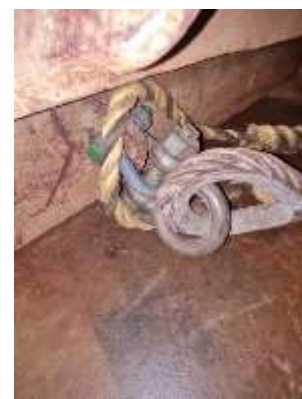
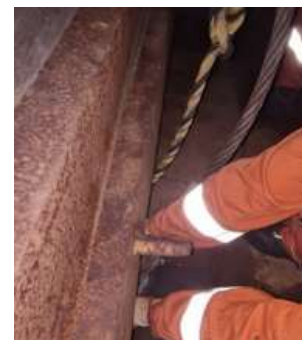
While the riggers were in the process of disconnecting the shackle there was an unexpected movement of both the barge and vessel which caused the slings to tension up. This resulted in one riggers being struck by one of the slings on his arm and the other two riggers being struck by the load on their hands.

- The riggers started disconnecting the shackles before there was sufficient slack in the slings to compensate for the motions of both vessels;
- The riggers started disconnecting the shackles before they were given the instruction from the rigger foreman that it was safe to do so;
- The rigger foreman did not instruct the crane operator to pay out more slack to compensate for unexpected barge / vessel movements.

- Be aware of the additional risks created by separate vessel motions when conducting lifting operations at sea, and take additional steps to take such motion into account e.g. pay out more slack;
- *Wait for it....* always wait for the instruction to start the task from your supervisor, even if you know exactly what your role is;
- Consider leaving the rigging arrangement in place where possible. This will eliminate the risk of injury as nobody will be required to disconnect anything.

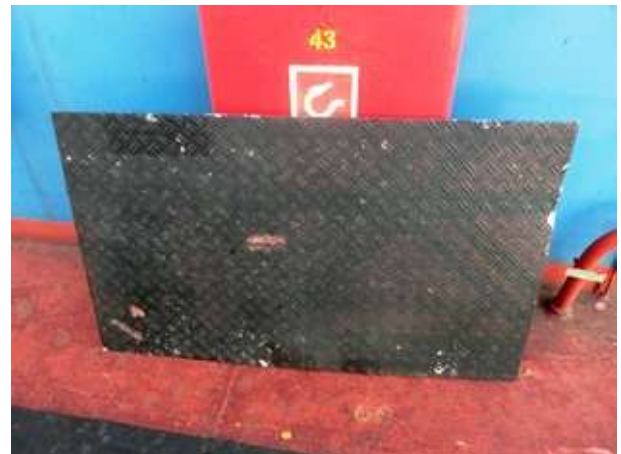
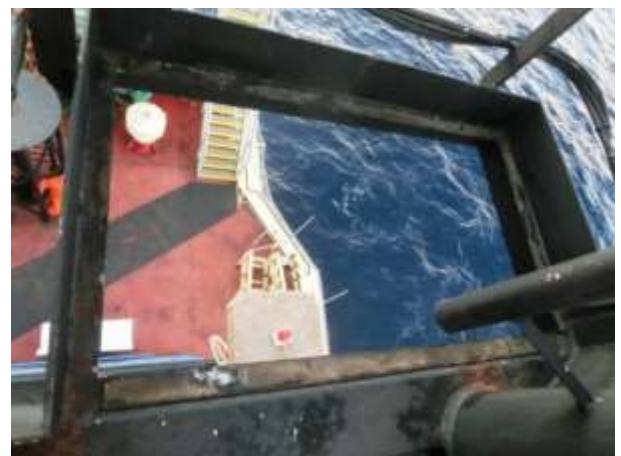
A floor plate fell from the main mast to the deck during a storm. At the time there were violent storm force winds of 55 to 60 knots with an 11m swell. A crew member suddenly heard an object falling from above. It landed near the upper deck port forward crane. It was a piece of 50 x 80 cm aluminium plate with 4 holes for securing and weighing about 2Kg. There were no injuries nor property damage.

The four screws securing the floor plate had sheared. The plate was from the mid platform of the mast at the base of the Inmarsat dome mast.

The screws had been replaced by a sub-contractor during fabric repairs, just over one year previously, and were found to be too short, and of too poor a quality, to ensure the plate remained secured adequately.

- Re-secured the plate with proper fixings;
- Held a thorough check of all similar plates on deck, especially in areas where this particular sub-contractor had been working, so as to avoid similar potential problem;
- Fed back to the sub-contractor about this near miss, requiring higher attention to quality performance in future work.

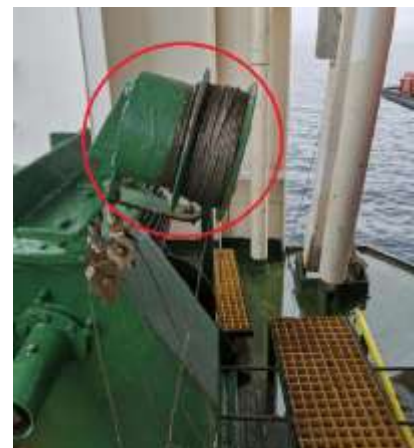
Brake release wire drum overpainted

Investigation showed that the brake release wire drum was stuck/not turning, apparently due to there being an excessive amount of paint (see illustration) applied during the recently done maintenance. Once the paint was removed, the drum could be easily moved by hand.

- The damaged sheave was reshaped. Thorough examination of the sheave surface and inspection by means of dye penetration testing showed that there were no cracks;
- Ensure close monitoring of the crane movements after each order given and when working near any of the crane limits;
- Test alarms after maintenance on the crane;
- After maintenance/painting check that all equipment parts are still movable and fully operational.

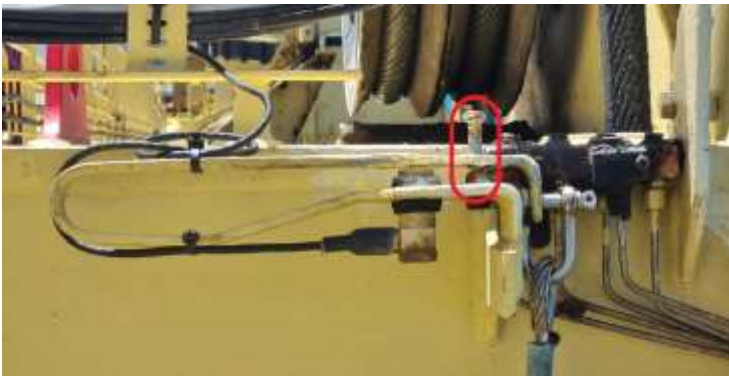
Investigation showed that one of the runner sheaves underneath the jib was bent slightly and unable to move freely. During the inspection of the high hook alarm, it was discovered that the flat bar (see illustration) in front of the sensor was not moving. It was stuck in place because of dry paint from maintenance that morning.

High hook alarm flat bar

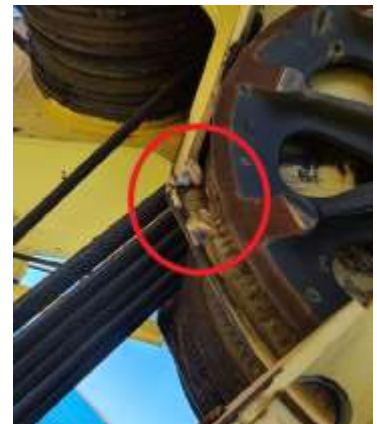
Damaged sheave

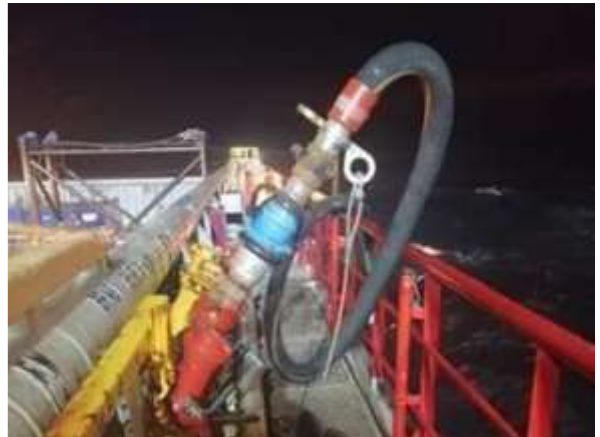
The crewmember was forced into an awkward manual handling position causing additional strain and overexertion due to the following contributing factors:

- The angle of the vessel manifold in relation to the connections, deck and surrounding pipework;
- The length of the hose end including a series of rigid connectors and adapters;
- The weight of the hose due to residual liquid inside the hose length.

Hose connections are a common weak link and most likely to experience fatigue which could result in a leak. An increased number of connections and adapters, increases the risk of manual handling injury to crew and environmental pollution. Good practice would suggest that the number of connections on the hose should be kept to a minimum and efforts ought to be made to drain back the liquid contents of the hose on completion of operations and prior to transfer.

- Reviewed manifold arrangement and made proposal for modification and improvement on other similar vessels;
- Suggested to installation operator that they
 - Review the hose connection arrangement with opportunity for improvements;
 - Review internal procedures for draining back hoses.
- Proposed recommendations to be included in the review of relevant chapter of the *Guidelines for Offshore Marine Operations (GOMO)*.
