## COBRA Advisory Notice: Setting Positive Pressure

### COBRA Guidance Note

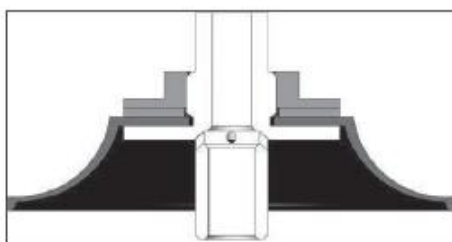
Figure 1 - Diaphragm Resting Shape

1. Firstly, it is necessary to determine whether the diaphragm is actually bulging or merely sitting asymmetrically. Bulging is defined as having any protrusion beyond the shape developed by the diaphragm when the set is in standby mode and gas is venting from the external relief valves (due to lightly purging the demand valve). If any bulging is evident, the diaphragm must be replaced.

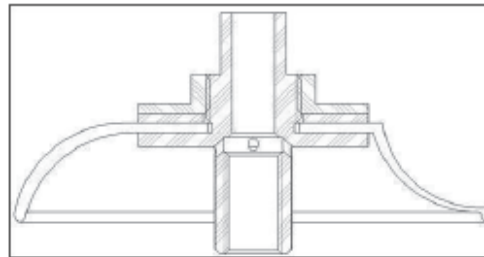
If the diaphragm is sitting asymmetrically, this is not a problem in its own right. If a stable positive pressure can be achieved, it is perfectly acceptable to use the COBRA set. In use, the diaphragm is clamped at the circumference and pulled down in the centre. Depending on the inherent stiffness of the individual diaphragm, the positive pressure acting on the underside of the diaphragm may or may not be sufficient to cause the flexible section of the diaphragm between the edge and the centre to adopt a fully convex shape.

Figure 3 - Acceptable Asymmetric Shape

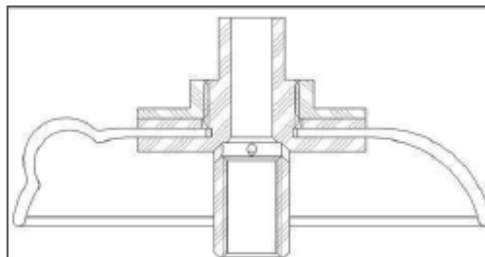
Figure 4 - Unacceptable Asymmetric Shape

3. Although JFD has observed this effect, we have not managed to recreate it at JFD sufficiently often to perform a full investigation. This effect could be related to overtightening (or previous overtightening) of the diaphragm retaining ring. JFD recommends replacing the diaphragm if this effect is observed.

In all cases JFD now recommend a torque of 8-10 in-lbs for the diaphragm retaining ring.

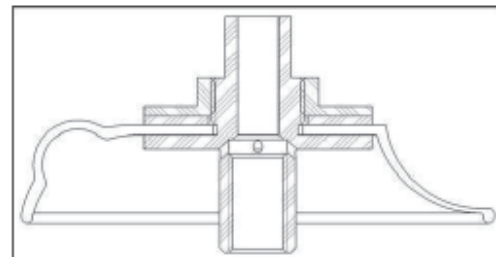
Figure 5 - Unacceptable Asymmetric Shape
