IMCA Safety Flashes summarise key safety matters and incidents, allowing lessons to be more easily learnt for the benefit of all. The effectiveness of the IMCA Safety Flash system depends on members sharing information and so avoiding repeat incidents. Please consider adding [safetyreports@imca-int.com](mailto:safetyreports@imca-int.com) to your internal distribution list for safety alerts or manually submitting information on incidents you consider may be relevant. All information is anonymised or sanitised, as appropriate.

## 1 Surface decompression near-miss

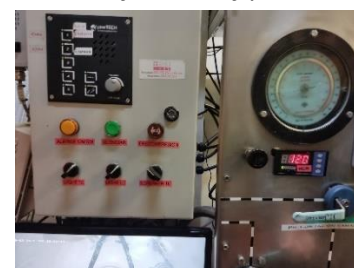
*Modification of panel*

*Depth less than 12msw, visual alarm*

*Exhaust valve open, visual and audible alarm*

- The root cause was the dive supervisor running the decompression, without anyone supervising him (no human second barrier);
- Procedures/manuals were updated to highlight that a diver runs the chamber during decompression, and the dive supervisor controls the diver;
- The chamber panel was modified with a visual and non-mutable alarm for the venting;
- A visual alarm showing depth shallower than 12msw, and an additional camera for the SUPV to see the DDC chamber readings was installed.

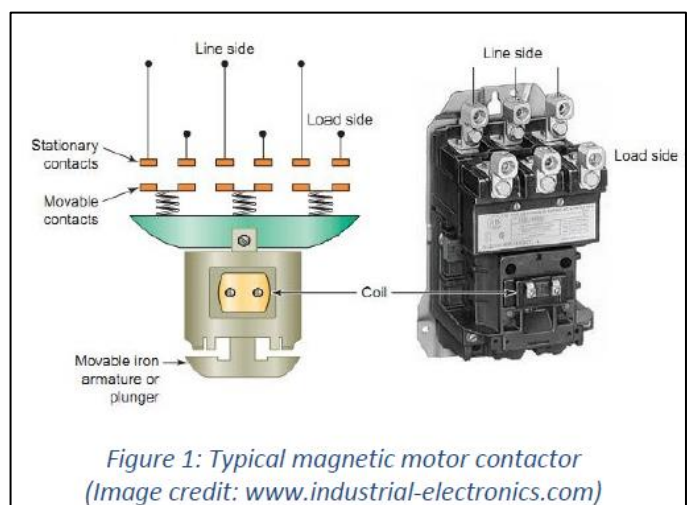
There was a failure during the routine maintenance and recovery of a rescue boat, where the electrical motor contactor for the winch motor failed in an energized position (i.e. motor in an “on” or “hoist” condition). This failure occurred when the contactors fused together due to exceeded duty rating. Metallurgical/post-event analysis ruled out any other failures with the contactor. The hoist button, emergency stop and limit switch circuits all failed to stop the winch from hoisting.

The USCHG noted that *analysis found that the contactors were not rated for intermittent cycling (start and stop sequences) of the winch and the contactor manufacturer had issued technical guidance on the issue of welded contacts. Intermittent cycling is a common practice during recovery of a lifeboat or rescue boat into the stowed position. A winch may be cycled after the boat has cleared the water to verify release gear condition prior to continued hoisting, possibly cycled several times during long hoists to reduce pendulum motions of the boat and cycled at approach to davit guides/stops. While commonly employed for a safe recovery process, intermittent cycling may exceed design and duty ratings of the electrical components.*

- Verify condition of winch motor contactors and replace any contactors that show signs of excessive wear, overheating, or welding;
- Verify the duty cycle ratings of lifeboat and rescue boat davit electrical components and compare those ratings to recommended and commonly-practiced boat recovery procedures/processes;
- Verify the design of the davit safety devices (i.e. emergency stop and limit switches) to see if they will secure electrical power to the motor in the event of welded contacts;
- Implement training for all personnel that operate the davits to ensure awareness related to electrical duty cycles and actions to isolate power in the event of a welded winch motor contactor.

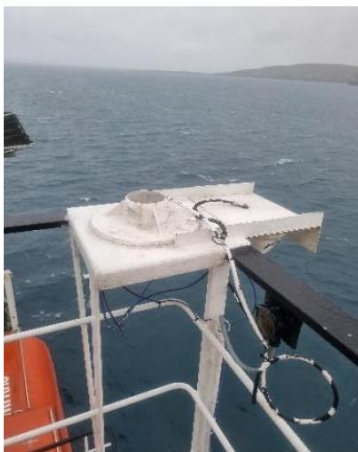
The starboard wing searchlight became detached from its mounting bracket in heavy weather, and fell directly into the sea, snapping the secondary tether that was in place.

The secondary tether was jury rigged out of a whip-check designed to contain a parting airline; it was not designed to take any loads.

*Dropped Searchlight Following Heavy Weather*

- Immediate Causes
  - Exposure to extreme weather
  - Dropped Object
- Underlying Causes
  - Inadequate safety controls
- Root Cause(s)
  - Improper safety securing device – Secured with whip check which is not designed to hold weight

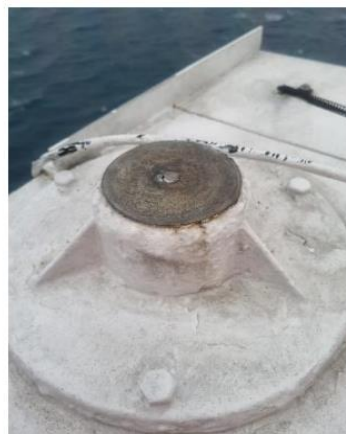
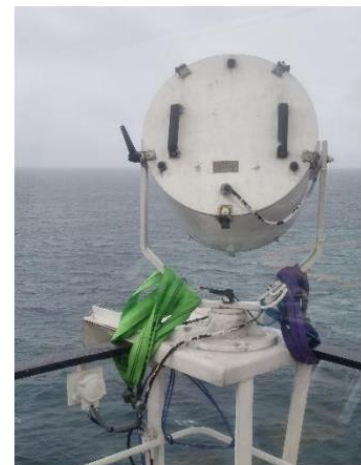
*Remaining Searchlight with  
Additional Securing*

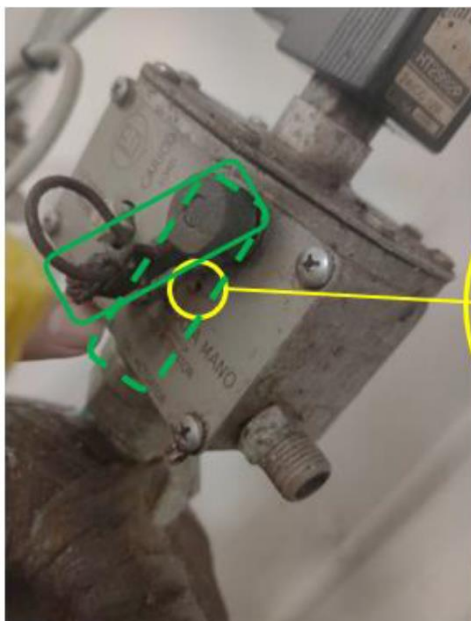
The Marine Safety Forum (MSF) has published [Safety Alert 22-09](#) relating to observations involving the CO2 firefighting system onboard a vessel. Significant corrosion was found during routine monthly inspection of the fixed CO2 system. This resulted in it not being possible to insert the safety pin to isolate the cylinder during any maintenance.

See Photo A below, which shows the safety lever and pin, unable to be positioned correctly in line with the pinhole. In Photo B after corrective maintenance and repair, it can clearly be seen that the activator arm, and therefore the safety pin aligns with the hole and can now be set to isolation for maintenance if required.
