1 Flash fire on Oxygen gas quad hose

2 Damage to flexible riser

3 USCG: Unexpected Dangers: Lifeboat Remote Control Wires

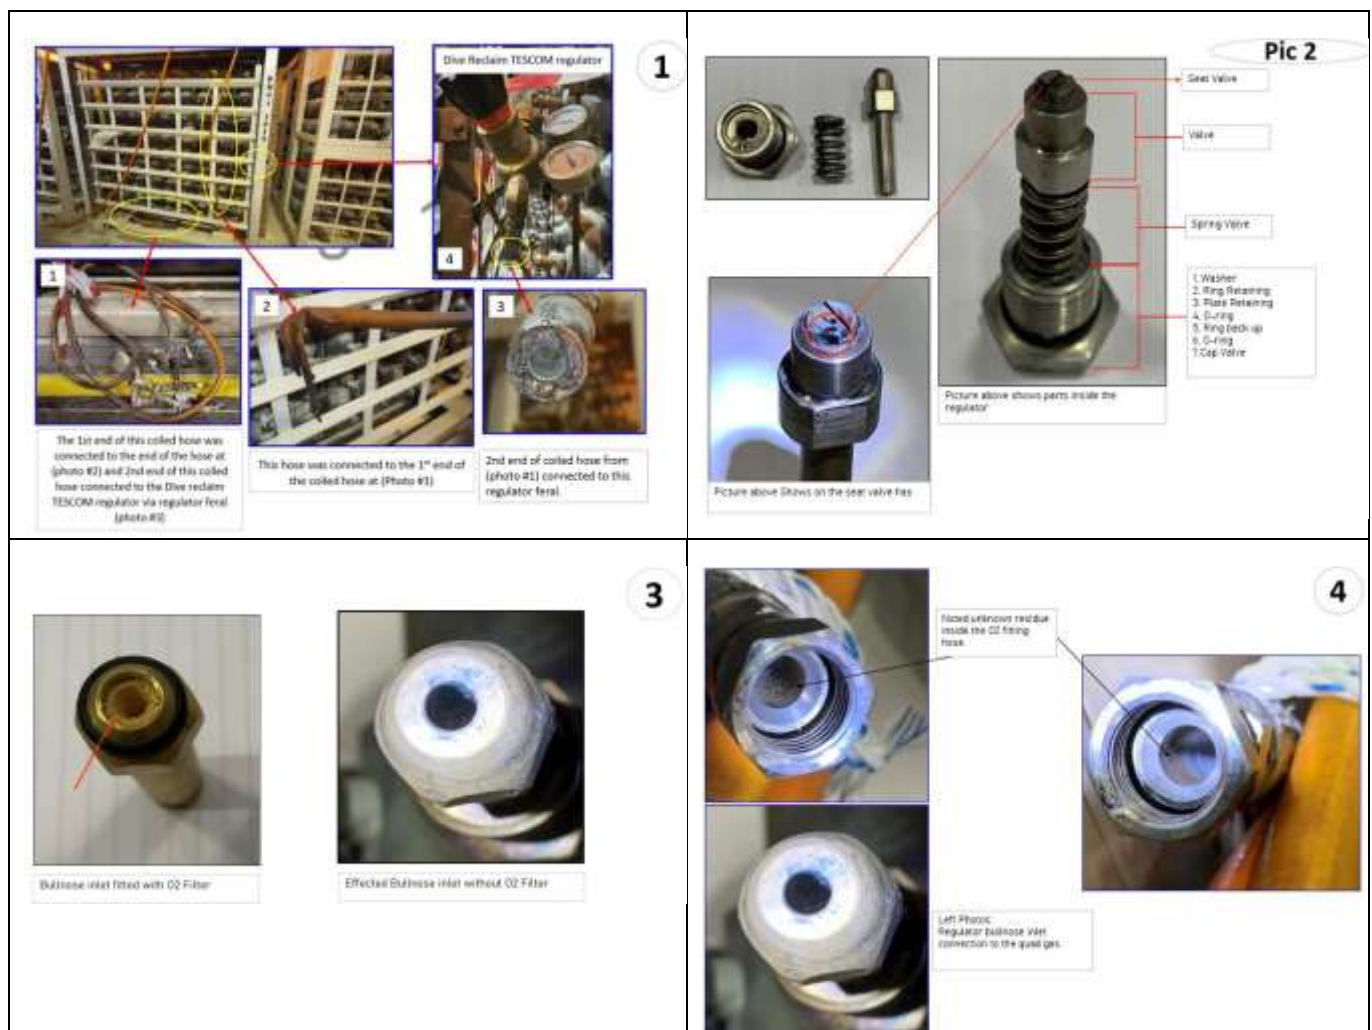
There was a flash fire on an Oxygen hose line onboard a DSV. The incident occurred during routine checks, when an LST (Life Support Technician) reported that the Oxygen supply pressure to dive control was low (25 Bar). SAT control informed Dive Control and agreed that a new Oxygen supply was required. The LST went to the appropriate quad (on the main deck), and started by closing the row of eight bottles of Oxygen before opening a new row. Whilst opening the new row of Oxygen supply bottles the LST heard an unfamiliar noise (a flapping sound from the regulator) and immediately closed the cylinder pillar valve and closed the valve on both regulators (SAT control and reclaim regulator valve) and quickly moved away from the Oxygen quad. The LST immediately returned to SAT control and reported to his supervisor.

Shortly afterwards, the Oxygen hose burst followed by an explosion and flash fire at the reclaimed Oxygen hose line. The deck foreman who investigated the source of the explosion immediately extinguished the fire with a dry

powder fire extinguisher. There was no damage found on the nearby gas quads apart from the affected hose and regulator.

Investigation showed that the bullnose inlet (connection to the pillar valve) had no filter to stop rust contaminant from the cylinder going into the regulator. Small particles of rust from inside the cylinder accumulated inside the regulator causing high friction after the Oxygen release, resulting in heat and contributing to the spark, explosion and fire.

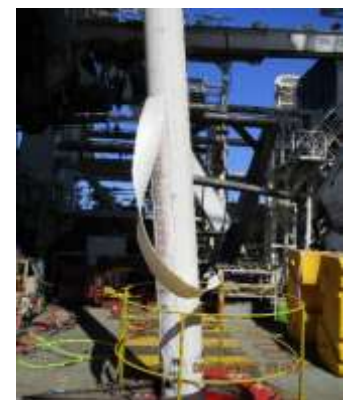
During deployment of a water injection riser from a vessel, damage to the outer coating occurred when it came into contact with the sharp edge of the flare in the moonpool area. A water injection riser was being installed through a project-supplied flare in the moonpool via the vessel's Tilttable Lay System (TLS) at an angle of 6.8°. The flare had been designed to direct and protect the riser at the exit. However, design reviews, subsequent risk assessments and inspections had failed to identify the hazard of the sharp upper lip of the flare with the potential to damage the riser.

- During design the sharp edge of the flare had not been identified as a hazard and therefore, was not chamfered for protection of the product;
- The project risk assessment did not identify proper controls to prevent and mitigate possible damage to the product or its coating due to seabed topography, tilted TLS etc;
- Lessons had not been learned - previous learnings from similar flexible product damage events had not been transferred to the project team prior to design.

Showing damage to the riser

- **Learn the lessons!** Learnings from previous or similar flexible product damage events to be reviewed and considered during the full life cycle from design to installation;
- During design reviews and risk assessments specific to flexible products, ensure sharp edges and potential hazards that can cause damage are considered and mitigated;
- Project supplied equipment to be integrated into lay systems should be reviewed by vessel team before fabrication and then again at installation.

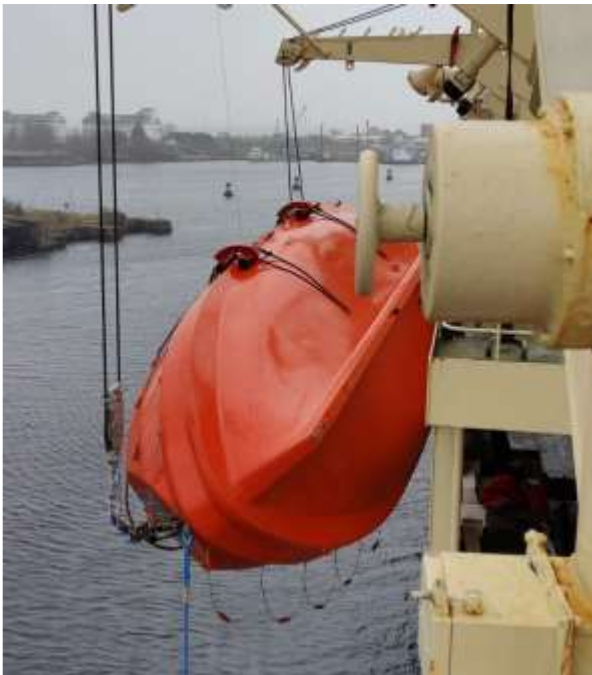
Lifeboat listing more than 90 degrees w/crew inside

- The second failure occurred a day later after the replacement remote control wire was hand spooled from extra wire found on board. During testing with crew on board the boat using the remote control wire to lift the brake, an unexpected pay out of wire led to the winch brake prematurely engaging, which made the lifeboat stop lowering and swing erratically above the embarkation deck. Seconds later, the movement caused the wire to regain tension, which lifted the winch brake arm and caused the lifeboat to lower again. While lowering in a swinging motion, the skag of the lifeboat caught on the knife-edge of the ship's deck, causing the lifeboat to list more than 90 degrees.

An internal company investigation of these incidents identified the crew did not follow existing company policy which required a test lowering without crew prior to embarking crew. The company's policy is based on recommendations within MSC.1-Circ.1578, *Guidelines on Safety During Abandon Ship Drills Using Lifeboats*.

The USCG strongly recommends that ship's crew conduct a thorough visual inspection of lifeboat launching systems and test lowering prior to operation with crew on board, paying special attention to the following inspection points:

- Verify the proper spooling of the remote control wire, expand inspection as necessary;
- Verify the proper position of the remote control wire weight. If the weight is very close to the top of the lifeboat, this may indicate the remote control wire is too long;
- Verify material condition of the shackle that connects the pull cable to the remote control wire within the lifeboat. These steel shackles can corrode and may be overlooked during weekly/monthly/annual inspections.

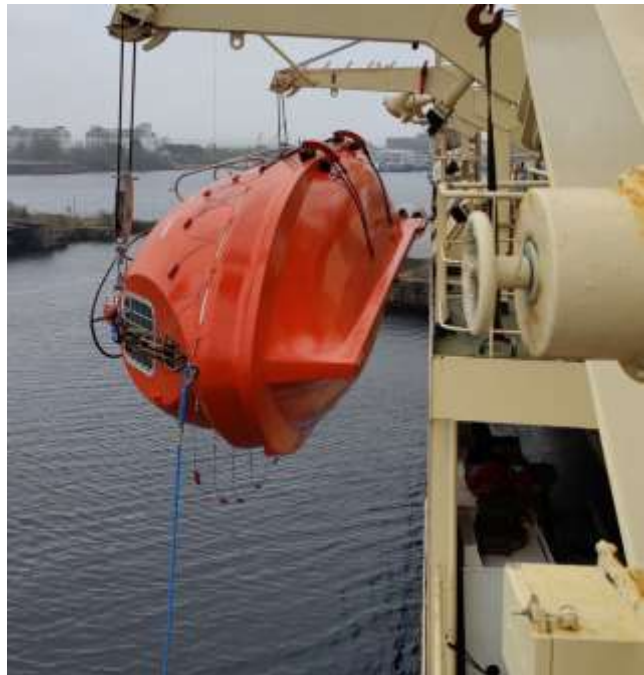
Lifeboat skag caught on deck edge

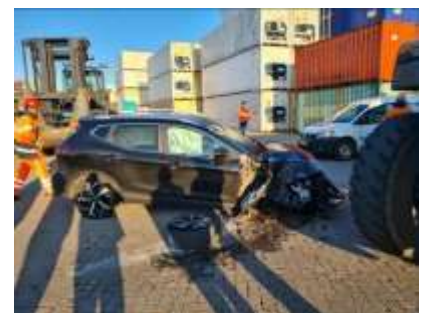
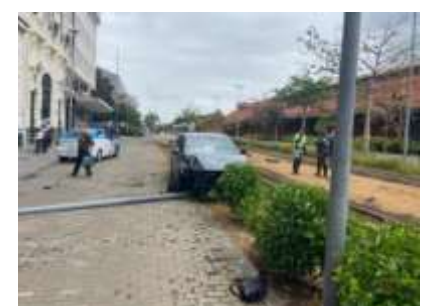
Incident 1: In the Netherlands, a contractor was driving on a third-party site when the his car collided with a 30Te forklift truck. The site had poor road markings and the visibility at the junction where the accident occurred was poor, due to stacked steel coils. Neither driver had stopped at the junction to check whether the route was clear. The car sustained significant damage, but the driver and the forklift driver did not suffer any injuries.

- Visibility was restricted at the junction but neither vehicle stopped to check the way before proceeding;

- The known hazards on site associated with movements of heavy machinery had not been communicated to the team on site, nor had relevant actions from risk assessments been closed out.

- Be willing to intervene and stop unsafe behaviours during journeys;
- Ensure everyone who is driving on work business is aware of their personal responsibilities and have defensive driving techniques in mind when they step into the vehicle;

- When mobilizing personnel to third-party sites, known hazards such as moving machinery, ongoing hazardous work, pedestrian safety, and security should be clearly communicated by the site during the induction and/or prior to travel;
