The following case studies and observations have been compiled from information received by IMCA. All vessel, client, and operational data has been removed from the narrative to ensure anonymity. Case studies are not intended as guidance on the safe conduct of operations, but rather to assist vessel managers, DP operators and DP technical crew in appropriately determining how to safely conduct their own operations. Any queries should be directed to IMCA at dpreports@imca-int.com. Members and non-members alike are welcome to contact IMCA if they have experienced DP events which can be shared anonymously with the DP industry.

1 Case Study – Maintenance – Not a good Idea During DP Ops

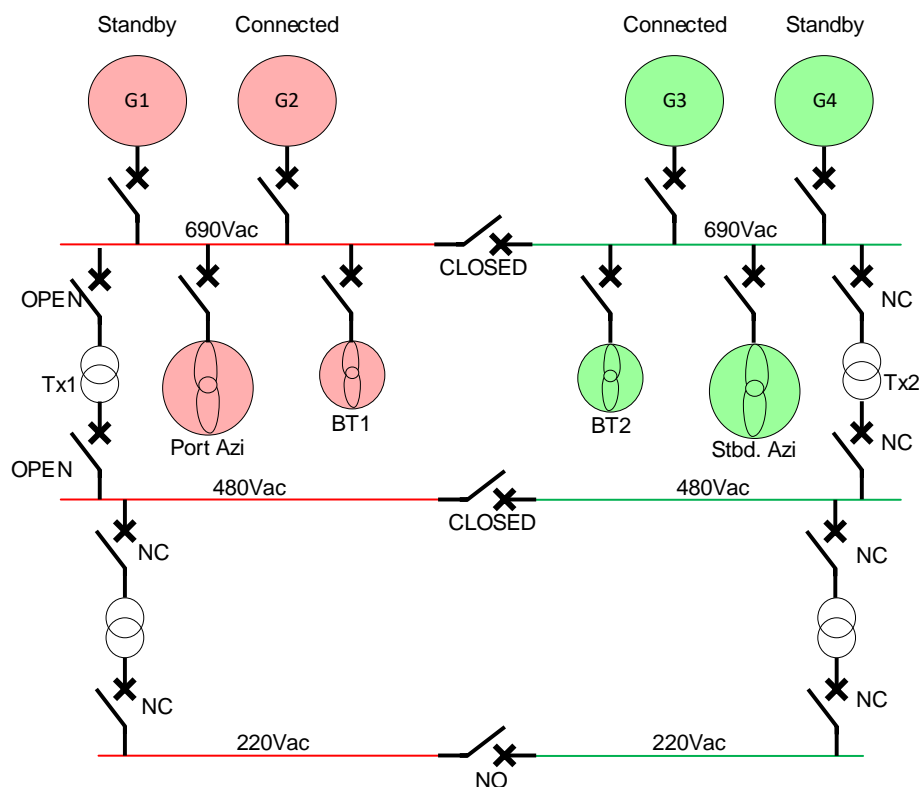
Figure 1 – 1 Configuration for maintenance on Tx1

During routine maintenance on Tx1 the 480Vac bustie was closed, and the two feeder breakers for Tx1 were opened to allow Tx1 to be isolated.

Upon completion of the maintenance it was noted that the 690Vac feeder to Tx1 would not close. Troubleshooting determined that a Port 690Vac switchboard 'REF' protection relay was faulty and needed to be exchanged.

It was decided to exchange the 'REF' relay. After remounting the replacement relay and in the process of terminating the new relay, an unknown live wire inadvertently contacted a surface and grounded. This grounding caused the remaining 690Vac circuit breakers on the Port bus to trip and open, since they were connected via "daisy chain" configuration by design for protection purposes. This then caused the bus tie to open as per design in order to protect the Starboard power bus. Port Azi and BT1 failed as a result.

The bus tie opened upon sensing low voltage on the Port bus. No loss of Position was experienced.

- That the vessel was configured in such a way that a single failure would exceed the WCFDI.
- The event occurred as a result of the decision to replace a critical switchboard component while remaining on DP.

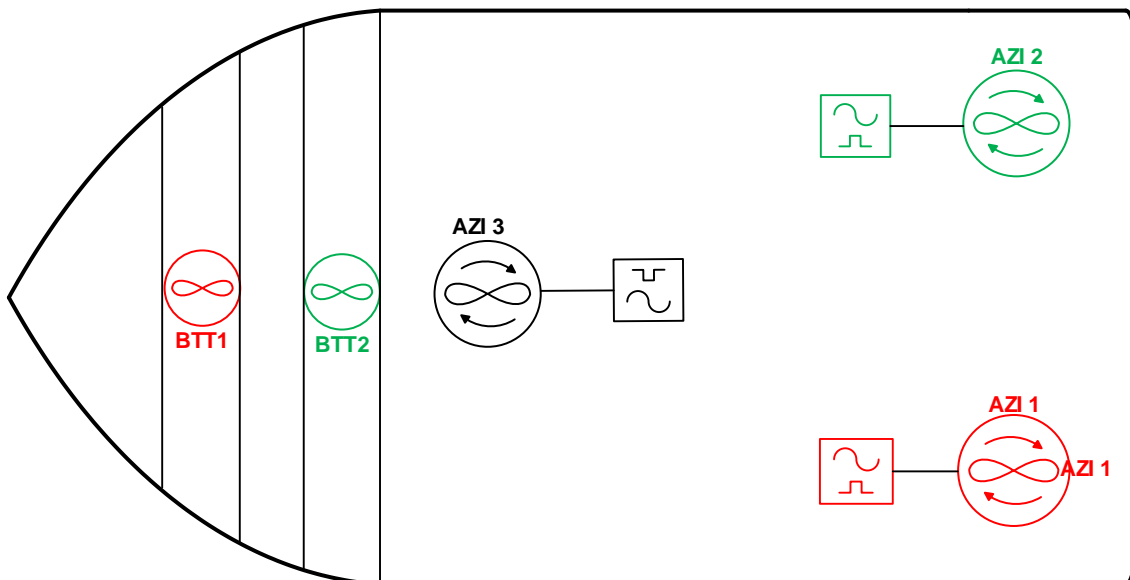
Figure 2 – 1 Thruster Setup

Upon completion of DP field arrival trials, the vessel began sub-sea operations. One ROV was deployed and the crane was in use subsea. The vessel set the two stern thrusters AZI1 and AZI2 to bias, in addition the bow drop-down thruster AZI3 was set to bias mode.

Biasing was set at 0.5t with a turn factor of 50%. The vessel lost position due to stern thrusters oscillating thrust against each other, ramping up to over the 50% turn factor causing them to kick into variable mode.

An all stop was called and the crane and ROV's were recovered to deck. The stern thrusters continually circled around their azimuths, unable to meet their set points. The stern thrusters continued to increase their thrust up to 100% causing the bow thrusters to ramp up as well. The excess thrust increased the demand on the available generators on each side of the bus (open bus), starting the 2 remaining standby generators. Vessel heading was lost by 5 degrees, and the position up to 10m.

An on-coming DPO then changed offset values from their correct value in metres to feet believing that feet were the correct value for the DP Control System. However, the DP system was still selected to operate in metres.

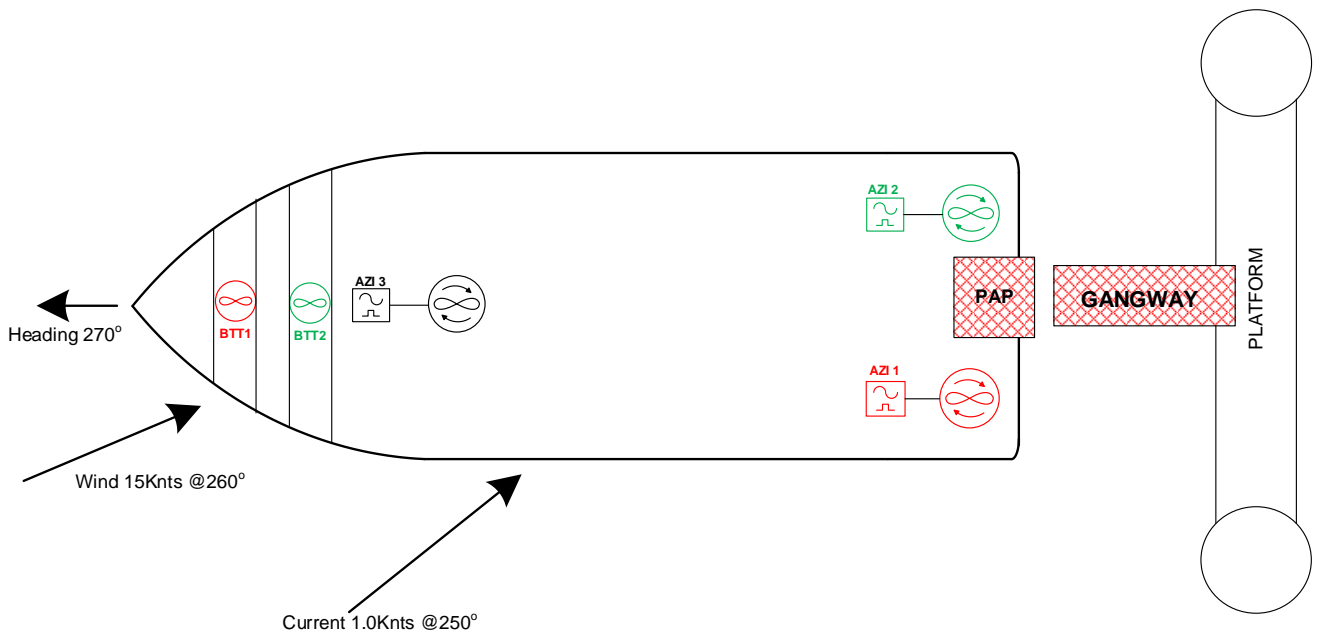
Figure 3 – 1 Overview

An SOV was approaching a Platform for personnel transfer via use of onboard Personnel Access Platform (PAP) and the Platform’s gangway. When the distance was approximately 1 metre between the gangway and the PAP, there was a sudden rejection of the vessel’s starboard azimuth thruster by the vessel’s DP system without any warning. The ‘ready’ signal was lost to DP Control for the starboard Azimuth thruster. The vessel started to drift astern.

While the vessel was manoeuvring into position to prepare for passenger transfer, the DP system reported an intermittent failure of one of two aft azimuth thrusters causing the starboard thruster to be incapacitated and de-select from DP Control, however the DP system still showed the thruster as ready, the operator re-selected the thruster back into DP Control.

The vessels DP system calculation was distorted by the inclusion of an unresponsive thruster and therefore could not stabilise.

The vessel could not hold position with the remaining Bow and Port azimuth thrusters.

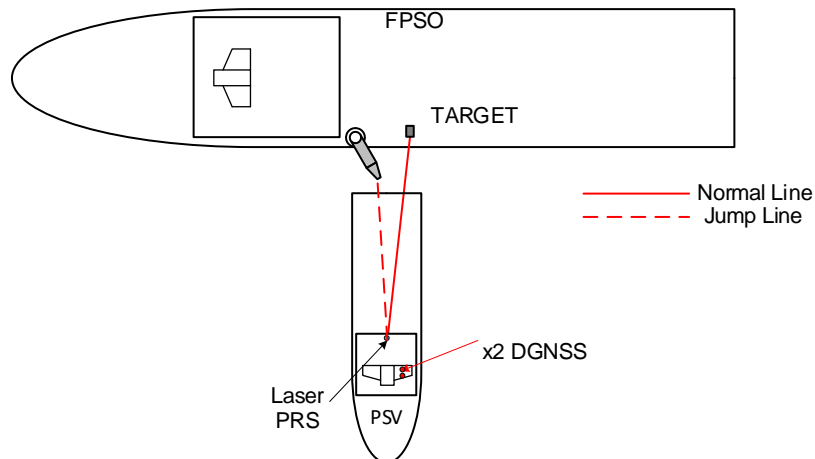
Figure 4 – 1 Position of Vessels

A PSV was conducting cargo operations alongside an FPSO which was moving around its moored position. Selected into DP Control were two DGNSS absolute references and one Laser based relative reference, there were no other available relative references for the DPO to select. The DP Control system was selected to 'Follow Target' mode.

During a lift from the deck of the PSV, the vessel thrusters suddenly ramped up and the vessel started to move off position. The DPO switched the DP Control into Joystick manual heading control to stabilise the vessel and move out of the 500m Zone.

The laser based relative position reference had switched to another target, in this instance the reflective tape on the crane hook. As there was only one relative reference available and selected this caused the DP Control to move the vessel off the original position.

- There was no redundancy for relative position reference
- The Laser target appears to have been positioned in the wrong location. Targets should be located clear of crane operations and personnel with reflecting jackets moving around
