IMCA Safety Flashes summarise key safety matters and incidents, allowing lessons to be more easily learnt for the benefit of all. The effectiveness of the IMCA Safety Flash system depends on members sharing information and so avoiding repeat incidents. Please consider adding safetyreports@imca-int.com to your internal distribution list for safety alerts or manually submitting information on incidents you consider may be relevant. All information is anonymised or sanitised, as appropriate.

1 Third-party truck not in appropriate or safe condition

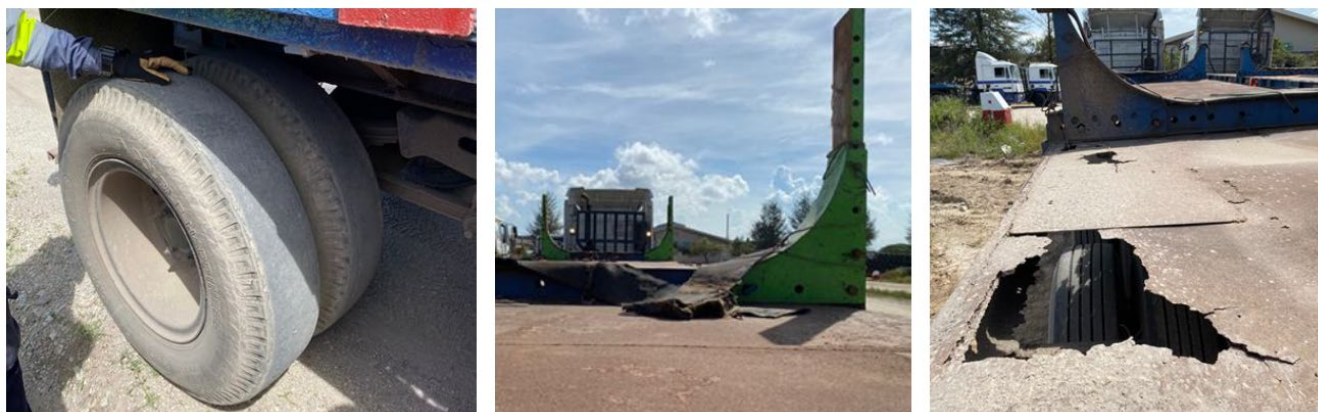
During preparation for transporting pipe sections from port to a coating supplier's facility, trucks to be used for the pipes were inspected and several defects identified. Trucks found in an unsafe condition were rejected by the company's site representative.

- Unsafe tyres (low tread levels);
- Expired vehicle registration certificate displayed on trucks;
- Heavily corroded trailer beds, including holes on surface;
- Rubber padding was found worn and detached from bolsters;
- Fuel gauge not working;
- Missing side mirrors;
- Sagging wheel fenders, contacting tyres.

A planned inspection of trucks was performed jointly by the coating supplier and company site representative as part of the preparation activities. Several defects across multiple trucks were identified. The supplier was instructed to remove the trucks from service until all defects were rectified.

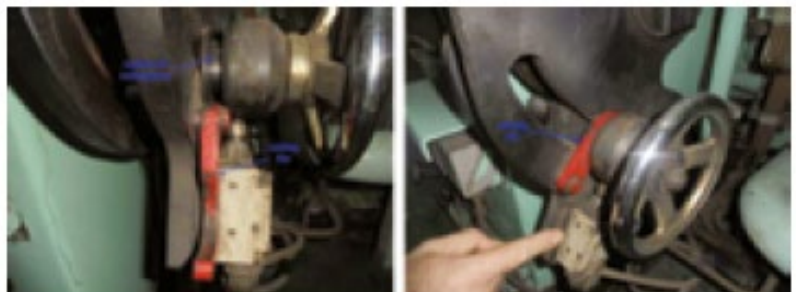
- Detailed inspection identified significant hull damage although the vessel was not holed.
- Investigation revealed that engine control system maintenance work conducted 6 days beforehand had not been properly completed nor had it been inspected afterwards.
- A red locking pin (see photos) had not been correctly secured back into position and during manoeuvring had shaken loose due to vibration. This activated the emergency manoeuvring system which overrode both the bridge and engine room control systems.
- The root causes for this incident were found to be a **lack of understanding of the risks** by the engineering officers carrying out the checks, which were not overseen by a supervising officer – a company procedural requirement which was not followed.

- Amend pre-arrival and departure checklists to include physical verification of the emergency manoeuvring system's locking arrangement;
- Ensure closer integration between pilot and bridge team;
- Look out for single points of failure.

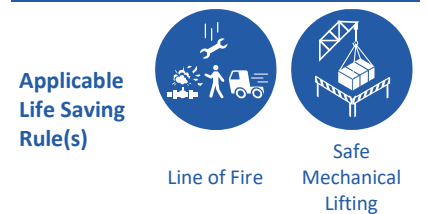
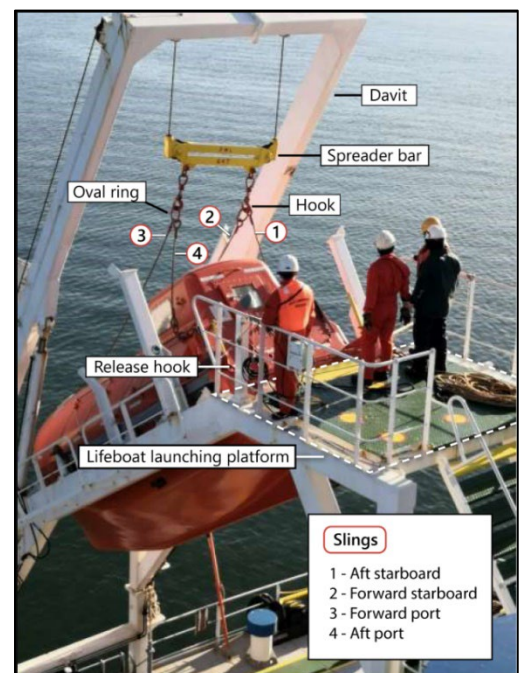
- The crimp sleeves on the lifeboat slings had weakened over time as a result of intergranular stress-corrosion cracking;
 - The manner in which the slings were attached to the hooks caused the load to concentrate on the aft starboard sling. This, in combination with the weakened crimp sleeves, caused the sequential failure of the slings and the aft port sling bracket;
