1 Near miss: divers umbilical drawn beneath a load

2 Incorrect as-built drawing configuration

3 Engine room fire on a ferry

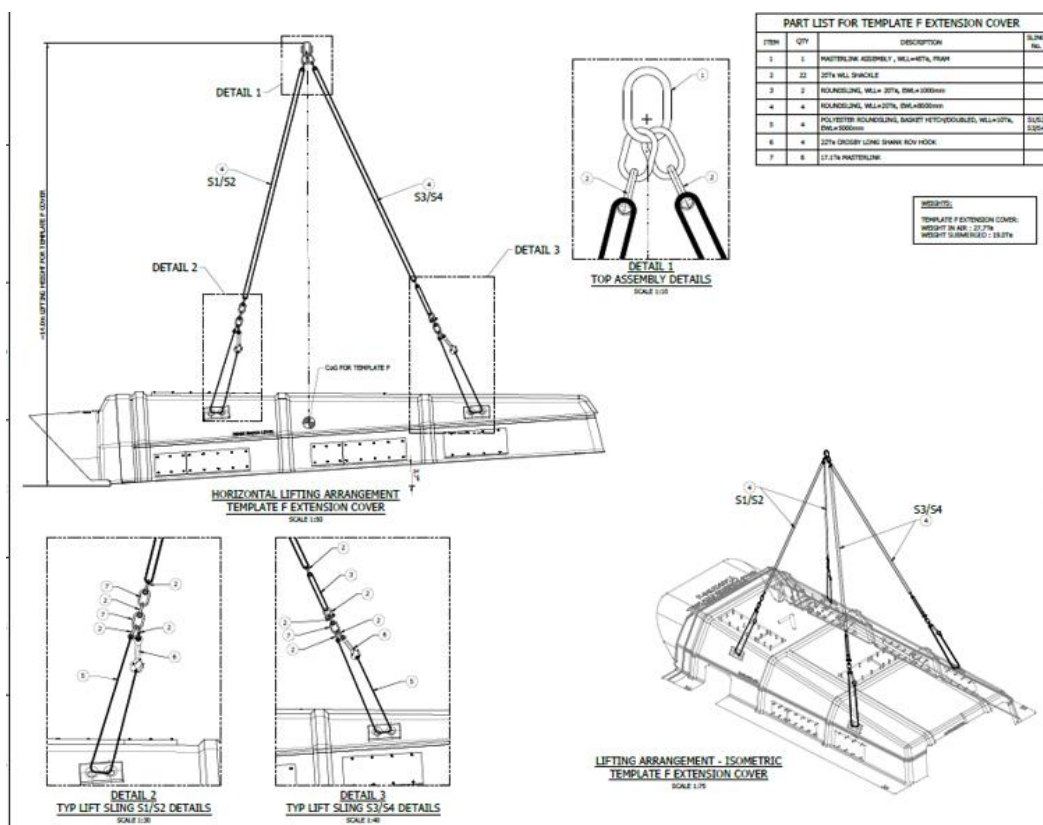
Suction from a large GRP (glass-reinforced plastic) cover during lifting resulted in a diver's umbilical being drawn beneath the load. The incident occurred during hook-up of the GRP lift rigging, when unexpected movement of the cover led to suction which drew Diver 1's umbilical under the corner of the cover. The cover was lifted and the divers' umbilical was cleared. The soft nature of the seabed prevented damage to the umbilical. There was no interruption to any diver's services, and no injuries.

During hook up of the cover, using crane active heave compensation, the vessel experienced heave which resulted in the cover being lifted in an unexpected way. This occurred when standing up the rigging in active heave

compensation (AHC) to ensure there were no twists prior to switching modes into auto tension (AT). At that moment the vessel took a disproportionately large heave and consequently partially lifted the GRP cover.

Our member notes that large GRP covers (this one weighed over 20 tons) are notorious for the suction forces they create when being lifted, yet the diver needs to be close to enable the fine placement over assets.

Although the diver and dive supervisor were not expecting the GRP cover to lift, and good umbilical management had been identified as a requirement in the risk assessment, the potential for this movement of the umbilical to be sucked under the structure had not been identified and the appropriate umbilical management fully recognized.

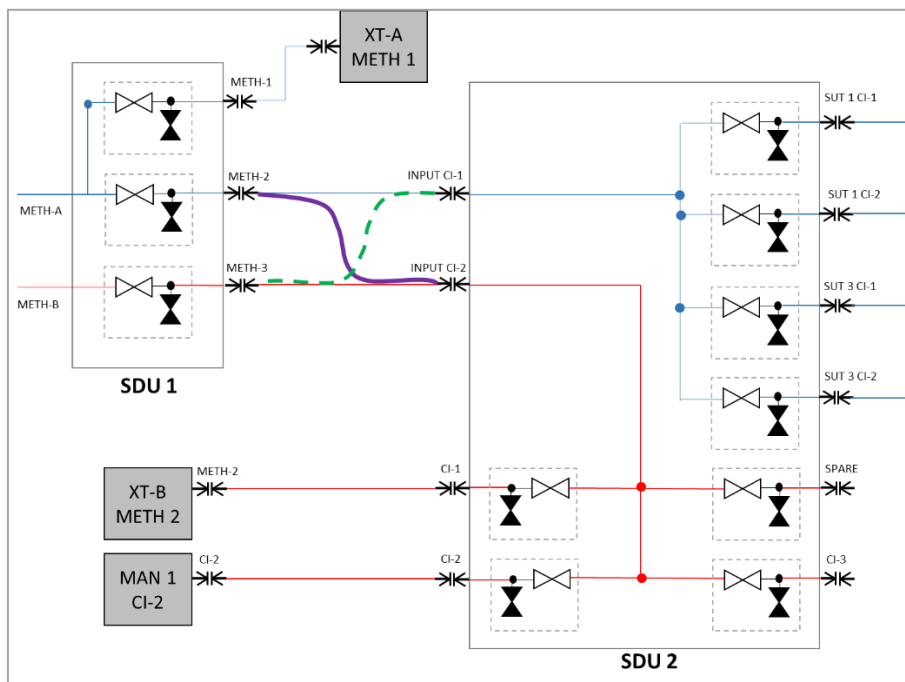
It subsequently became apparent during fault-finding that the subsea asset's actual jumper configuration differed from the data received from the client.

Divers carried out intervention on a system which actually only had a single unproven barrier in place.

Incorrect information was provided by the client.

- Work was stopped until it could be ascertained that the system was safe for further intervention;
- The client was alerted and conducted a thorough internal investigation. They could not pinpoint how the error occurred. The drawings were redone with the amendments in place and formally approved.

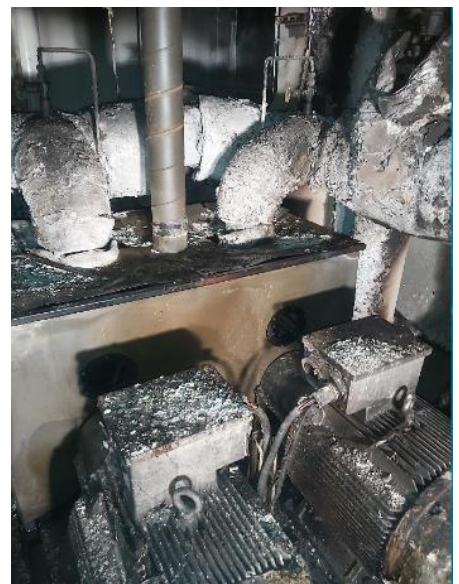
A fire was detected onboard the “roll-on roll-off” passenger ferry *Pride of Hull* when it was outbound in the Humber Estuary, UK. The fire was detected in the vicinity of the thermal oil circulation pumps, part of the vessel's heat reclamation and transfer system. Shortly afterwards, the vessel lost electrical power and propulsion but used remaining headway to anchor safely.

The vessel's Hi-Fog fire suppression system activated automatically but did not operate as anticipated and could not control the fire, which was extinguished using the vessel's fixed CO₂ system. The vessel returned to port, under its own power, the next day. No one was hurt, damage was limited and there was no pollution.

- **Bearing failures:** examination of the thermal oil circulation pump identified that progressive bearing failures resulted in extreme frictional heating, generating temperatures in the order of 1,200°C, far in excess of the auto-ignition temperature of the thermal oil used in the system;
- **Compromised fire suppression systems:** Assessment of the fire suppression system identified that the system's effectiveness was compromised by pump output when multiple zones were activated and its dependence on a domestic fresh water pump to maintain supply for longer than two minutes. Additionally, the system's pumps were not connected to the emergency switchboard and therefore stopped when the vessel lost electrical power. These limitations were compliant with requirements but were not reflected in emergency response guidance.

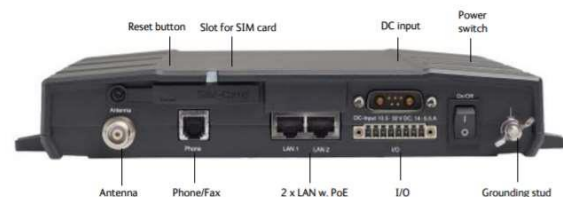
Sailor 150 Fleet Broadband connector panel

The radio frequency interference came from a failed connector panel of SAILOR 150 Fleet Broadband System. This caused an outage of GNSS positioning systems for the surrounding vessels in close vicinity.

- Failed equipment can transmit a radio signal which can interfere with the communication or navigational equipment nearby;
- Check for any similar equipment onboard that is not in use, but not disconnected or powered down – removal may be worth consideration.

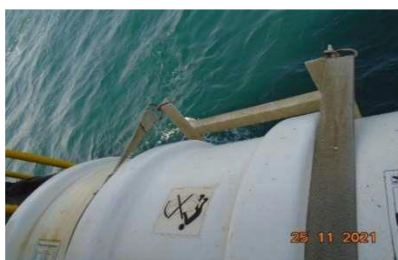
During rough weather on a vessel at sea, the lashing on a life raft gave way due to wear on stitching on the strap eye. The life raft fell into the water and became inflated.

Life raft lashing parted

- Lashing straps literally affected by “wear and tear” during poor weather condition;
- Inspection of the straps was not part of the vessel planned maintenance system.

- A “Y strap” wire lashing may be used (see illustration), given the approval of the manufacturer;
- Regular inspections and pre-checks before rough weather;
- Specific inspection of life raft lashings to be added to vessel planned maintenance system (PMS).

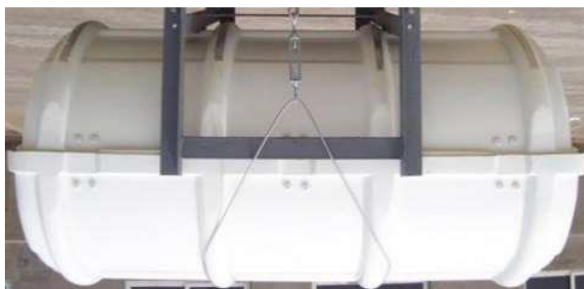
*Suggested lashing arrangement
using wire lash strap*
