1 BSEE - “Green hats” – training and supervision of short service employees

2 American P&I Club: Vessel grounding - fatigue was a factor

3 MAIB: Capsize and sinking of fishing vessel Joanna C – vessel stability

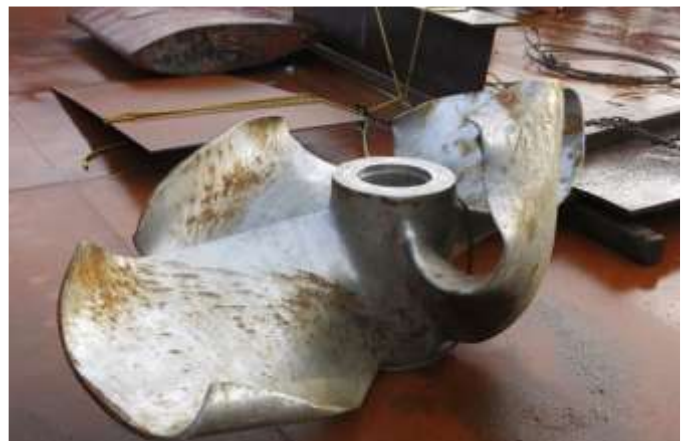
At approximately 1:25 am, the towing vessel ran aground on the shoal. The grounding caused both main engines to shut down. The engineers were unable to restart either main engine and suspected damage to both propellers and shafts. Both ducted propellers were heavily damaged. The towing vessel was out of operation for 10 weeks. Repairs cost over \$950,000. The vessel itself could easily have been lost had the hull been breached, or had one of the propeller shafts been seriously compromised.

- The Mate fell asleep in his chair on watch. He indicated that a combination of the previous sleep disruption, extra work the night prior, and very calm seas caused his fatigue;

- A review of the work/rest log on the vessel indicated that the true hours of work were not being recorded daily. They appeared to be recorded once weekly for the entire week. A quick review indicated that the hours did not vary from day-to-day despite a varied work schedule for the crew;

- The Mate indicated that he had:
 - worked 13.5 hours in the 24-hour period prior to assuming the watch on which he fell asleep.
 - worked just over 29 hours in the 48-hour period prior to assuming that watch.

- The Mate also indicated that he did not set an alarm in the ECDIS to remind him of the planned course change nor did he set up depth contour alarms. He said he was familiar with how to do both, but it had not been their standard practice onboard this vessel.

- Except in emergencies, the requirements for adequate rest should never be ignored for the sake of operations;
- Records of hours worked should be honestly filled out and maintained. Recordkeeping associated with work and rest should be made part of the culture onboard each vessel and part of the vessel's safety program;
- Mariners on watch who are having difficulty staying awake should recognize that the safety of the crew, the vessel and the cargo is at risk. They should either take direct action to maintain their alertness (stand up, move around, call a deckhand to come to the bridge, have a cup of coffee) or call the Master and ask for assistance.
- ECDIS alarms are valuable tools that should be fully used and correctly set.

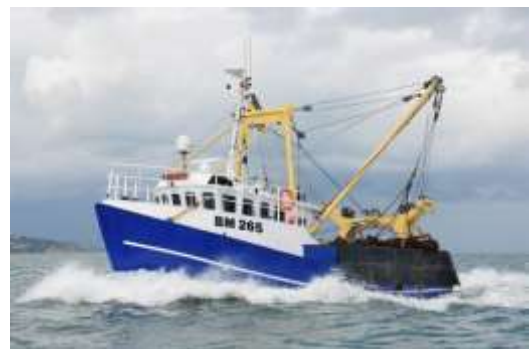
Early in the morning, in darkness and windy conditions, the crew of a scallop dredger was recovering the dredges, full of catch, back on board. As the gear emerged out of the water, the skipper realised that the starboard dredge bar was snagged on a potting line. At the same time, the vessel started to heel to starboard and rapidly capsized. The mate, who was on deck, was thrown into the sea, but the skipper and deckhand were initially trapped inside the floating, upturned hull. After about 40 minutes, the skipper managed to escape as the boat sank, but the deckhand remained trapped inside.

The MAIB's investigation found that through-life modifications, culminating in extensive alterations in 2019, had reduced Joanna C's previously good stability to a state where she had very low reserves of positive stability and increased vulnerability to capsize. The detrimental effect of the modifications was unknown to the crew and regulator alike because, although a stability assessment had begun after the 2019 modifications, the analysis was never completed, and the vessel was free to continue operation.

The vessel's life raft did not inflate during the accident because the uninflated life raft had insufficient buoyancy to initiate the inflation mechanism. The absence of a life raft adversely affected the survivability of the crew in the sea after the vessel sank.

- Modifications will alter a vessel's stability characteristics.
 - Post-accident analysis identified that multiple modifications over many years had eroded the fishing vessel's stability condition from one of being very satisfactory, to that of failing the required criteria by a wide margin;
- Automatic lifesaving appliances need to be arranged so that they float free and aid survivors.
 - After Joanna C sank, the float free life raft was released from its cradle by the Hydrostatic Release Unit (HRU) but did not subsequently inflate. The life raft did not inflate because it was a model intended for use in the leisure industry and was not manufactured to meet any design standard. At the time of this accident, the carriage of a liferaft that did not meet any industry standard was acceptable under the small fishing vessel regulations.
