1 MAIB: mv *Teal Bay* mooring fatality

2 Failure of moorings during heavy weather

3 BSEE: Hazards associated with cranes on idle facilities

5 USCG: Hidden corrosion on deck fittings can cause dangerous failures

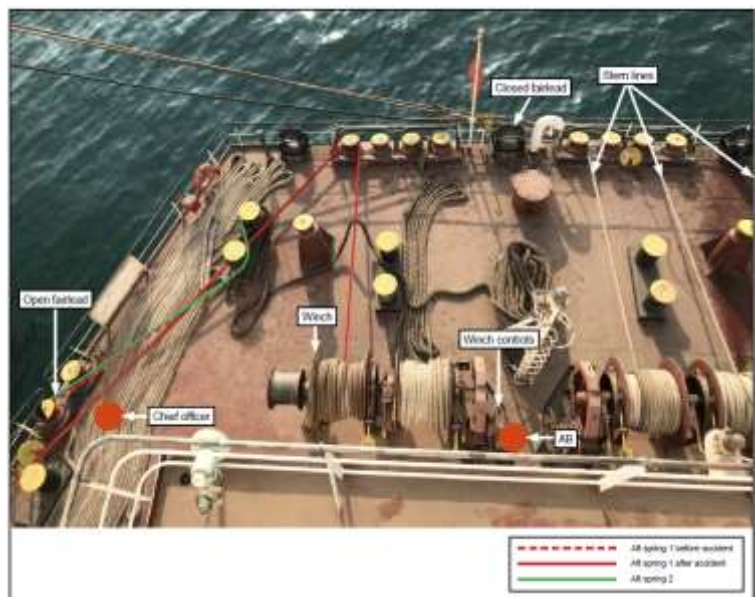
The Chief officer was fatally injured when he was struck on the head by a tensioned mooring line that sprang out of an open roller fairlead. *Teal Bay* was loading grain when moored alongside an anchored bulk carrier. The mooring line was being used to pull *Teal Bay* forward and it sprang free when its lead angle became too great for the open fairlead to restrain it.

- The mooring line sprang free because the fairlead in use was open and the lines had developed a hazardous upward lead during Ship-to-ship cargo operations as the difference between the vessels' freeboard increased;
- Leading two lines through the same fairlead restricted the space available and almost certainly contributed to the loss of spring line 1 containment.
- The number of crew assigned to carry out the warping operation was insufficient and almost certainly influenced the Chief officer's decision, which went unchallenged, to stand in a hazardous area;

Showing mooring arrangement (dotted line indicates position of aft spring 1 before the accident)

- Fleetwide safety alert to highlight the safety issues raised;
- Additional safety training with crew, including modules on safe mooring operations and ship-to-ship transfer;
- Planned to remove open fairleads and replace them with a closed type or universal type of fairlead;
- Reviewed and SMS procedures and risk assessments.

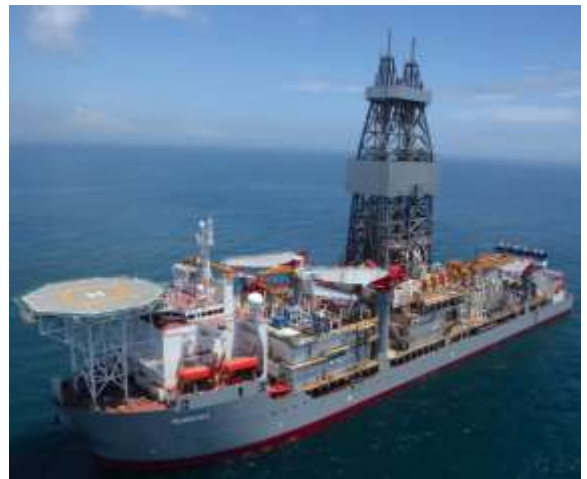
Offshore winds from the northeast had increased throughout 2 February 2021 and by 1800 were between 50-55 knots. At about 1915, VALARIS DS-4's moorings failed during storm force winds. The drill ship was blown off the jetty and drifted to the southwest until about 1923, when the anchor, which had previously been deployed as part of the VALARIS DS-4's mooring arrangements, held. This likely prevented the drillship from going aground on an island about 400m to the west. Another similar drill ship ENSCO DS-8 remained moored alongside the jetty with tug assistance and the use of its thrusters.

- the inability of crew to bring the thrusters online in time to prevent the mooring lines from being overloaded by the storm force winds from the northeast;
- the Master did not request tug assistance when the weather forecast for storm force north easterly winds was received on the afternoon of 2 February 2021;
- Additional factors identified included:
 - inadequate coordination between vessel management and the port;
 - inadequate identification and consideration of local conditions, including the weather;
 - inadequate identification of the drill ships' power requirements;

- Ensure thrusters can be started appropriately and in a timely way – in this case, all six should have been able to start simultaneously;
- Develop new and better mooring plans and emergency response procedures;
- Review and revise their procedures for planning for vessel lay-ups.

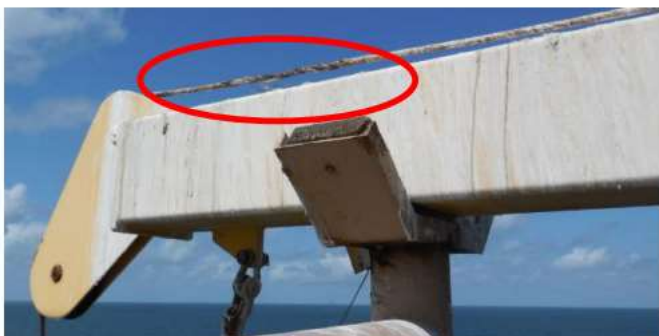
Figure 1 – Corroded crane cable

After extended periods of inactivity, with little or no operator inspection and maintenance, lifting equipment deteriorates due to harsh offshore environmental conditions. BSEE inspectors have observed corrosion on numerous crane cables, which support main blocks, auxiliary balls, overhaul/headache hook balls, and anti-two block equipment. Without proper oversight, the weakened cables have parted, resulting in cables and associated crane components dropping from elevation.

- Removing all blocks and balls from inactive cranes on idle facilities. If immediate removal is not possible, temporarily secure the blocks/balls with straps or slings that are in adequate condition to prevent dropped objects hazards;
- Conducting a full-function operation inspection when an out of service crane is being put back into service, paying special attention to the lubrication of the wire ropes. All slings on idle facilities that are kept on outboard brackets should be appropriately stored or discarded to eliminate the possibility of falling overboard;
- Clearing diesel and hydraulic reservoirs and associated hoses on cranes that have been permanently taken out of service, to eliminate pollution potential.

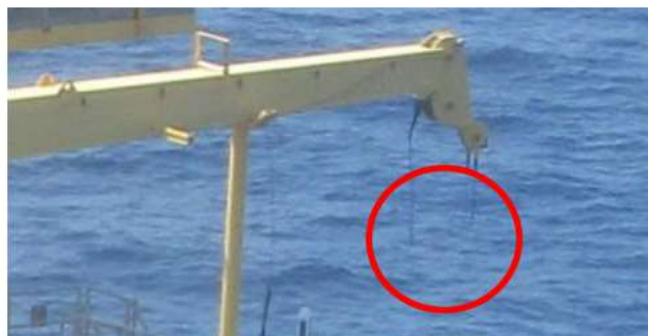
Figure 2 – Crane missing main block and auxiliary ball

BSEE inspectors have observed multiple crane components in poor condition on idle facilities throughout the Gulf of Mexico. Additionally, BSEE inspectors have noted various crane components missing that were previously attached by crane cables.

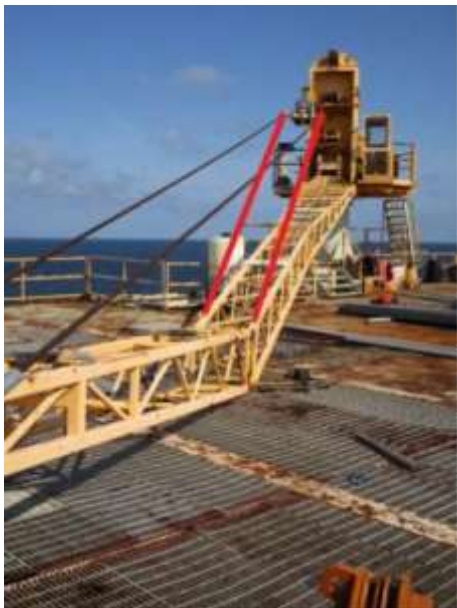
A lead mechanic suffered a severe leg injury while performing a boom tip changeout on an offshore pedestal crane. He and his assistant deviated from the planned scope of work, failed to rig up the mid-section to the bridle (Figure 1) prior to removing the mid-section to boom tip connector pins (Figure 2), and failed to use boom connector safety pins (Figure 3). After removing the bottom right pin, both employees assumed the bottom left pin would be difficult to remove since it was bearing the weight of the boom section. When the lead mechanic struck the remaining connector pin, it unexpectedly ejected, causing the boom to drop and pinning his leg against a sledgehammer and grating (Figure 4), fracturing his tibia.

Figure 1 – Example of how mid-section should have been rigged

- Review of policies and procedures, ensuring compliance with the JSA requirements;
- Reinforcing the use of **Stop Work Authority** particularly when the scope of work changes;
- Understanding the importance of staying out of the line of fire when working near heavy equipment and considering all possible pinch points when walking down the job;
- Verifying all safety equipment is available and in place before the job starts;
- Providing specific written procedures to individuals disassembling cranes;
- Ensure that you do actually review the paperwork, risk assessment, JSA etc **before you sign off on it** and before you start the job!!
- Ensuring specialized contractors create and maintain written procedures and checklists for common jobs;
- Conducting drills based on realistic injury and first-aid scenarios and inspect medical supplies and kits at the facility level.

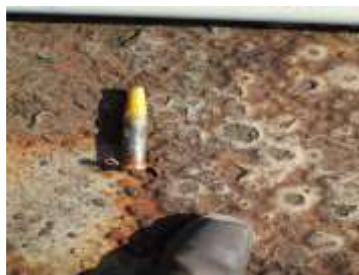
Figure 2 – Boom connector pin

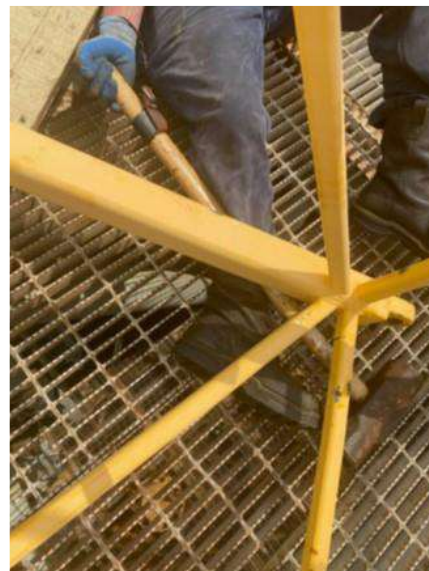
Figure 4 – Boom section on injured person's (IP) leg

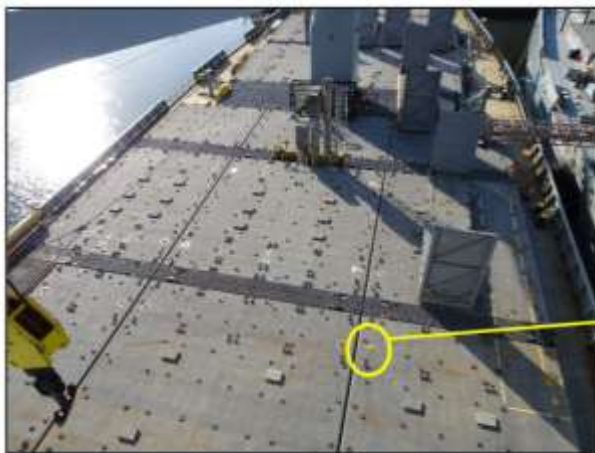
Figure 1. Deck Configuration

While positioning a removable hatch cover on the vessel (Figures 1 and 2), three of the four D-ring securing straps failed (Figures 3 and 4), causing an uncontrolled snap-back of the lifting sling assembly that struck the crewmember in the head. The three fractured securing straps showed similar failures with a significant amount of corrosion beneath the paint and on the underside of the straps. It is likely that just one D-ring failed initially, which would have instantly doubled the load on the two adjacent corner D-rings, both of which were apparently weakened and

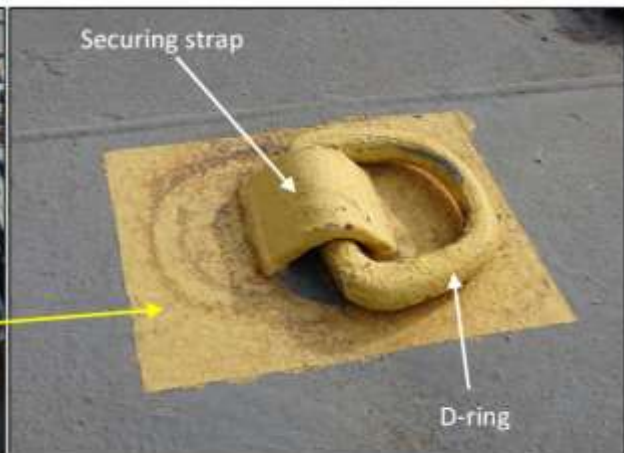
Figure 2. Example D-Ring Configuration

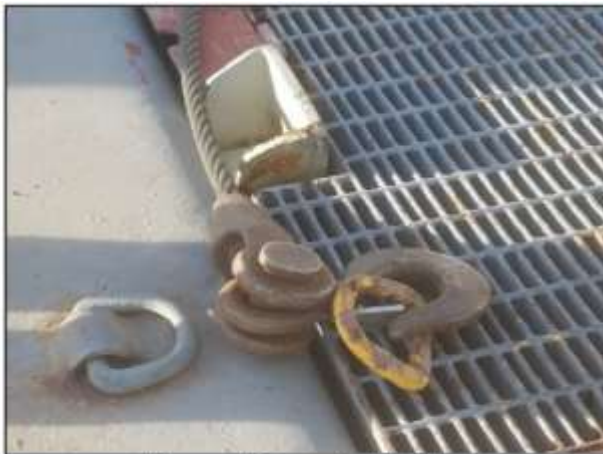
Figure 3. Separated D-Ring

- Whilst the arrangement of the hatch cover lifting points were in accordance with all available drawings and design schematics, there were no records of any pull-tests or other testing conducted on these lifting points since their installation in the mid-1980s;
- There were no records of any D-ring replacements, indicating that these have likely been in an exterior weather deck environment for several decades;

- Immediately identify high-risk D-rings and similar lifting-point fittings. High risk factors include: Age, weather exposure, and lifting load. These factors will cumulatively cause corrosion losses on the fitting, increasing its stress and fatigue vulnerability during each lifting cycle;
- Thoroughly inspect all high-risk lifting points for damage, hidden corrosion, and wastage. Audio gauging, pull-testing, or even replacement may be appropriate;
- Consult with the manufacturer's instructions to ensure safe lifting limits are in place and that the effects of service life are considered in their determination;
- Establish a maintenance schedule for periodically inspecting all lifting points and audio gauging or testing any fittings as they age into high-risk status.

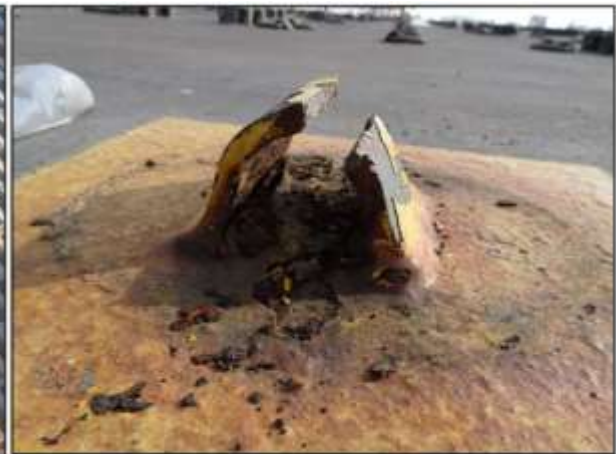
Figure 4. Failed Securing Strap
