COBRA Bailout System: Top Handle Failure

COBRA Guidance Note

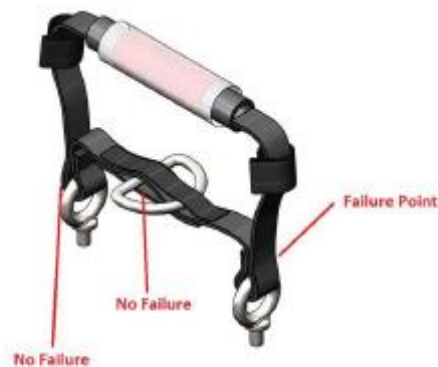
The top handle on a COBRA set failed while the COBRA set was being lifted or lowered on a pulley system.

The stitching was found to have failed at one eyebolt. The COBRA set dropped but the other eyebolt and the D-ring remained connected to the COBRA set.

Users are reminded to check the condition of the handle and stitching before any lifting operation and to clip the lifting tackle into the D-ring as intended.
