## 1 Focus on third-party dropped objects

## 2 Hydraulic Oil Leak to Sea from Downline Fitting

## 3 BSEE: Poor preparation prior to hot work leads to fires

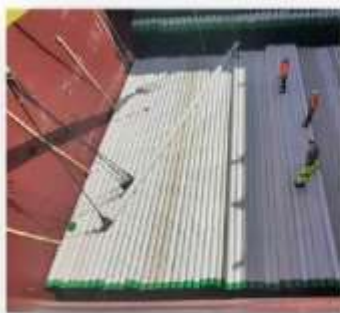
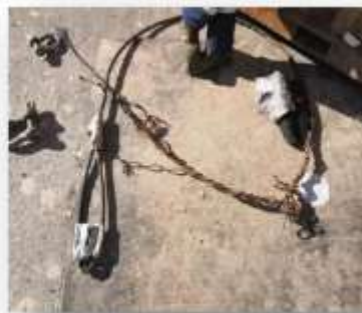
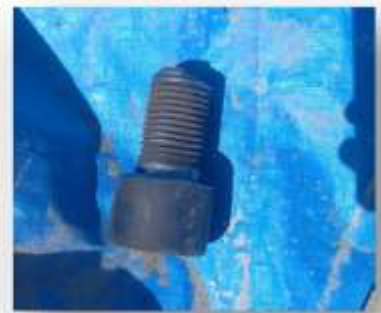
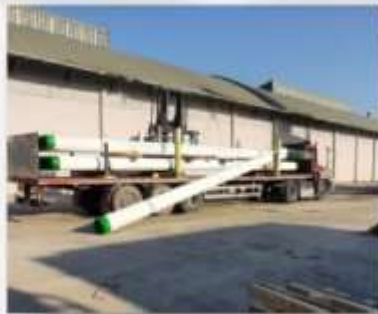
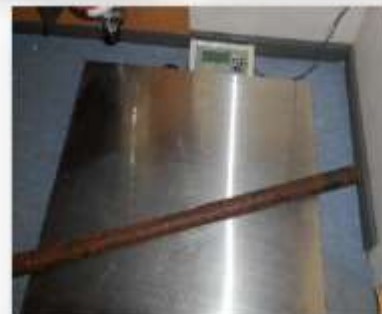
The dropped object incidents have included many high potential near miss dropped objects which under different circumstances could have resulted in debilitating personal injuries. The dropped objects have been all manner of items, from heavy pipes, rigging failures through to nuts and bolts, that all had the potential for personal injury.

- Rigging failures;
- Weld Failures;
- Overhead gantry crane failures;
- Dropped pipe during pipe handling;
- Snagged rigging during pipe transfer;
- Incorrectly secured rigging.

- Inadequate procedural control that did not identify the correct process and risk management to be followed during pipe handling;
- Inadequate acknowledgement, adherence, understanding and assessment of risk controls in the risk assessments – truck inspections, banksmen/additional spotters not positioned correctly, toolbox talks not identifying the hazardous activities;
- Certifications of lifting equipment not adequate for expected use case;
- Incorrect equipment being used for transferring pipe;
- Human factors, risk perception and competency of personnel involved in operations;
- Inadequate quality control and inspection;
- Inadequate planned maintenance systems in place.

- During the contracting process ensure that third-party HSE Management Systems (HSEMS) have fit for purpose risk controls in place to prevent/mitigate dropped objects;

- Set clear expectations with third-party contractors in respect of lifting and pipe handling activities.
- Formal understanding of differences between company and third-party contractors’ levels of oversight, mode of control and accountabilities – BEFORE starting work;

- Audits, inspections, and verifications of third-party operations to ensure that proper risk management controls are in place to prevent dropped objects;

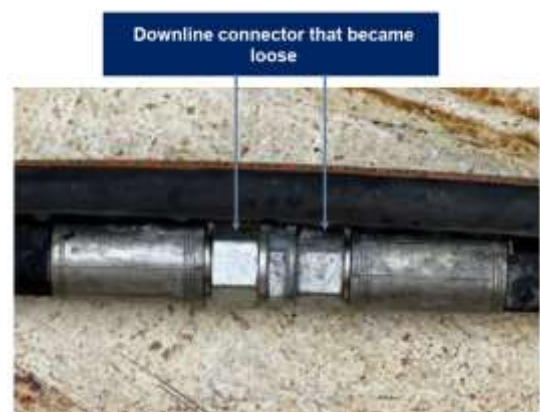
*BSP fitting which came loose*

- Immediate Cause: the fittings became slack: It is not known when the fitting slackened. It is suggested that a combination of handling on deck, energising and de-energising were contributory factors;
- Underlying Cause: checks were omitted: Fittings were not checked for tightness when overboarding the diamond wire saw and downline;
- Root Cause: the checklist used did not prompt the check of all fittings for tightness, only visual checks.

- Added additional supports on fittings attached to the tugger over and above existing controls;
- Ensured that physical checks for tightness were conducted;
- After a review of feasibility, the bight of the hydraulic hose was removed;
- Checklist was updated to include checks for the tightness of fittings;
- Incident was shared with other users of similar equipment.

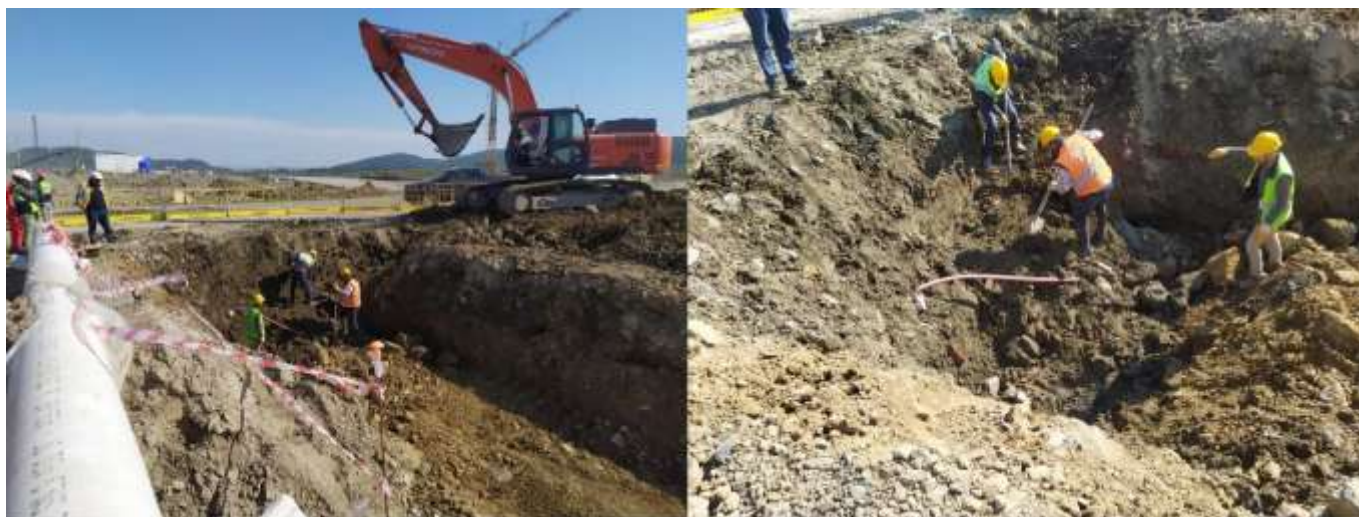
A high potential near miss occurred during onshore preparations for a pipeline installation when an excavator cut into an energised power cable. Trenching activities for the onshore pipeline installation were being completed. During the trenching works, the excavator operator inadvertently cut into an energised three-phase 21.6kVA power cable buried at approximately 2 metres.

- Work Planning
  - The cable had been installed two years before by the client’s subcontractor, before our member was involved;
  - Investigation found that the cable was not reported on the initial as-built report;
  - Review of client-supplied drawings found that the power cable was noted as a ‘future cable’; and should not have been in its as-found location.
- Control of Work
  - The cable was live with no isolation in place;
  - During the excavation works there was a spotter in place but there was no expectation of finding a cable.
- Risk Assessment
  - During the risk assessment process covering the excavation and trenching work, this cable hazard was not identified, and therefore a cable tracker application was not included as a key control measure.

- Prior to all operations we must remember the “7T’s” – **Take The Time To Think Things Through.**
- Consideration of use of the IOGP Life-Saving Rules “Start Work checklists”, to verify that controls/safeguards designed to prevent fatalities and serious injuries are in fact in place and functioning;
- Excavation works to ensure consideration of “Live” sub surface cable hazards during work planning and risk assessments with cable trackers as a primary control;
- Ensure that the obligation and expectation to exercise the **stop work authority** is clearly communicated and understood by all parties across all operations.

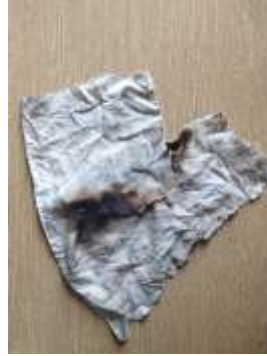
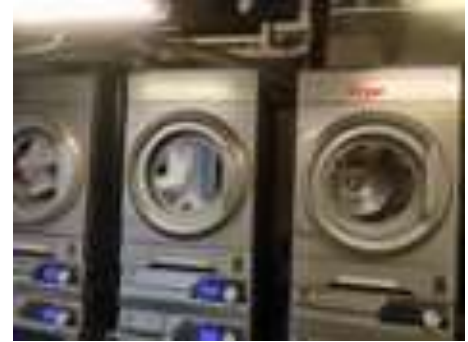
The power supply to all the dryers was immediately switched off. The smoke (there was no fire) was found to have come from an oily rag in the pocket of one of the coveralls being dried at the time. There were no injuries and some minor damage to clothing.

- An oily rag in the pocket of one of the coveralls being dried at the time – existing, known, laundry procedures were not followed – realistically, someone forgot to check the pockets of their overalls before putting them in the wash.

- Updated risk assessment with additional controls;
- Renewed signage in laundry to
  - remind crew to check all pockets prior to laundry.
  - remind crew to segregate oil-soiled work clothing when doing laundry.
- Arranged separate laundry collection point for clothing that may be oil-soiled;
- Dryer to be set at normal temperature – drying laundry at too high a temperature can greatly increase the risk of combustion;
- Laundry procedure to be made part of sign-on & vessel induction training.
