1 MAIB: “pinkie is no longer perkie”

2 LTI: person suffered serious crush injuries

3 LTI: burns to forearms

4 LTI: Foot trapped between pipes

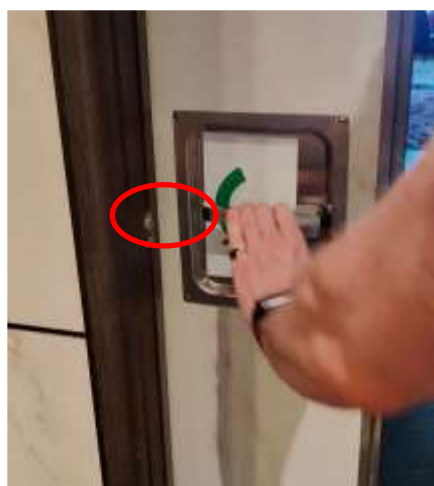
The door opened fully, *while the crew member kept their hand on the handle*. As the door retracted fully, the crew member’s left hand became trapped between the handle and the doorframe, resulting in the little finger suffering amputation of the fingertip and nail above the first knuckle. It could not be reattached.

Door operating handle – red circle indicates line of fire

The door was not faulty: Subsequent inspection for technical, hydraulic and electrical defects found it to be in good working order.

- Training: automatic or powered doors are potentially very dangerous. Hydraulic and electric power-operated systems are unforgiving in their closing force and should be treated with respect. Crew should be provided with suitable training on both the safe use of these doors and the dangers of their unsafe operation;

- Procedures: If we go through a powered door often, it is easy to forget the dangers and take shortcuts such as walking through the door before it has fully opened. Previous accidents have sadly resulted in more serious injuries than those suffered in this case, and sometimes death;

- Awareness: Entrapment is a hazard often associated with moving machinery and wariness is the watchword. There should have been no need for the crew member’s hand to remain on the door’s operating lever and this action indicates insufficient knowledge of the system;

- Short cuts: if the operator was attempting to take a shortcut, then a greater understanding of the system would have been required to understand the dangers of doing so. Lack of understanding of how a system will work when shortcuts are taken, and the potential consequences, are a good enough reason not to take short cuts.

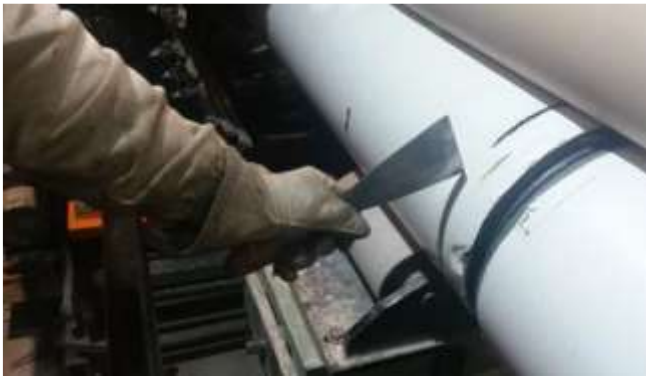
Re-enactment of task (spatula)

- The task was deemed to require manual intervention using a spatula as a marking tool, thus exposing people to possible injuries;
- The task was seen as routine, to be undertaken on a regular basis. There was no challenge to re-engineer the task by those performing it or supervising it;
- There was no consideration of hierarchy of risk controls, or specifically automated or engineered methods to eliminate human exposure;
- Company management had paid a visit and had previously identified the risks associated with the task and provided improvement suggestions to the sub-contractor.

- Ensure that the obligation and expectation to exercise the **stop work authority** is clearly communicated and understood by all, particularly third-party and sub-contract personnel;
- Can we do the job in a safer way? Ensure we have clear expectations in respect of controlling risk and identifying tasks that can be reengineered to remove the risk of human intervention or manual handling;
- Dare to challenge the “norm” with a fresh set of eyes as to how tasks are actually being conducted.

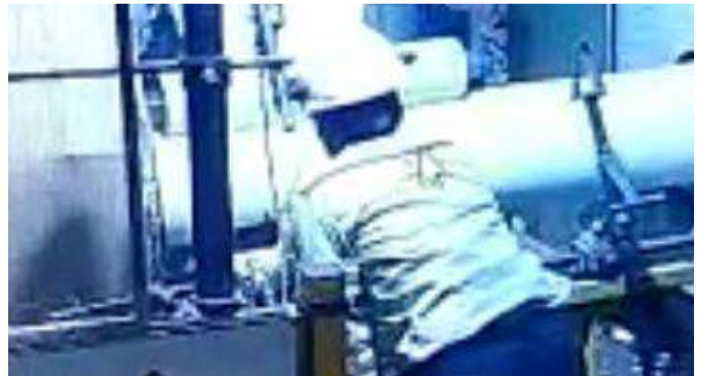
During pipe coating application work at a third-party sub-contractor worksite, a worker received serious burns to both forearms, that resulted in an LTI. The injury occurred at the start of the operation when the pipe was being coated with the first layer. During this operation the transition between pipes required the manual application of a spatula to mark the pipe cutting area, as shown below. While marking the pipe, the injured person's arm touched the pipe due to an unexpected movement of the pipe assembly, causing serious burns to both forearms. This injury was seen by another employee who activated the line emergency stop and helped the injured person away from the line of fire situation to a safe place. First aid was given before the casualty was taken to hospital for further treatment.

CCTV footage of the task being undertaken by the injured person.

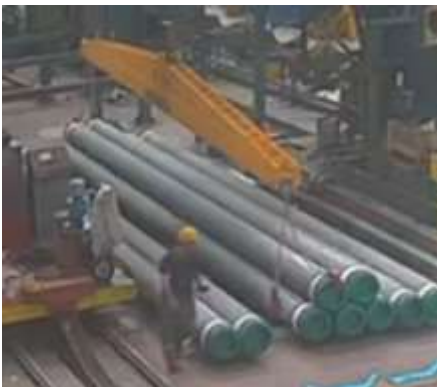
Crew member walked towards the pipe stack. The pipe on the top layer was still connected to the gantry crane

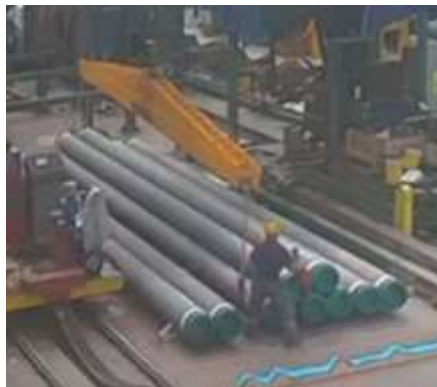
Crew member stepped forward into the gap on the bottom layer. At the same time, the pipe stack shifted, trapping his ankle.

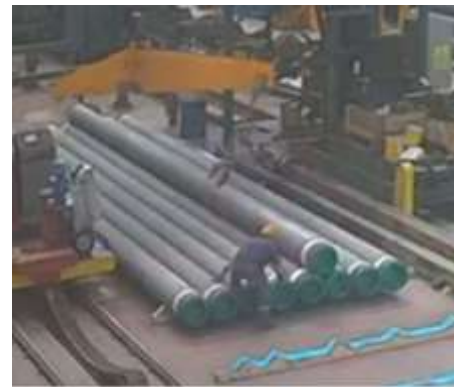
Crew member's left foot trapped between the two pipes

- This was a repetitive task which had been ongoing for two months (loading and unloading 2000 pipejoints during this period);
- There were sufficient team members on site, but the other riggers were involved in another task elsewhere. The crew person involved decided to continue the task on his own to get the job done;
- Temporary wedges were available during the pipe handling operations. The pipe stacking area, however, was not set up with permanent wedges or spacers to ensure the pipes could not roll;
- A stacking plan and a risk assessment were available, but neither were being followed at the time;
- Inspections and audits had failed to verify controls and preventive measures;
- Human factors - risk perception and competency of personnel involved in operations.
