1 MAIB: Engine room fire flashover

2 Clogged tumble-dryer exhaust fan - potential for fire

3 Dummy hot stab ejected during leak investigation

4 Near miss: load lifted without notice putting crew in the line of fire

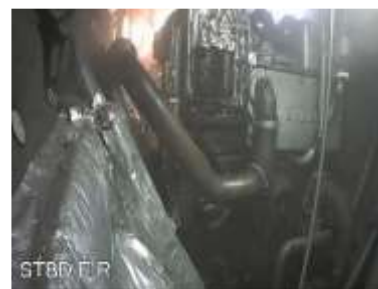
A high speed ferry was on passage after a period of maintenance. There were no passengers on board, just the master and two crew. During the passage, the fire alarm sounded for the starboard engine compartment; the master monitored the closed-circuit television (CCTV) and after a few moments saw smoke and then flames.

Engine room fire as seen on CCTV

The master and crew followed the emergency procedure for an engine fire: the engine was shut down, the compartment was sealed off, and the fixed carbon dioxide (CO₂) fire extinguishing system was initiated. The master assessed that the situation was under control. He informed the port authority of his intention to continue to the intended berth and requested that the local fire brigade meet the ferry on arrival. The master continued on passage with one engine in use. The crew monitored the bulkhead and deckhead temperatures around the compartment; water hoses were prepared for boundary cooling although this was not judged necessary.

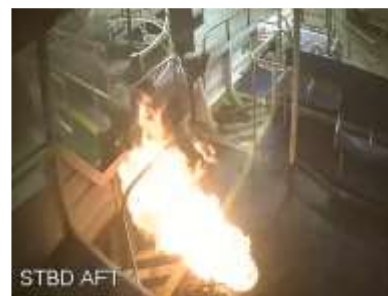
Once the ferry was berthed, the local fire and rescue service boarded the vessel to take charge of the situation. *Without liaising with the crew*, one of the fire officers opened the access hatch to the starboard engine, causing rapid reignition of the fire with significant flames and smoke emanating from the compartment. This forced the fire and rescue team to retreat to gather their firefighting equipment and the fire was eventually extinguished by completely flooding the compartment with water. The reignition of the fire caused severe damage to the engine and the starboard engine compartment, requiring extensive repairs.

Flames coming from engine room after re-ignition of fire

- **Poor communication: The local fire and rescue service inadvertently reignited the fire** by opening the access hatch. This was inappropriate as the situation was under control and the correct action would have been to leave the compartment sealed until the deckhead temperature had fallen to ambient level. The master remains responsible for the vessel and communication is vital to build a clear picture of the situation. The fire officer's actions were well meaning; however, the outcome was avoidable damage to the vessel.

Work hard to maintain clear and open communications, whether between vessel crew and project crew, vessel crew and management, deck and bridge, rigging crew and crane operator, client and contractor, contractor and sub-contractor, to name but a few.

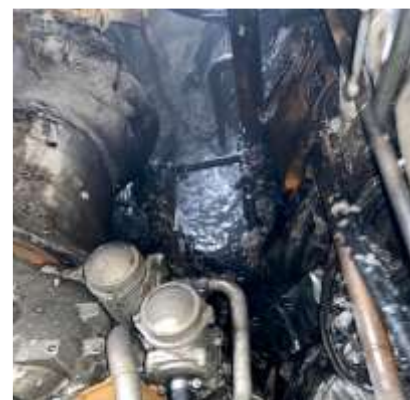
Fire damage

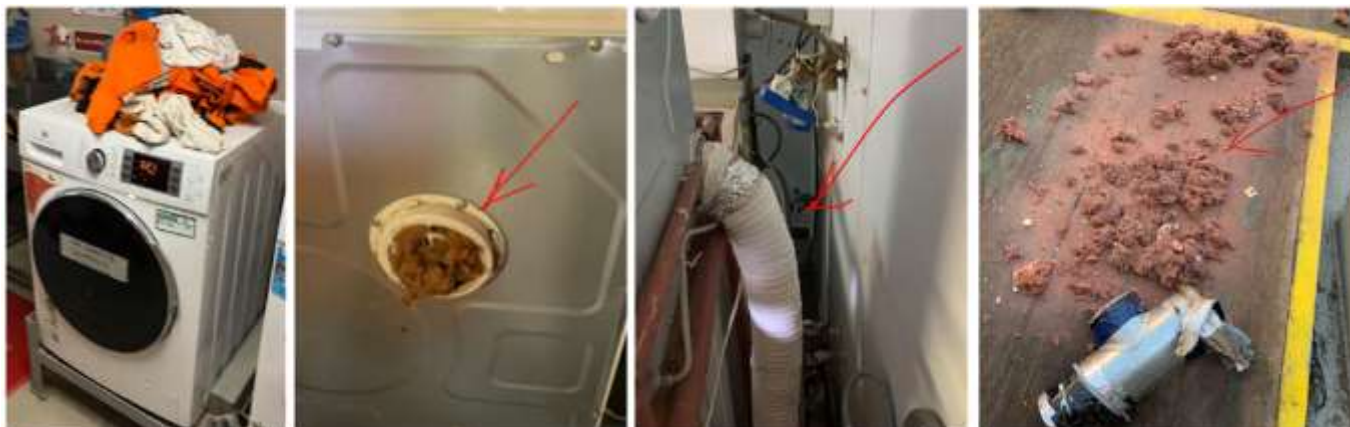
During a weekly inspection of the laundry room on a vessel, rags and lint twisted together were found in the exhaust fan of one of the dryers. Further investigation revealed more accumulated lint in the dryers' outlet exhaust pipe. When the end of the outlet pipe was removed to check the inside, it was found to be almost completely blocked with lint.

Our member notes that it would only have taken a small spark, short circuit or static electricity inside the drying machine for there to have been a fire.

There was no regular checking or cleaning of filters and exhaust ducting. Build-up of dust and residue inside the exhaust ducting could have caused the safe operational temperature limits of the dryer to be exceeded, with the possible consequence of a fire.

- Ensure regular check and clean of tumble dryer exhausts and filters;
- Regular check of ventilation pipes and systems which may create lint traps where lint accumulates over a long period of time, creating a potential fire hazard;

- Ensure design and installation of tumble dryers enables easy and full access to exhaust ducting and filters.

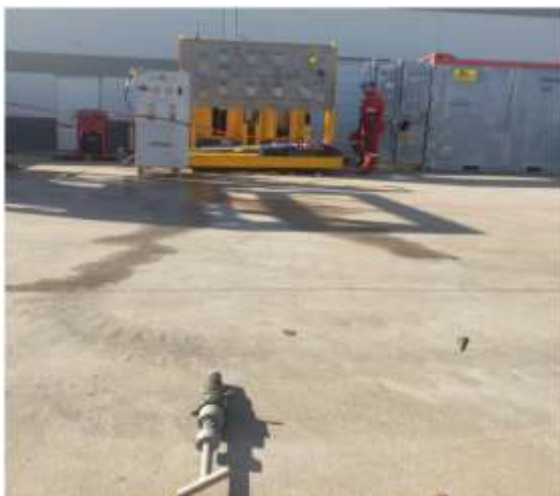
A high potential near miss occurred when a dummy hot stab was ejected at 20,000psi. Personnel were out of the direct line of fire but within 1-2 meters of the skid. Issues of weeping tubing on a skid had been identified and required investigation. The required 'Blue Logic' dummy stab was not readily available, and it was decided to use a 'Seanic' dummy stab manufactured to the same design code (API 17H) and thought to be interchangeable. A maximum test pressure of 20,000psi was applied in 1,000psi increments and had been held for 30 seconds when there was a loud noise, and the hot stab was ejected from the receptacle. The hot stab was propelled 6 metres before striking the ground and then travelling another 2 metres before coming to rest. At the time of the failure personnel were not directly in line of fire but there were people less than 2 metres from the travel path of the object.

Incident site (stab final position) Hot stab

- During pressure tests, ensure that:
 - ONE single person is nominated as responsible;
 - Only essential personnel are present, that an exclusion zone is established at safe distance and that blast screens are positioned where appropriate;

- The test procedures are clearly explained to all involved and that they all confirm their full understanding;
 - A safe system of work is fully implemented and maintained throughout the duration of the test;

- Correct test fittings are confirmed securely attached, hoses secure, equipment has been maintained and is within the expected range of the pressure test;

- Any monitoring during pressurization is conducted from a remote or safe position;
 - If leaks are experienced the system is fully depressurized before investigating;

- If possible, test when there is minimum personnel or vehicle density or movement.
- Whenever possible request the supply of and use hot stabs and receptacles from the same manufacturer.

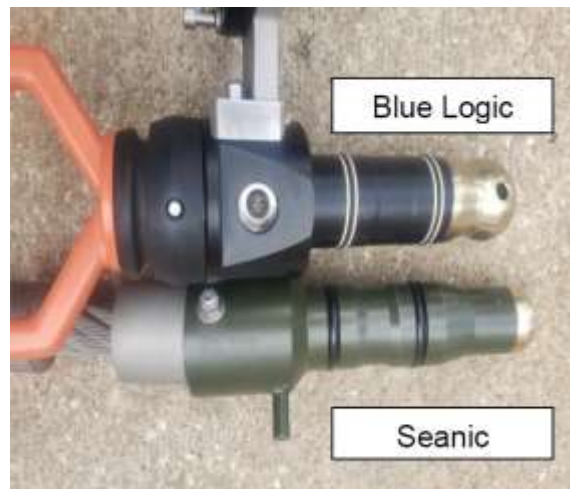
Hot stab comparison

- The wrong hot stab was used. A misalignment of 0.75mm between the hot stab and receptacle (invisible to the naked eye) failed at 8000psi during the test. Subsequent tests confirmed the 'Seanics' dummy hot-stab and the 'Blue Logic' receptacle are incompatible;
- There was no J Lock in place to secure the hot stab;
- Procedures not followed:
 - The operation was not conducted within the expected Safe System of Work (SSoW) process;
 - There was no documented Task Risk Assessment (TRA), Permit to Work (PTW) or Toolbox Talk (TBT) for this activity;
 - A Factory Acceptance Test document which includes the test steps was not referred to.

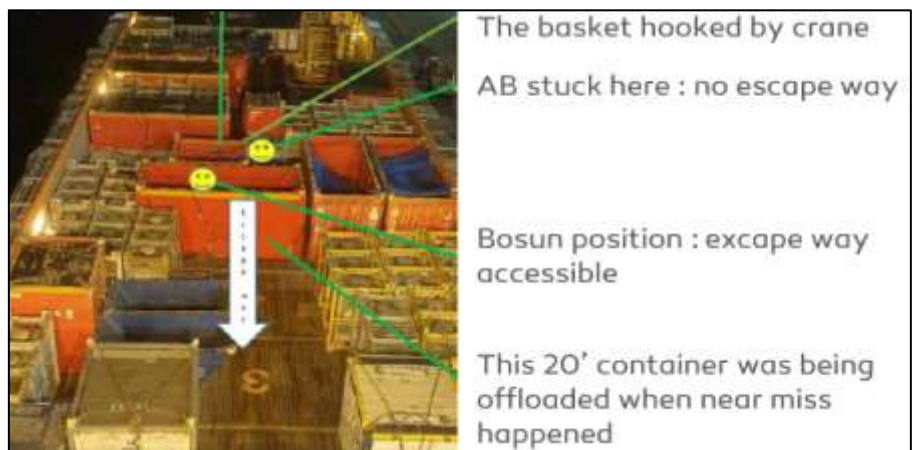
During cargo operation at an offshore installation, the deck foreman on the installation noticed that a sling was twisted while starting to heave up a cargo. An AB on deck was asked to remove the twist, when the crane operator started lifting the load without proper notice, which placed the AB between the cargo and a 20’ container. This could have resulted in a fatality or severe injury. The operation was stopped immediately; there were no injuries.

- The crane operator had poor visibility on deck;
- Poor communication:
 - The deck foreman on the offshore installation rejected the officer of the watch’s request to disconnect the crane before sending the AB;

- Nothing was done to secure the safety of the AB in charge of untwisting the sling;
- The crane operator started to lift with no instructions nor signal.

- When the situation deteriorates, STOP. Become extra vigilant, remain aware of what is going on around you, ensure good communication between all stakeholders;
- Ensure clear deck policies and stop work policies are followed;
- Don't take short cuts, don't hurry, don't assume that everything is OK.

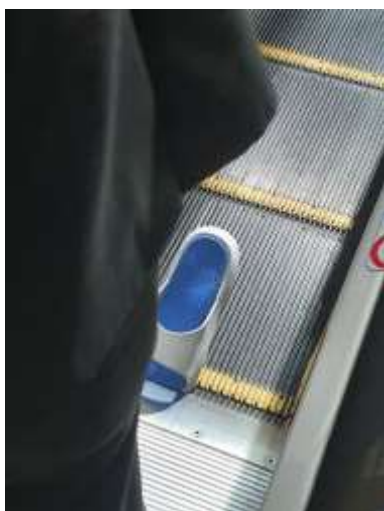
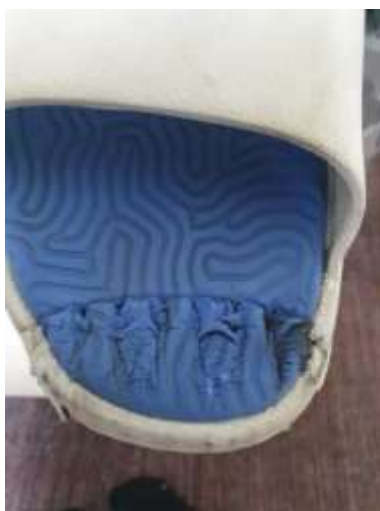
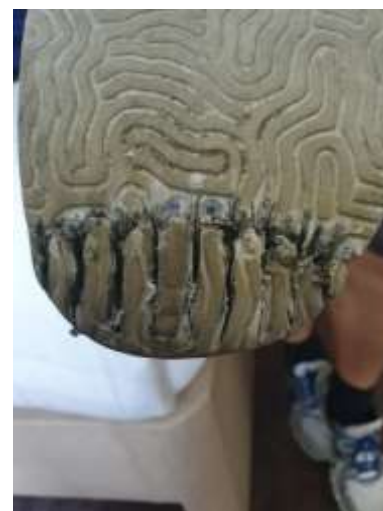
A member reports an incident in which someone got their leisure footwear (sandals) caught in an escalator and narrowly escaped a serious injury to their foot. Someone's right sandal was caught in the escalator. The person managed to get their foot out before their toes were trapped.

The footwear was not on tightly enough and the wearer's foot position allowed the point of the sandal to enter the gap between the escalator tread and the chute.

Lack of situational awareness – the sandal wearer was either not watching the gap where the escalator treads were disappearing, or did not know the gap was large enough to snag the sandal, or most likely both. In any scenario he clearly had his foot in the line of fire, and was lucky not to sustain an injury;

- Remain aware of your surroundings at all times, especially around moving or rotating equipment and fixtures;
- "Task seen as routine" – beware of ignoring or becoming hardened against risks that are present, because you have seen them hundreds of times before, and nothing has happened;
- Ensure that clothing and footwear, particularly PPE, is correctly sized, fitting properly and worn correctly.
