## **1 Case Study – Closed Bus – Knowing the Risks**

## 2 Case Study – Vessel Degraded Capability

### 3 Case Study – Open Bus Saved the Day

## 4 Case Study – Closed Bus Ruined the Day

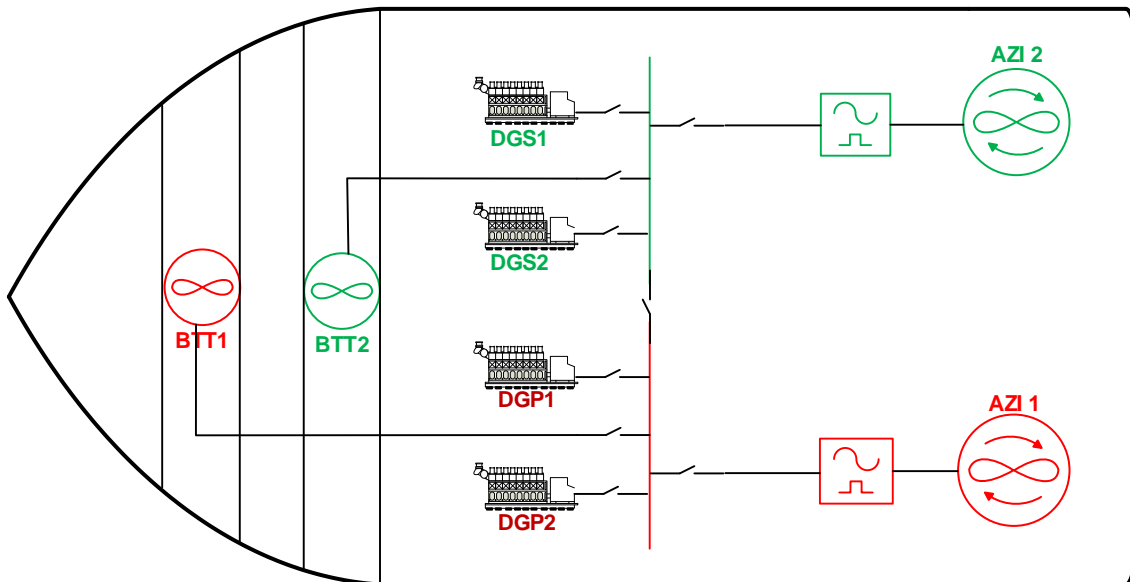
Figure 2-1 Thruster Setup

The Worst Case Failure (WCF) identified from analysis of the DP system on the vessel is loss of the port engine room due to an auxiliary failure, this would cause the loss of the two generating engines, Switchboard, Azi 2 & BTT1, with BTT1 being the most forward thruster.

- Azi 1 had hydraulic issues on the azimuth circuit which meant it was required to be in 'Fixed' DP Control mode.
- BTT2 was very sluggish in following the DP Command and was continually activating feedback alarms.
- Due to a leaking turbocharger, Generator DGP2 was only to be used in an emergency, and if used, not to exceed 50% power.

The vessel is degraded in its intact and post failure capability, and is no longer single fault tolerant.

If the Port redundant group fails, the vessel will be left with a subpar bow thruster that could be lost from DP Control at any time.

If the Starboard redundant group failed, the vessel would be left with a subpar azimuth thruster that could be rejected by DP Control at any time. The port redundant groups generating capacity is severely constrained because there is no confidence in DGP2's ability to supply adequate power.

An in-depth evaluation could have been performed to determine post-failure capability, resulting in an update to ASOG. This would ensure client transparency, and DPOs would be fully aware of the vessel's reduced capability.

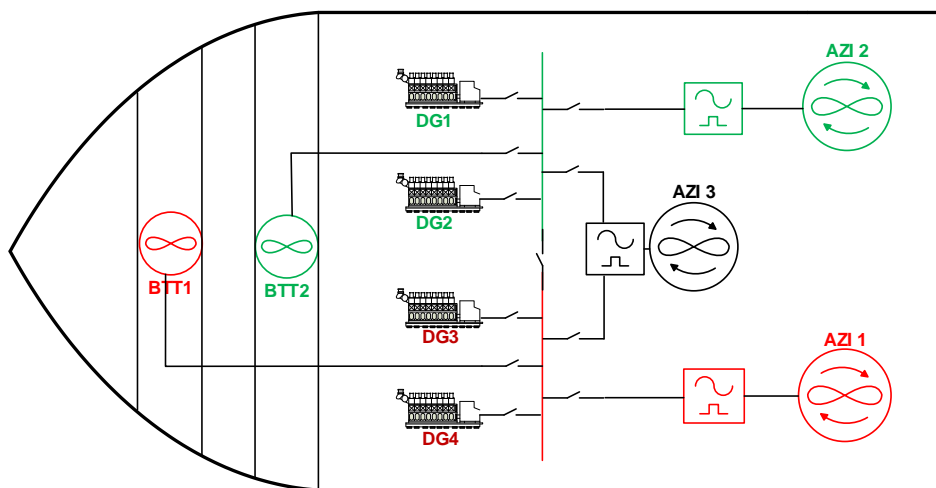
Figure 3-1 Overview

The port redundant group experienced a blackout during the trenching operation, resulting in the loss of three of the five thrusters. The vessel maintained position on the two remaining thrusters in the starboard redundant group. Once deemed safe to do so, the retractable thruster was reconfigured and re-connected to the starboard switchboard. It has to be noted that the retractable thruster needs to be eliminated as the possible cause of the blackout before it can be re-configured into the healthy redundant group.

The cause of the blackout was traced back to a short circuit within the drive of the aft azimuth thruster, which propagated the fault up to the port switchboard and causing the blackout.

There was no loss of heading or position reported.
