1 Umbilical management – near miss

2 Lost ROV incident

3 Incorrect gangway rigging

4 Blocked emergency exit hatch

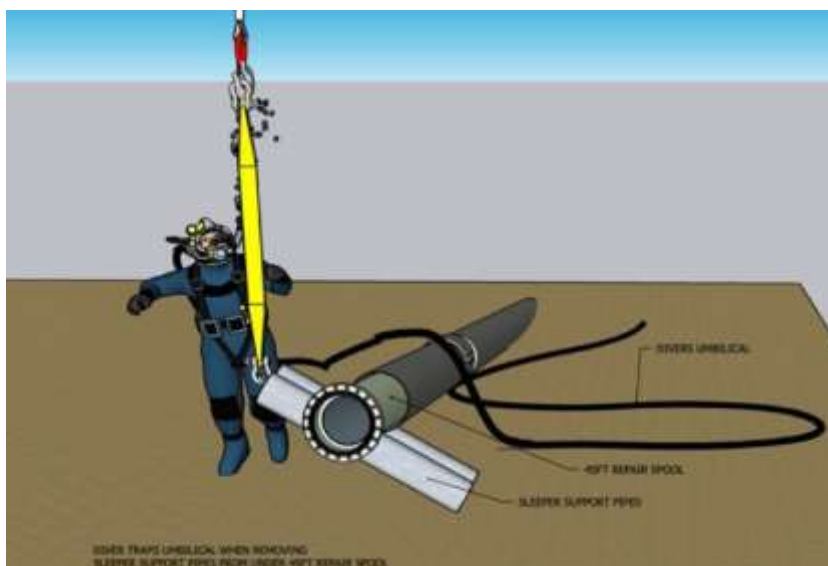
A diver was working with the barge crane to remove two sleepers from under a newly installed 16" x 45 ft (40cm x 13.5m) repair spool. The crane was rigged directly onto the sleepers to be moved. Once the sleepers cleared, the pipeline moved and rolled over a section of the divers umbilical. The diver discovered that his umbilical was trapped and was able to free it himself. Visibility was excellent, it was daylight, and the diver was able to move his umbilical over to a suspended section of pipe, and was unharmed.

- Procedural - no procedure existed for the sleeper removal, due to an oversight during the project planning phase;
- Human Performance - the diver did not recognize the line of fire umbilical management hazard;
- Human Performance - the Dive supervisor did not call an "all stop", due to a lack of full procedural understanding. No MoC (management of change) was created.

- Develop a removal procedure to include the removal of the diver's umbilical from the bottom, before starting the operation;
- Review with the entire crew the Umbilical Management process and sleeper removal procedure.

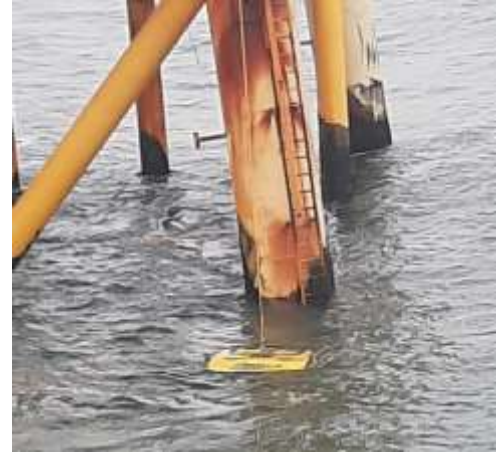
The ROV at the surface just before the tether parted and the ROV drifted away from the platform.

- Direct cause: The tether parted due to abrasion against the jacket structure, and the ROV was lost with no communication to it;
- Root causes
 - Insufficiently detailed instructions, risk assessment of hazards, and emergency recovery procedures;
 - Understaffed team.

- Procedures revised to include more details; environmental limitations and more details for a recovery scenario;
- Added a current reading on ROV pilot user interface (GUI).

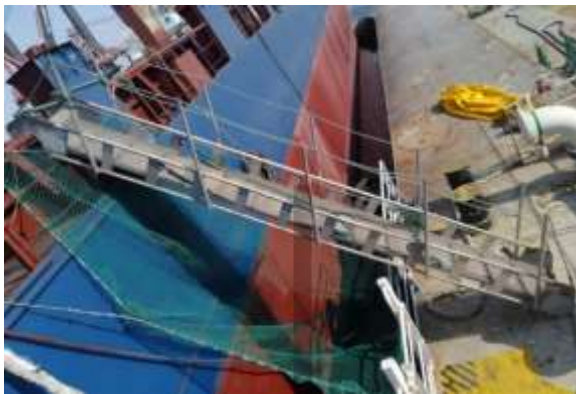
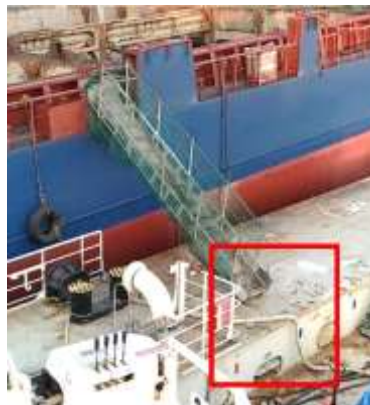
- The bottom of the gangway was placed on the deck less than 1m from an un-barriered drop on the quay, which could potentially have led personnel descending the gangway to fall;
- A safety net was not mounted correctly.

Red box shows un-barriered drop

- The gangway was relocated closer to a substructure away from the recessed deck and with adequate fencing;
- A safety net was correctly mounted to cover the gap between the ships.

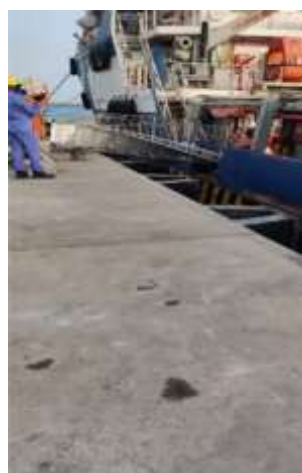
A Platform Supply Vessel (PSV) was alongside loading deck cargo. The PSV suddenly started moving alongside the jetty due to propeller wash from another vessel passing nearby. A passing workman on the quayside observed that the gangway had got stuck over a quayside bollard and was getting deformed by the vessel movement. He released the gangway rope and informed the gangway watch. The gangway was recovered to the vessel. It was found that it was significantly damaged; it was quarantined and sent away for repairs.

Gangway bent round quayside bollard

- Crew failed to assess the risks related to potential vessel movement due to weather conditions and other vessel movements nearby – in this case, propellor wash;
- The gangway watch was not thorough enough – a passing worker noticed what was happening.

- Ensure risk assessments related to gangway management cover risks of vessel movements due to weather conditions and impacts of waves from other vessels passing nearby;
- Ensure gangway watch and management is suitable and sufficient.

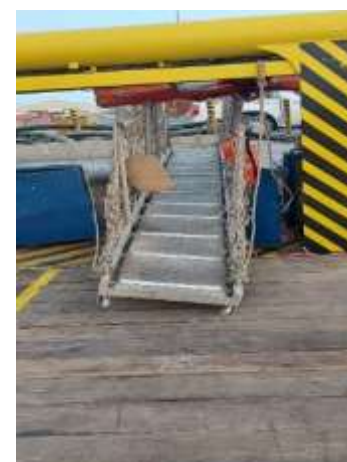
Deformed gangway

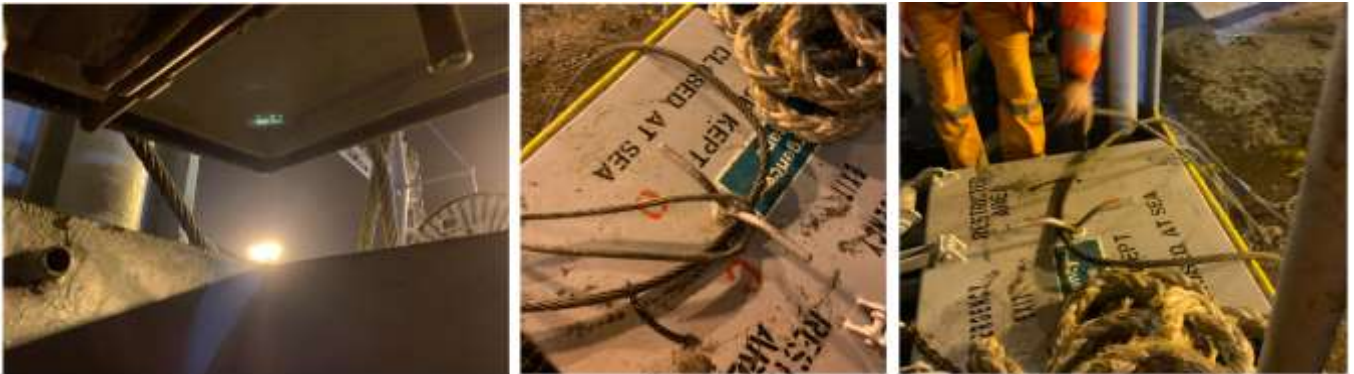
Emergency Exit hatch blocked by wire ropes

It was discovered that the hatch was blocked by wire ropes left on top of it during recent spooling works on the main deck area. These activities had been observed on deck, as part of anchor handling preparation process conducted by a contractor party. The used wires left on top of emergency hatch was not noticed by the deck crew.

- Keep emergency escape routes free of obstructions and in a safe condition at all times;
- Better control of third-party activities onboard;
- Hold regular "cold eyes" or cross-departmental reviews and safety walkarounds. You may be surprised at what the cook will discover on a walk round the back deck, or what the third engineer will spot on a visit to the bridge wing;
- Imagine yourself in the position of the person who might be trapped by that stuck hatch. What can YOU do to make sure that never happens?

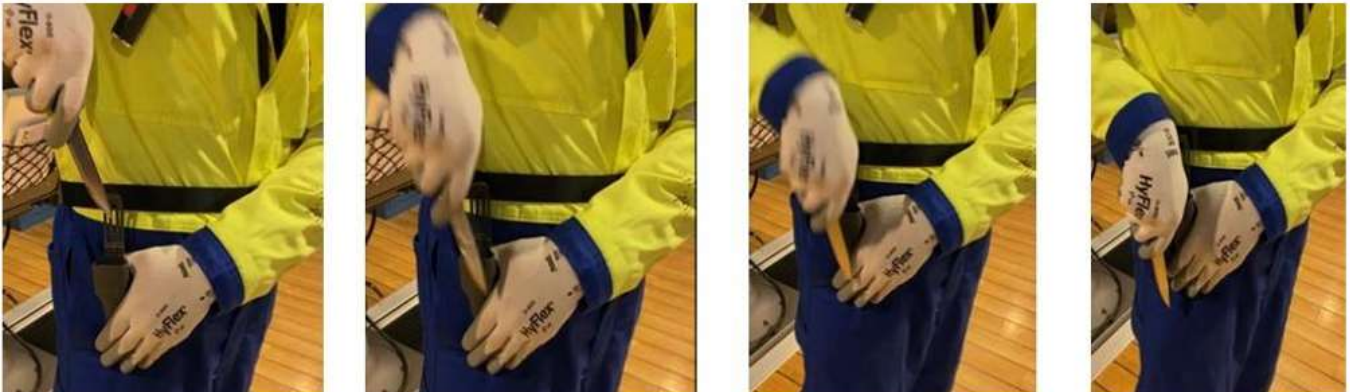
The MSF reports in [Safety Alert 22-12](#) an incident involving an inadvertent self-inflicted finger injury. This serious injury was sustained while someone was replacing a knife into its sheath. The crew member had been splicing 12mm polypropylene rope for use as guide ropes on the gangway. He had removed his gloves to splice the ropes, and once finished, attempted to put his knife back into its sheath at his belt, still without gloves.

He missed the sheath with the knife and pushed the knife into and down his left Index finger, causing a large deep incision, requiring surgery to correct possible tendon damage, and close the wound.

- Only use knives for their intended purpose;
- Never use “homemade” tools;
- Cut away from yourself, away from your body, keeping all fingers out of your cutting line;
- Use all personal protective equipment required including gloves;
- Cut on a stable surface;
- Stay focused;
- Don't rush, take plenty of time, care and pay attention to what you and your knife are doing.
