1 Diving instructor killed – incorrect valve threads

2 Near miss: pilot ladder – side rope failed

3 LTI: finger injury during davit test

4 Small fire following hot work

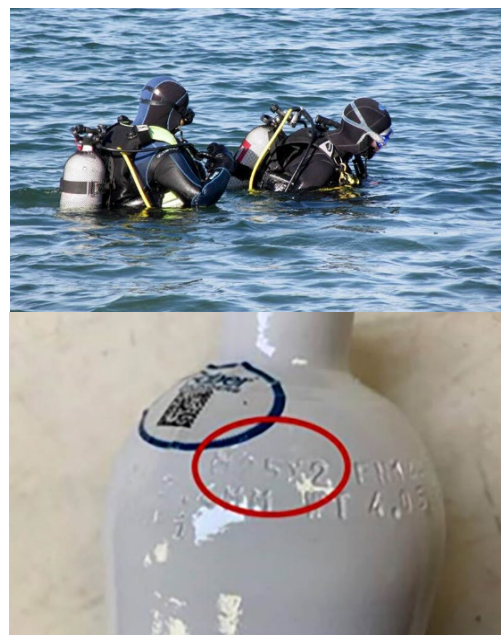
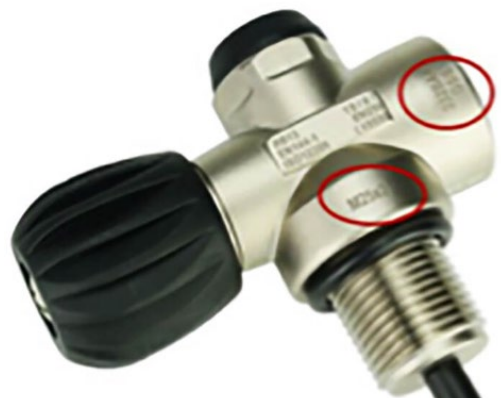
During a dive, the valve came loose from the diving cylinder and fatally hit the diving instructor; a cylinder with internal thread G3/4 was used, which was fitted with a valve with external thread M25x2.

Threads on the diving cylinder and the mounted valve were incompatible. In this case, the screw thread of the valve was slightly smaller than that of the screw thread in the diving cylinder. The result was that there was an increased risk that the valve will come loose from the cylinder when at pressure.

Members are advised to follow the guidance contained within [IMCA D 064 Guidance on diving cylinder and valve thread compatibility](#).

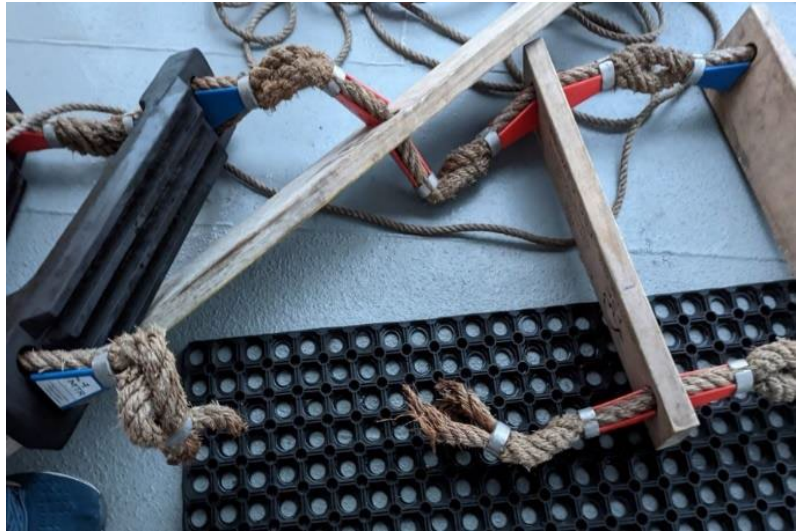
Whilst undertaking pilot boarding operations during the hours of darkness, a side rope on the pilot ladder parted when it was being weight tested by the pilot. The pilot was not injured; however if the ladder had not been weight tested by the pilot, it could have failed whilst it was being climbed, resulting in a fall from height into the sea.

- The pilot ladder had not gone through a 30-month strength test because the requirement to do so had not been uploaded into the vessel's planned maintenance system;
- It was known that the pilot ladder was in poor condition, but it was decided to continue to use the ladder beyond its operational life knowing that the vessel would soon be de-commissioned;
- The vessel did not carry a spare / second ladder.

- A Pilot ladder is essential safety equipment and should always be serviceable / available for use;
- Safety critical equipment should be inspected before use and any deficiencies found should be reported and rectified;
- The defective pilot ladder was replaced with a new ladder;
- Carry a minimum of two pilot ladders and replace them every two years;
- Ensure vessel planned maintenance systems are up to date and include everything that should be included.

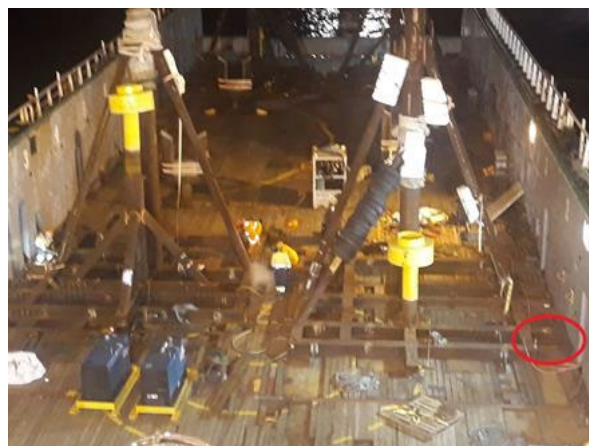
On a member's vessel alongside, a small fire started following hot work conducted by the client's welding sub-contractors. The incident occurred during the welding of jumper stands on the main deck. After completing their work, the welders left the vessel without notifying the bridge, and the Permit to Work was closed. Shortly thereafter, an AB discovered smoke coming from a rag left over the welded area. The small fire was

- There was inadequate communication between the third-party welders and the vessel crew;
- There was no joint inspection (by vessel crew and third-party welders) of the work before the welders left the vessel and the Permit to Work was closed;
- There was no fire watch.

Smouldering rag was found at place marked by red ring

- Closer liaison with third-party contractors to ensure understanding of requirements for
 - Monitoring of work;
 - Opening and closing of Permits to Work.
- Ensure joint inspection and agreed acceptance of work done by third-party contractors before allowing them to leave or closing Permits to Work;
- Ensure fire watches are set.

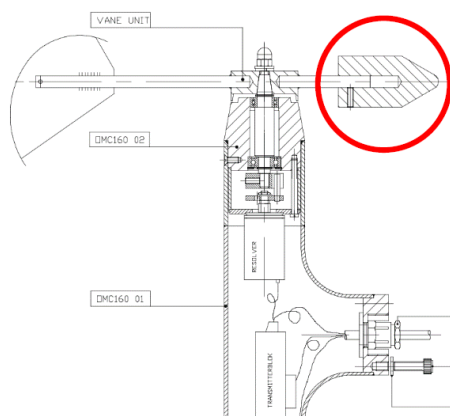
A small part weighing 0.3kg fell 20 meters from an OMC-160 wind speed and direction sensor installed on a vessel's main mast. Two wind speed and direction sensors were installed on the vessel's main mast; they consisted of a wind speed sensor and a wind direction sensor. The wind direction sensor was of the wind vane type unit and had a counterweight (length 6 cm/diameter 3 cm; 300 grams) fixed to it. This counterweight was only secured to the wind vane by a single grub screw. The grub screw came loose causing the counterweight to fall off. There were no injuries, nor any damage to the vessel or equipment.

Before: single point failure – one grub screw

- The counterweight was secured with only one screw, and this single point failure was not identified during the previous DROPS surveys;
- The OMC-series wind sensors are designed for minimal maintenance and as such were not part of the vessel's planned maintenance system;
- The original grub screw worked loose because of vessel vibration.

- The crew secured the counterweight by drilling one more hole on the opposite side of the existing one, and thus used two new screws to secure it. In addition, Loctite was applied to secure these screws;
- After checking for similar situations on the main mast, the same modification was done to the counterweight on the second direction sensor;
- Check if there is anything similar in your work area that could fall from height following a single point failure, or, is not included in the vessel planned maintenance system – check all instruments on masts;
- Check fixings at height very thoroughly. Particularly worthwhile and important when access is difficult.

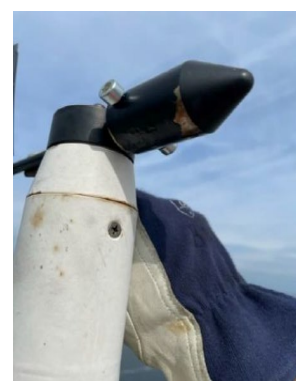
After: new securing method – two grub screws
