## 1 LTI: person crushed in watertight door

## 2 LTI: finger crushed while moving mobile gantry crane

## 3 LTI: crew member crushed finger when opening fire flap

## 4 High potential incident: person struck by Yokohama fender

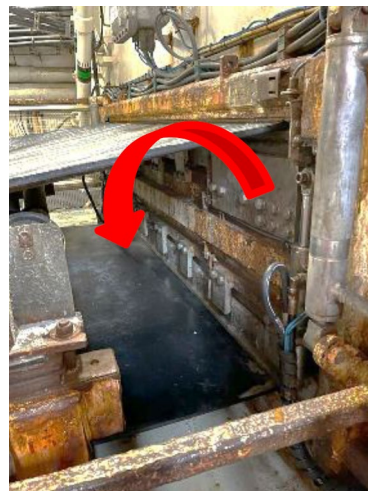
An electrician was crushed and severely injured while working on a watertight door on a vessel. He was evacuated by helicopter. The incident happened when the door opened unexpectedly, during adjustment of a proximity sensor for the door.

Vertical watertight door

- Ensure energised systems are isolated and locked out before working on them;
- Ensure there is a Permit To Work in place, a Lock-out/Tag-out procedure, and a suitable and sufficient job safety analysis before you start;
- Hydraulic system ball valves are not “safety valves”. Take care that you fully understand what you’re working on, and ensure systems are fully de-energizing before putting yourself in the line of fire;
- The switch on the primary operating system was not in working condition but there were not sufficient spares on board to replace them. Sufficient spare parts should be on board, so these can be replaced immediately.

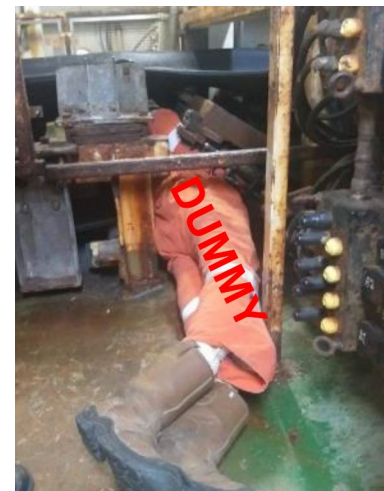
Watertight door opening on dummy (DEMONSTRATION)

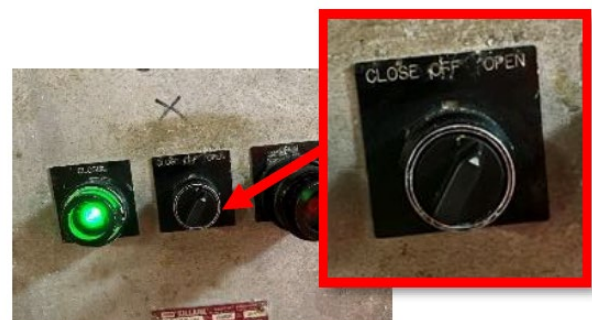
Just before this adjustment, the electrician had closed a ball valve in the hydraulic system, believing this was a safety valve which would prevent the door from opening. Once working on the system, the selector switch on the primary operating system, which is used to open and close the watertight door, did not return to the neutral position enabling a signal to be sent to the PLC (programmable logic controller). When the electrician manually aligned the sensor which he had to repair, a signal went to the PLC and the door opened unexpectedly crushing him between the door and the deck.

Selector switch

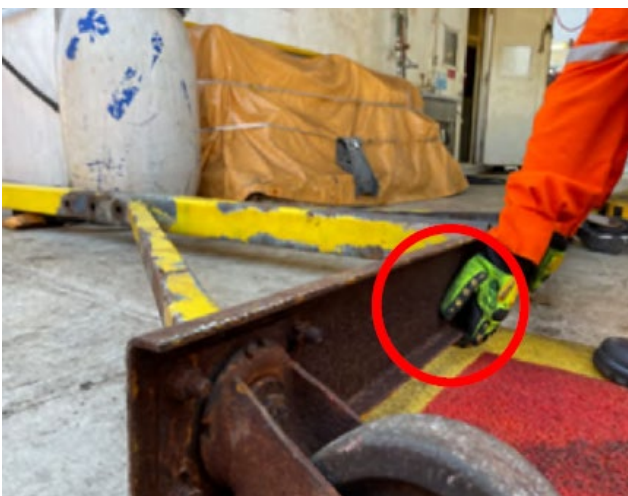
The injured person (the bosun) started dragging the first support leg, without waiting for help, by grabbing its base from below. As he did so, a vertically positioned wheel turned, causing the support leg to collapse onto his finger and crush it against the deck. First aid was provided and the bosun had to be medevaced for further treatment ashore.

Grabbing the base of the support leg (simulation)

- The company discontinued the use of this very heavy steel mobile gantry crane with no safety locks on the wheels, and replaced it with a new, much lighter Aluminium mobile gantry crane with wheel safety locks;
- Easier access between port and starboard deck areas was created by modifying (extending) the height of cable tray pipes to avoid the necessity of assembling/disassembling of the gantry crane before movement;
- Re-emphasised crew training on Permit to Work and Risk Assessment – with particular emphasis on identifying the Hazards related to Pinch Points;
- Conducted further training with on-board leadership on the importance of applying safety tools such as toolbox talks, “step back and take 5”, stop work policy, etc.

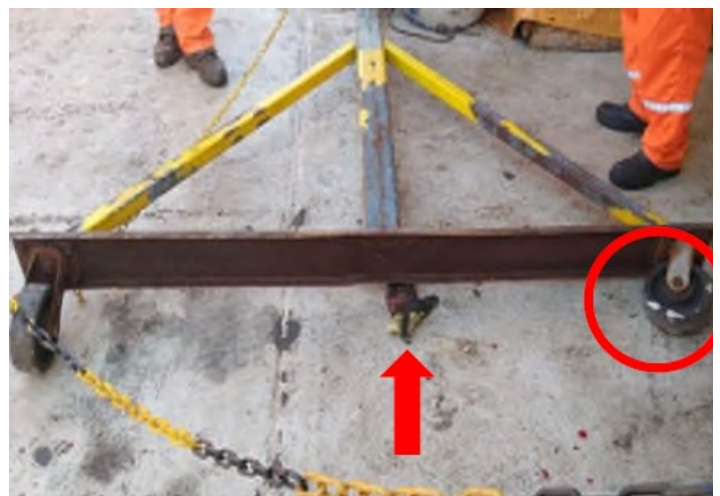
The wheel on the right turned, causing the leg to collapse

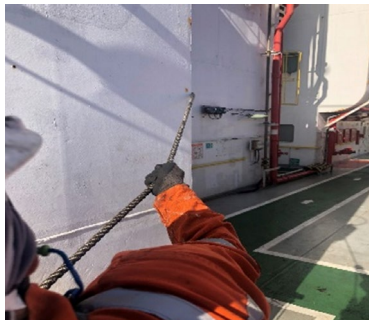
*AB to tie a rope and pull the hatch in the opposite direction in order to ease the pressure. (AB cannot see colleague)*

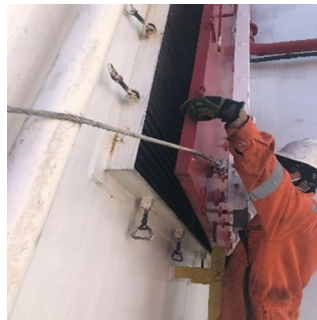
*Butterfly nut finally released...*

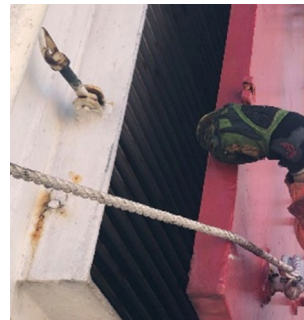
A crew member injured his finger while opening an emergency fire flap. The incident occurred after an annual test of the deluge system during which the emergency fire flaps had to be closed. Two crew members were releasing the securing butterfly nuts on the fire flap for the emergency generator. The final nut would not release owing to air pressure on the flap. A rope was attached to the hatch and pulled to reduce the pressure, to allow the butterfly nut to be released and to prevent potential uncontrolled swing of the hatch due to pressure build up. As the last butterfly nut was released, one of the workers got his index finger accidentally jammed between the hatch door and the frame as his colleague was still pulling the hatch in the opposite direction. His finger was crushed; he was sent ashore to hospital, where X-rays revealed a broken finger.

*Trying to open the hatch while AB is still pulling the rope in the opposite direction. Finger caught when hatch closed*

- Ensure suitable and sufficient risk assessment is conducted for all tasks, whether routine or non routine, and that all aspects of the task are covered;
- Ensure all personnel involved in any operation are properly briefed in detail during toolbox talks regarding hazards associated with the task, and controls in place to ensure safe and smooth operation;
- Risk Assessments and toolbox talks are not one-way conversations, but an opportunity for ALL team members to speak up and ask questions, discuss the task, ensure all control measures are in place and that everyone is clear on their duties and responsibilities during the job;
- If you need to change things, don't just carry on: exercise the Stop Work Authority. Stop, step back, and reassess the task to find a safer, easier alternative;
- Understand "Line of Fire" – see IMCA short video [here](#) and longer video [here](#).

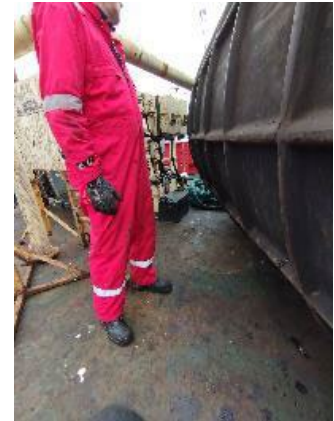
During the lifting of a Yokohama fender onboard a vessel in harbour, a person placed himself in the line of fire between the fender and bumper bars protecting an electrical services panel. He was struck and injured as the fender moved. The injured person had to move into the line of fire between the fender and the bumper bars in order to release cargo strap sea fastenings from the fender which were attached to the vessel bulwark. At this point the Yokohama fender pivoted and he became trapped between the fender and the bumper bar frame. Operations were immediately stopped and the vessel medic was called. The injured person was taken to a shore-side hospital for further examination. After medical examination he was released back to the vessel the same day.

*Post Incident re-enactment – where the person stood at the time of the incident*

- Reviewed how Yokohama fenders are stored on board vessels, with reference to reducing and controlling Line of Fire risks in the task of securing and relocating fenders;
- Reviewed vessel task plan and risk assessments for mooring operations, to ensure inclusion of:
  - lifting and installation of Yokohama fenders where appropriate;
  - Line of fire, personnel positioning, entrapment risks and escape routes.
- Heightened focus on controls, barriers, and risk management where Line of Fire risks have been identified;
- Considered regular “After Task” reviews as a key part of task planning to focus on learning, safety, and human/performance improvement;

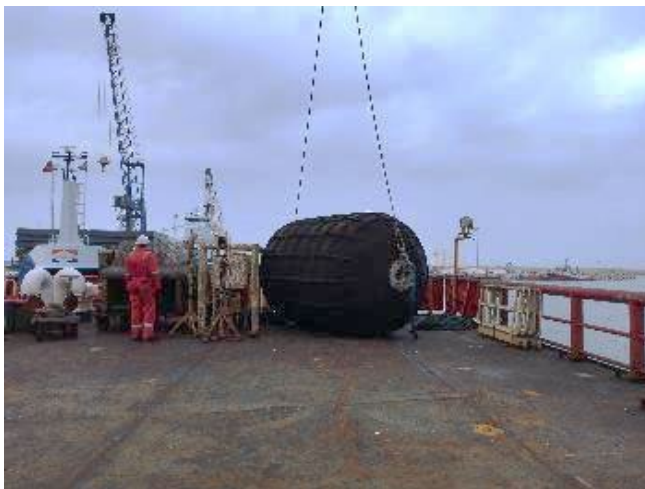
*Yokohama fender and bumper bar positioning*

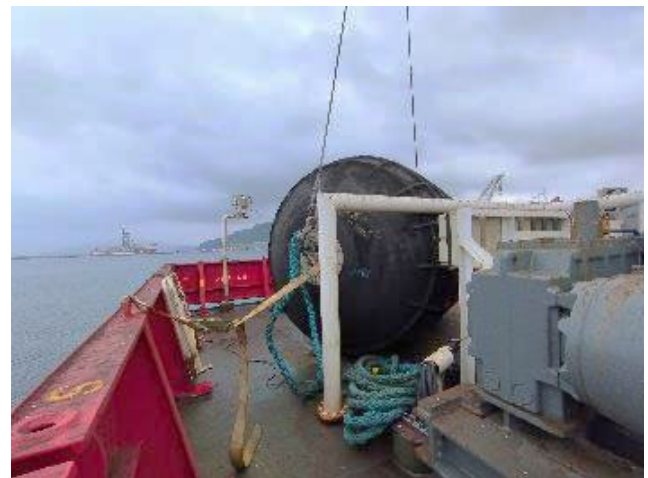
*Cargo strap sea fastening still attached to Yokohama fender*

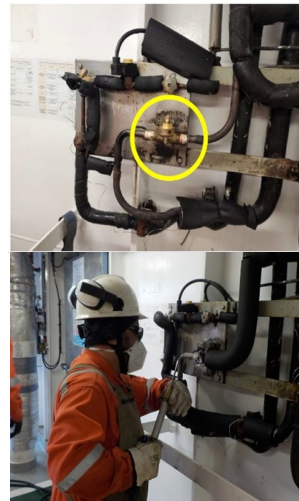
A crew member suffered from Carbon Monoxide (CO) poisoning during oxy-acetylene brazing. The incident occurred when the crew member was involved in the repair of a broken valve, part of the Freon pipe system for refrigeration. While doing the brazing on the gas return isolation valve, the crew member felt unwell, but continued the job. The task was completed after one hour and then the crew member felt breathing difficulties, was coughing and experienced chest pains. After a coffee break, the crew member sought medical assistance on board. Medical assessment showed had low oxygen saturation level. A medevac was activated due to possible respiratory distress or even heart problems.

Faulty gas return line valve

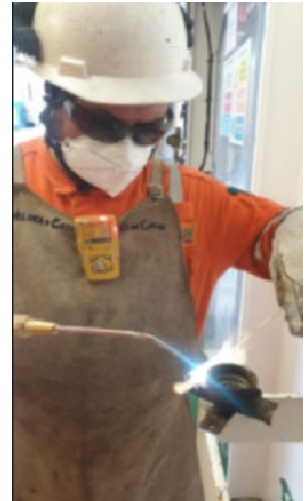
- The crew member did not wear a face mask during the welding job. The company’s procedures did not require the wearing of a face mask for this gas welding, although the wearing of a face mask was identified as a control measure in the risk assessment;

Atmosphere Gas Test (no mask was used in actual incident)

- Review condition and availability of portable exhaust ventilation equipment onboard and order more if required;
- Wear a welding mask when carrying out welding jobs;

- Review Risk Assessment for the task with regard to:
  - Use of portable exhaust ventilation systems to ensure adequate ventilation;
  - Duration of exposure time and rest periods.
  - Regular testing of air in areas where CO may be present;
  - Risks and hazards associated with Tungsten Inert Gas (TIG) welding.
- Use respirators with appropriate canisters, in conjunction with personal CO monitoring, for short periods under certain circumstances where CO levels are not exceedingly high (OSHA PEL for CO is 50ppm of air averaged during an 8-hour time period);
- Further appropriate refresher training for welders on risk and hazards of all types of welding used onboard;
- Further education for all crew about the sources and conditions that may result in CO poisoning as well as the symptoms and control of CO exposure.
