1 Serious LTI – Crew member slipped on deck breaking his leg

2 Head injury when crew member fell over in bathroom during heavy weather

3 Person slipped when exiting bathroom into cabin

4 Leak of oil-based mud

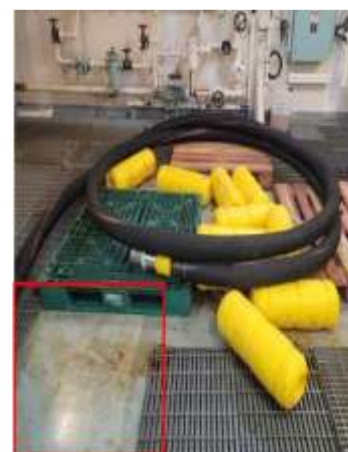
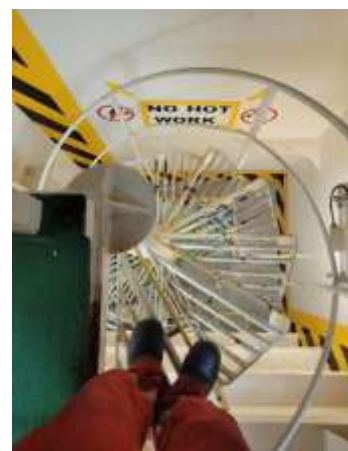
The spiral ladder did not allow evacuation by stretcher. Fortunately, however, the injured person was conscious and was able to assist the rescue team and go up the stairs. Our member noted that a later drill highlighted that in the case of an unconscious casualty, the safest rescue route would have been to unbolt a vertical hatch leading to the bottom carousel area, which would have proved to have been time consuming.

Spiral ladder which would not have allowed passage of a stretcher

- Identify all areas onboard the vessel presenting difficult rescue (with limited access/egress) and consider additional rescue drills in all identified areas complete with designated rescues plans.

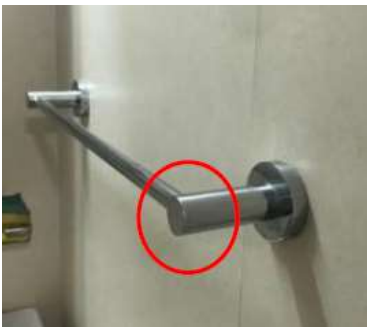
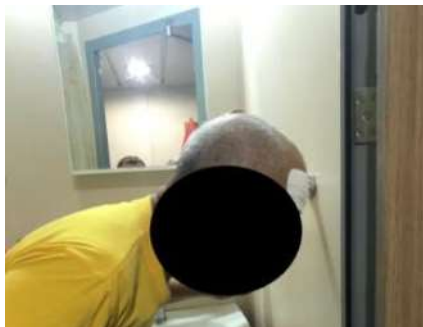
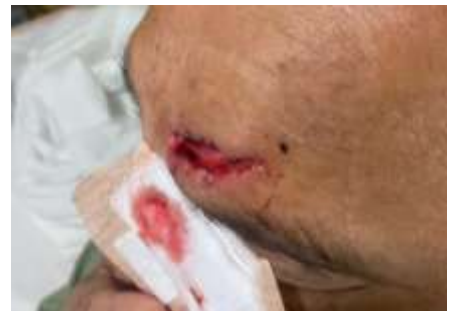
A member of the crew fell over in the bathroom of his cabin while the vessel was rolling violently, and suffered a minor head injury as a result. The incident occurred when the vessel was steaming at full speed during moderate weather conditions, and was rolling in consequence. When the vessel rolled suddenly, the person lost balance, tripped and hit his head against a towel rail. Five stitches were required to close the wound.

Reconstruction!

- The vessel was transiting at full speed across a heavy swell, on the instructions of the client. The high speed was causing the vessel to roll up to 17 degrees;
- The injured person was caught off-balance in a narrow space in the bathroom.

- Vessel Master to discuss with client the best and safest options for transit across rough seas or during heavy weather;
- Officer of the watch to warn vessel crew to remain aware and be more vigilant of sudden vessel movements, particularly on the stairs, in the galley, in bathrooms, on the open deck, in the engine room and anywhere else where there is risk of injury from overbalancing and falling or tripping over.
- An old saying from the days of sailing ships is: *“One hand for yourself, one hand for the ship”*.

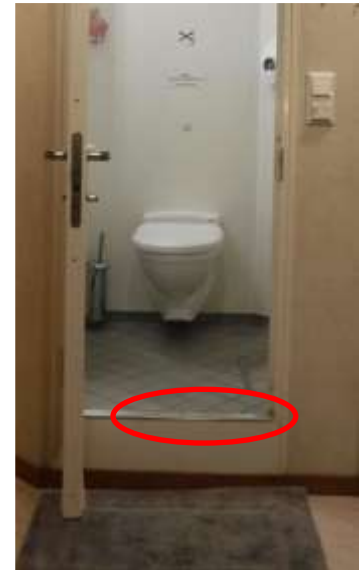
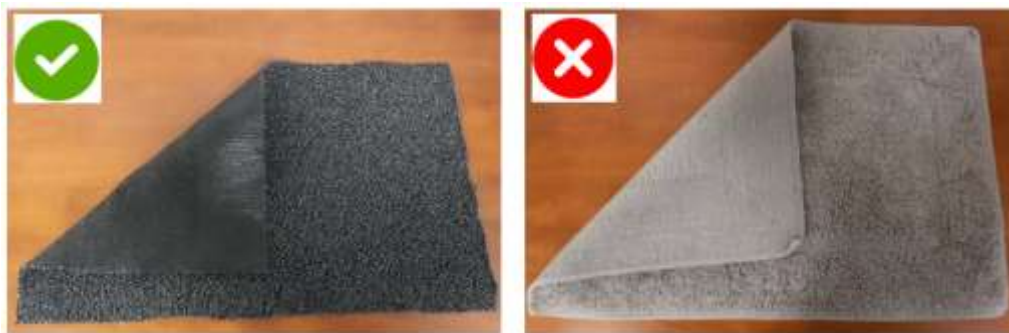
Investigation identified that the cabin mat did not have any anti-slip material on the underside. A check was completed on all cabins which found a number of mats which had the potential to slip due to no anti-slip or rubber material underneath. The assumption had been made that every cabin had an anti-slip type mat.

Cloth based mats were being used instead of rubberised (anti-slip) mats. There were not sufficient rubberised mats to supply each cabin. Cloth based cabin mats do not offer any anti-slip properties.

- The immediate corrective action was to apply deck grip tape, until suitable anti-slip mats were available;
- An adequate stock of rubberised matting should be maintained onboard;
- If there's a temporary need to use cloth based mats, some form of anti-slip material should be used to prevent the mats from slipping;
- Inspections of accommodation areas should highlight where anti-slip mats are not present or not available.

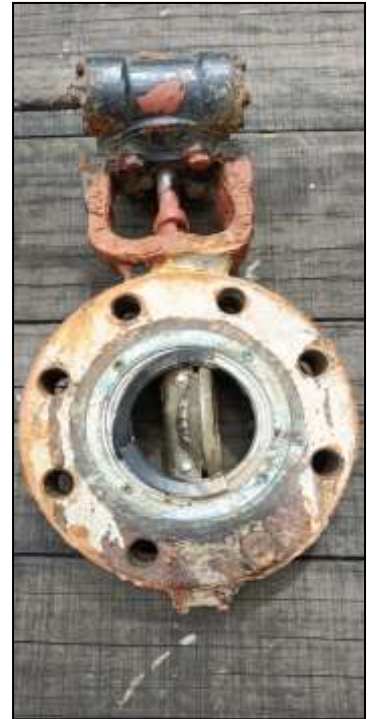
The valve seal was damaged, causing the valve's failure to be fully closed even when the valve's handle was in a full closed position. The oil-based mud cargo had mixed with certain chemicals remaining at the valve seat leaving the valve surface and seal deteriorated.

Showing damage on valve surface and seal

- Replaced the damaged valve;
- Arranged regular monthly cleaning on manifold valve;
- Ensured that after carrying out loading/discharge cargo, all lines were blown out to ensure there is no residual chemicals or mud at line and manifold.

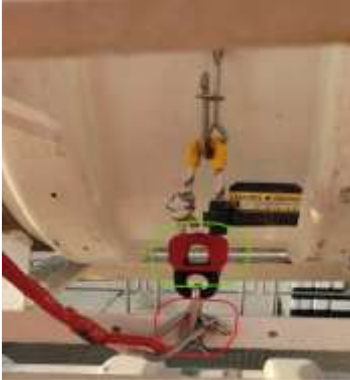
During an onshore visit to a vessel, it was observed that a life raft was attached/connected incorrectly to the life raft cradle. The life raft painter rope was connected to the cradle instead of to the weak link on the Hydrostatic Release Unit.

incorrect connection point in red and correct one in green

It was installed incorrectly and there was no post-installation check carried out. What inspection there had been, had been a visual check of condition with no check of whether the life raft was or was not correctly installed and secured.

Post-installation checks and life-raft weekly inspections added to planned maintenance system.

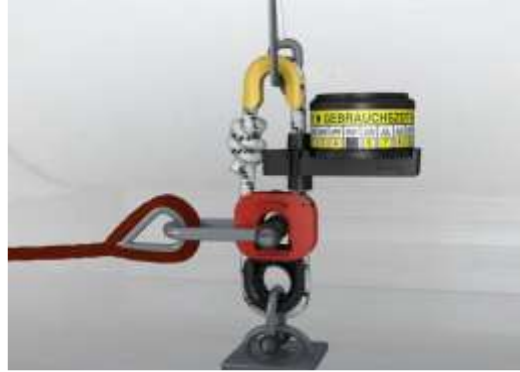
Correct life raft securing arrangement
