1 BSEE: Person injured when safety mechanisms failed

2 Dropped spanner falls 15m

3 Equipment Damage: Dropped Object from tiltable lay system

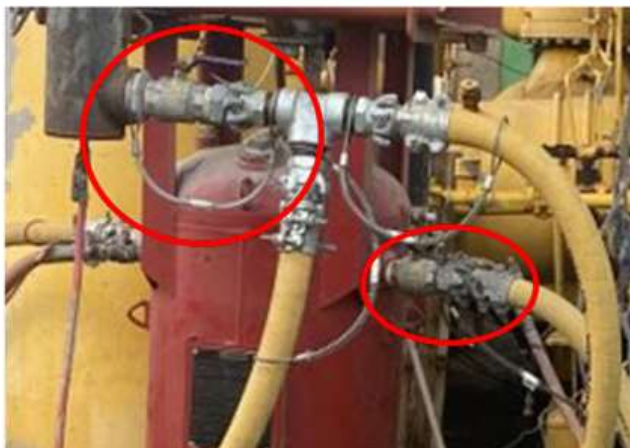
The worker was refilling the sand pot with an abrasive material to continue sandblasting operations. After confirming the air supply valve from the temporary air dryer to the sand pot was shut-in, the worker attempted to disconnect the air supply valve (Figure 1 – Right Circle) from the air dryer. As he tried to access this coupling, he loosened the T-connection. The T-connection blew off and broke the braided steel whip check or safety cable which hit the worker causing injury.

Figure 1 – Temporarily installed air dryer with bull hose connections. Original whip check position (Left Circle) and the location of the injured persons hand placement on the air supply valve (Right Circle).

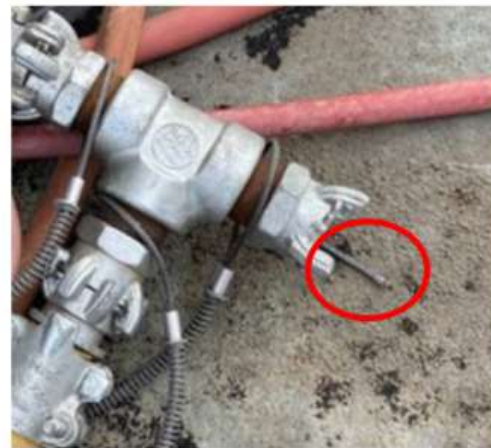
Figure 2 - Broken whip check from the incident.

- *The baling wire involved in the incident was slightly corroded, potentially diminishing its overall integrity. Baling wire is used as an additional safety measure to ensure couplings are securely connected. It is often used in place of a cotter pin on crowfoot couplings;*
- *The failed whip check cable was improperly crimped. Crimping the whip check cable before placing it into service allows it to function correctly at its full rated capacity.*

- Ensure all risks and associated mitigations of this kind of task are fully understood;
- Install stainless steel tie wires in addition to whip checks on bull hoses to reduce the risk of disconnection;
- Install 90-degree fittings (see illustration) to eliminate the horizontal orientation of the supply hose, reducing the stress at each connection;
- Where practical, depressurize equipment prior to adjusting valves;
- Inspect all equipment and parts pre-job to ensure they are in adequate condition.

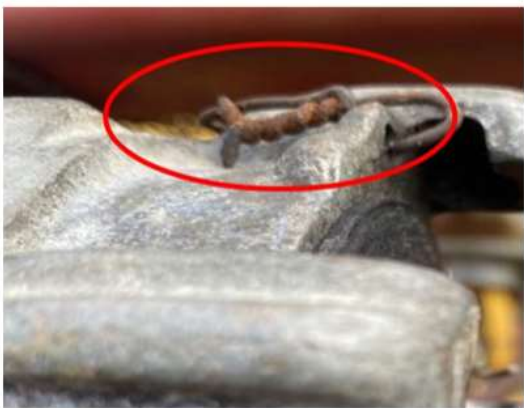
- The bull hose configuration on the air inlet valve from the platform air compressor was installed in a horizontal position. This added weight caused the T-connection to be off-centre at the time of operation, adding stress on the associated couplings and baling wire. The added weight, combined with the worker's force when manipulating the air supply valve to the sand pot, resulted in air escaping the inlet valve from the platform compressor, likely causing the connection to come loose.

Figure 3 – Baling wire on coupling that released.

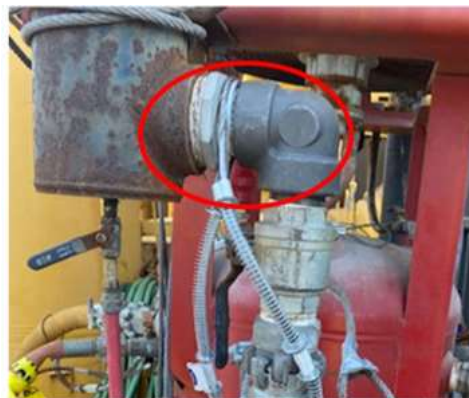
Figure 4 – 90-Degree fitting recommendation.

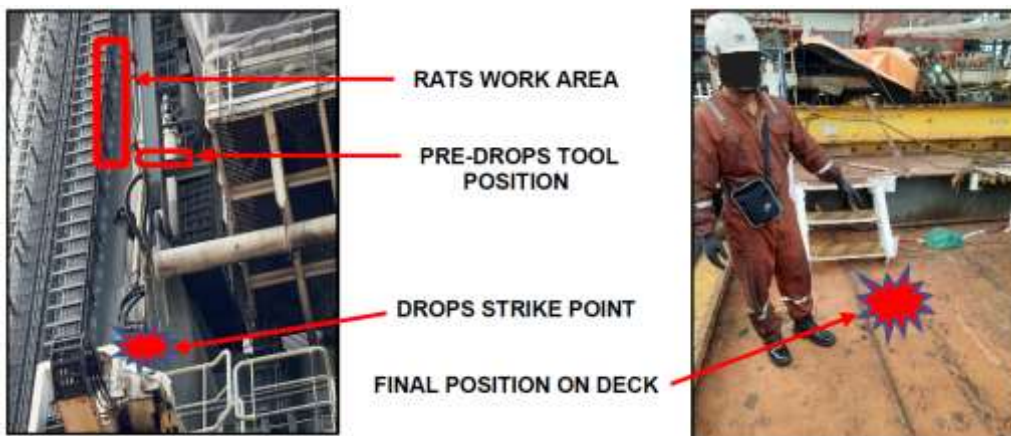
Protective netting had been installed for general maintenance on a pipelay system, which would be carried out by crew members and a third-party Rope Access Team. During work on hydraulic hose replacement, a member of the third-party Rope Access Team observed two hoses outside the netting protected area and proceeded to replace them. A spanner (60mm x 1.65 kg) was used, secured to the team member by a 1.2m DROPS prevention tooling lanyard, connected by threaded carabiners at both ends. During the replacement the carabiner threads became loose allowing the carabiner to open. The spanner fell 15 metres to the deck area below which was partially barriered off. No-one was injured. However, workers were nearby on deck.

- It was noted that because there is no swivel in the wire lanyard, there was a risk of the carabiner opening if the carabiner thread was open. The carabiner threads were also found to be heavily worn and contaminated which compromised the locking mechanism. The pre-work inspection failed to identify the equipment conditions. The DROPS tool kits were not covered within the planned maintenance system;

- Ensured all work teams were aware of the scope and limit of work activities and knew to not go beyond those limits without review from management;
- Ensured completion of pre-task inspection of tools/accessories for Working at Height;
- Subjected all Working at Height tools to regular inspection, maintenance and replaced defective parts as required;
- Considered barriers appropriate to the specific nature of the task – taking into account the DROPS cone;
- Properly manage barriers to ensure they are suitably positioned for the work, with sign-off to confirm purpose.

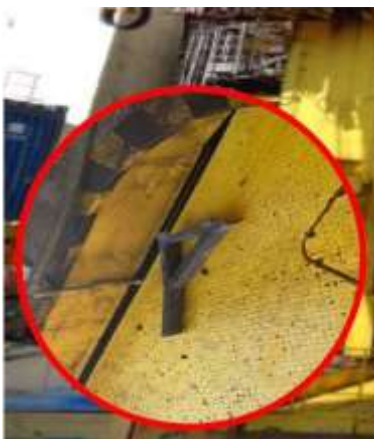
Dropped bracket

As the tensioner doors were being closed, the port side door made contact with a hinged bracket that was part of an inspection manhole gate which had been left open. This resulted in the bracket, weighing 10.5 kg, dropping approximately 16m to the work table below.

- Before this event, the inspection manhole gate had been damaged in a previous unreported incident. Subsequently some minor repair work had been undertaken which involved the removal of the grating from the gate/bracket. The hinged bracket was seized in the upright position and at the time it was not considered a dropped object hazard due to it being firmly secured to the TLS structure.
 - The seized bracket was not fully repaired following the original incident;
 - The latent hazard posed by seized bracket was not identified as a potential DROPS or as a clashing hazard.

- Although the first incident was recorded within the pipelay team handover notes, there was a failure to formally report it within the company incident reporting system - all damage incidents should be reported to ensure the correct level of investigation, and so that corrective and preventative actions are identified and implemented;
- The equipment design and layout failed to identify the clash points created when manhole gates were left in the open position.

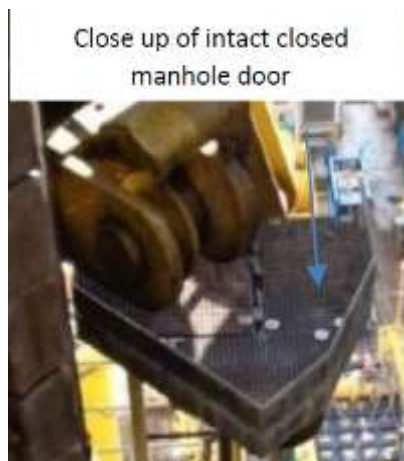
(Right) Intact manhole door raised, showing bracket in upright position. The dropped object bracket was in similar position due to previous unreported incident.

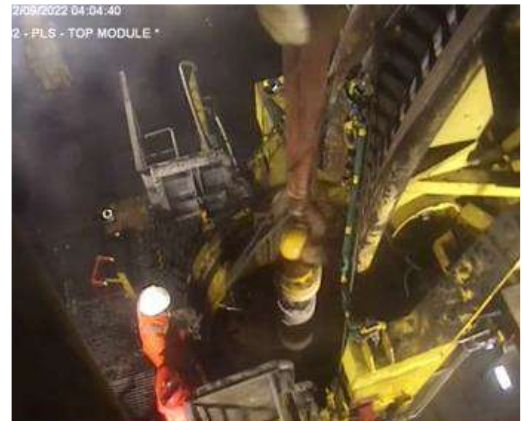
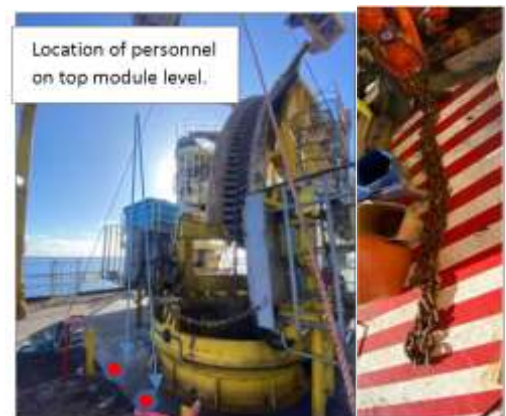
Crew were involved in the second end transfer of a 4" (10cm) production flexible up to the top module of the pipelay system. As the second end was being transferred, the tensioners were in the following position: upper tensioner – open, lower tensioner - closed. To allow the weight to be transferred onto the A&R wire the lower tensioners were opened. This then resulted in the production flexible rotating due to the residual torsion that had been built up within the line. A 16.5te chain used for the transfer of the second end was still attached to the pull-in head, as the flexible pipe began to rotate, this chain also spun. Two crew members who were observing the operation were stood nearby and were almost struck by the spinning chain.

- Key people involved were inexperienced in this specific activity and were not familiar with the task in hand
 - There was a failure to identify the risk posed from the chain still being attached to the flexible pipe.
- There was a language barrier:
 - Part of the team were unable to speak English;
 - The Task Risk Assessment for this operation was only available in English.
- The procedure did not identify when the chain should be removed nor other mitigation measures.

- Ensure important documentation such as Task Risk Assessment, procedures and checklists are available in the languages of the crew doing the work;
- Ensure it is specified in procedures or checklists when rigging or any other items are to be attached or removed;
- Always remove the rigging after transferring loads to the A&R; when removal of rigging is not possible, suggest additional mitigation actions in the Task Risk Assessment.
 - One mitigating measure was to install a gate with signage restricting access to the top module.

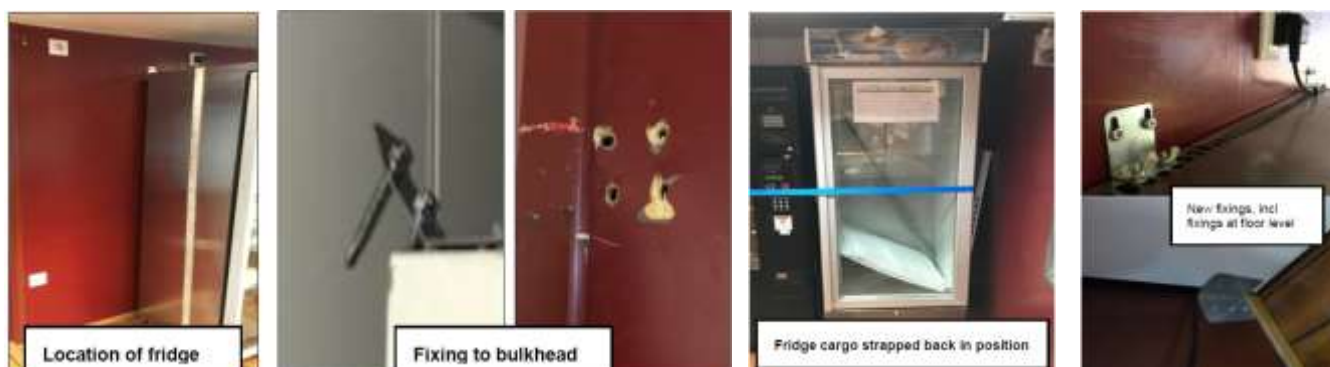
During transit through heavy seas, a fridge tore loose from the messroom wall and fell on its side. The incident occurred when the vessel was transiting out to the field and was experiencing 3-4m seas. During one large roll, a tall fridge in the messroom came away from the bulkhead after its primary securing brackets were pulled out of the bulkhead due to the motion of the vessel. The fridge swung on the last remaining fixing before falling on its side.

- Inadequate primary fixings used to secure fridge to bulkhead;
- The strength of the bulkhead construction (a stud wall) not taken into consideration;
- No-one took into consideration, the potential failure of fixings during rough seas.

The fridge was secured to the deck with cargo straps and later returned to the upright position, inspected by the ships electrician and secured to the bulkhead with alternative suitable fixings.

- Could this happen on your vessel?
 - Identify and inspect heavy objects in the accommodation areas e.g. galley, gym, etc to ensure that the securing is robust enough to withstand rough seas;
- When securing items consideration should also be given to what these fixings are secured to, in this example the hollow stud wall was not considered when securing the fridge. The fixings are no stronger than what they fixed to!!
- Suitable fixings for hollow/cavity walls should be utilised for fixing equipment e.g. hollow wall anchors.
