IMCA Safety Flashes summarise key safety matters and incidents, allowing lessons to be more easily learnt for the benefit of all. The effectiveness of the IMCA Safety Flash system depends on members sharing information and so avoiding repeat incidents. Please consider adding safetyreports@imca-int.com to your internal distribution list for safety alerts or manually submitting information on incidents you consider may be relevant. All information is anonymised or sanitised, as appropriate.

1 Differential pressure: dummy choke ejected close to divers

2 Crane boom stopper fell to main deck

3 Fire alarm activation in engine room

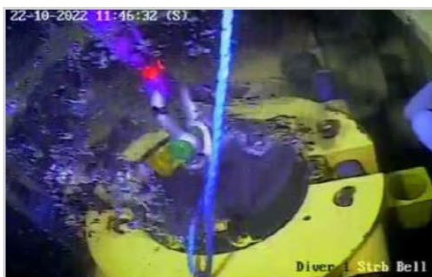
A dummy choke insert was ejected from a water injection (WI) tree by force of differential pressure, while divers were working nearby. A Dive team was removing a dummy choke insert and replacing it with a choke valve insert. The WI tree had been subject to hydrate remediation works. With no hydrates evident, limited trapped or pressurised gas was expected and tested barriers and isolations were in place. During the removal of the half shell clamps that retained the dummy choke insert, unexpected differential pressure from the flowline forced the dummy choke insert (85kg in water) out of the choke valve body at significant force. The two divers were loosening the clamp bolts around the dummy choke and were therefore close by when it ejected. Neither diver was in the direct line of fire; both were unharmed.

Image 1 – Initial gas release

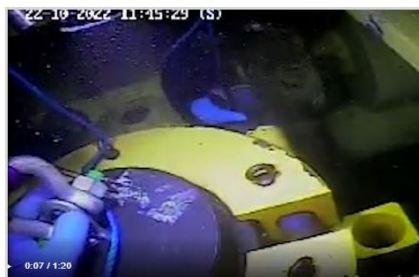
Image 2 – Diver loosening bolts

- Divers continued to work to loosen the clamp while gas/fluid was escaping from the choke, as the team had assumed that previous venting had been successful, and that they were safe to proceed;

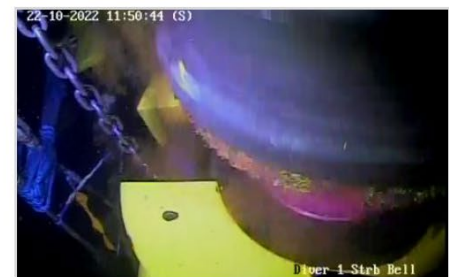
Image 3 – Dummy choke ejection

- During the design of the dummy choke insert, the decision was made not to include a test port, which would have allowed venting of any pressure built up in the flowline. The port was not part of the supplier's standard design, and there was not enough time to approve a design change to include the port;

- The project procedure instructed that the Subsea Pressure and Monitoring Manifold (SPAMM) should be left closed, so there was no local vent path from the flowline;

- When pressure differentials in the system were noted prior to the dummy choke removal, there was no recognition that readings were not as expected, and no discussions within the team relating to venting off the remaining pressure;

- Our member notes that *"the key point throughout was the failure to understand the exact pressure within the flowline, which was the residual 2 bar head of pressure from the riser after Floating Production Storage and Offloading (FPSO) venting"*.

- Design safety in at the early engineering phase of a project – in this case, inclusion of a test port;
- Ensure procedures and risk assessments are clear, unambiguous, and explicit in their requirements (rather than leaving things vague, ambiguous and implicit). This is particularly important when dealing with a pressurised system and/or with stored energy;

- Divers and Dive Supervisors should confirm a local vent is open before starting any work on pressurised systems;
- If any step in a procedure doesn't look right (e.g., local vent to be left closed when working on a pressurised system), **STOP the JOB**: Call an all stop and seek clarification.

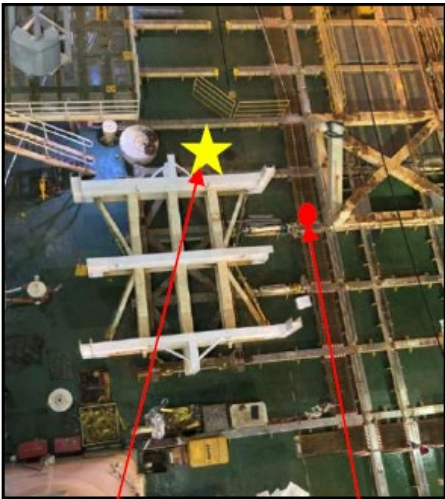
- The area where the knuckle boom stopper pad landed was not a restricted area, access up and down the deck was via a dedicated walkway, inboard of the boom, 5m away from where the boom stopper landed;
- The knuckle boom stopper pad was only attached to the backing plate by adhesive and then the backing plate bolted to the boom stopper frame structure.

Pad landing point - Banksman Position

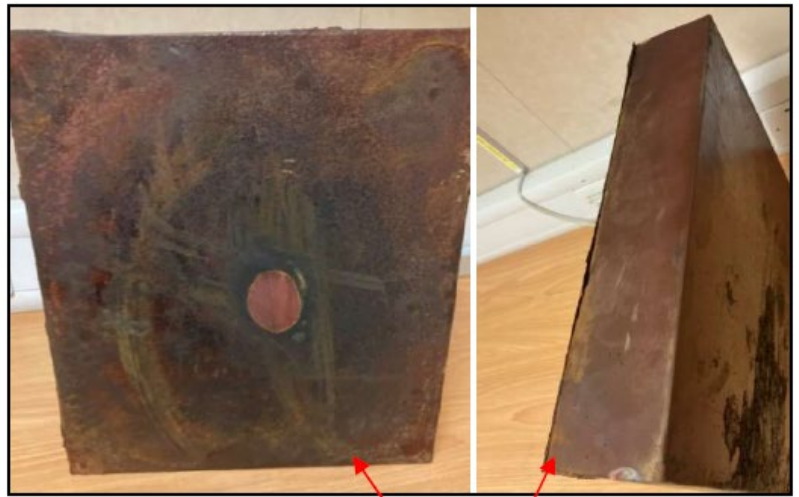
A knuckle boom stopper pad fell to the main deck directly below the knuckle boom. No personnel were injured, however there was potential for serious or fatal injury. The incident occurred when a crane operator started moving the crane boom in preparation for use. Once the crane was clear of all obstructions the crane operator started slewing it outboard. The rigging supervisor acting as banksman was in attendance, located on the inboard dedicated walkway. As the crane boom was slewing, the crane operator saw the boom stopper sliding down the knuckle boom and then falling to the deck. The crane operator immediately sounded the crane horn. The boom stopper weighed 15.5kg and fell 35m. There were no personnel near where it dropped/landed.

Knuckle boom pad

- Vessel technicians modified the backing plate by securing the boom stopper pad with 8 x M16 countersunk cap screws, Loctite and centre dab, and then it was reinstalled by a rope access team. The metal backing plate was

secured with M20 bolts using nyloc and Loctite, preventing any repeat of the boom stopper becoming detached.

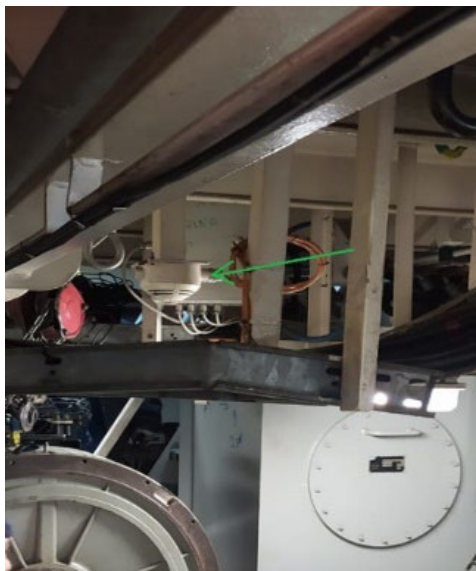
Smoke detector over the affected Shaft Generator

- The temperature sensor installed in the Starboard Shaft Generator was providing inconsistent readings since the most recent overhaul; this had not been reported by the engine crew;
- Our member highlighted two particular concerns:

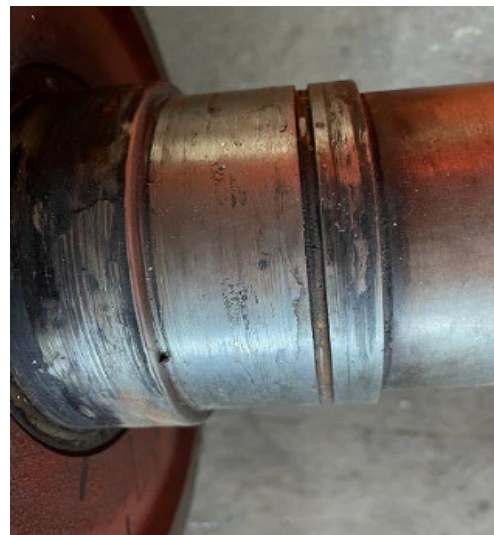
Rotor of Shaft generator/ failed bearing part caused overheating and smoke

The smoke was caused by a failed diesel generator bearing. After disassembling the starboard shaft generator it was observed that grease in the bearing had overheated; this had generated dense white smoke.

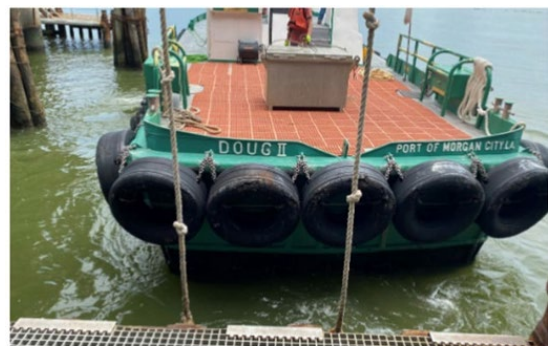
A recent example of an injury incurred during a swing rope transfer, is a fractured foot sustained by a worker attempting to use a swing rope to board a satellite platform from a work boat. As the Captain manoeuvred the boat, the worker placed his foot on a bumper tyre to position himself for the swing. The worker’s foot slipped between the tyre and the boat when the tyre hit the platform, resulting in injury.

View of Boat Stern Where Swing Rope Injury Has Occurred.

- All offshore personnel transfers are treated as stand-alone operations;
- Formal risk assessment is conducted before a transfer occurs;
- There is “Stop work authority” for all persons involved.

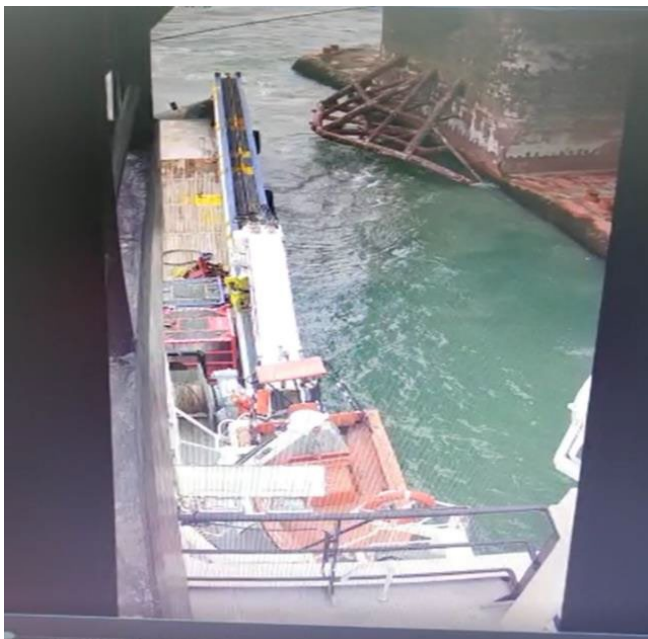
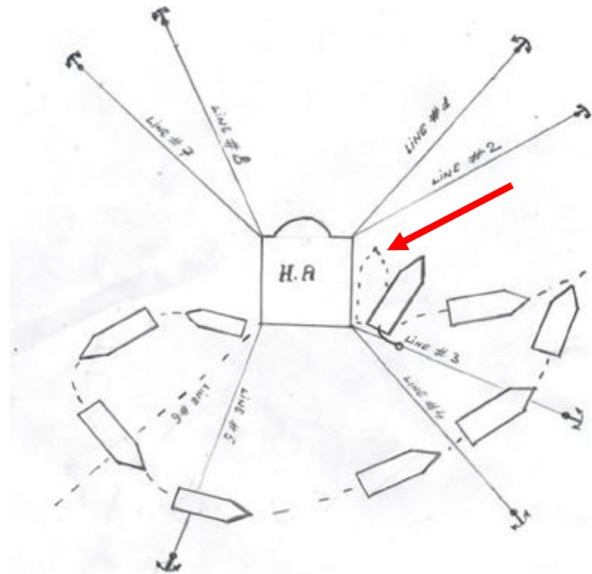
An AHTS vessel made a close approach to the mooring lines for an offshore rig. The AHTS was involved in anchor handling operations for the rig. The vessel passed anchor line #6 to the rig and started to move towards anchor line #3. Control of the vessel was transferred from forward to aft console. Once in position, the vessel received the PCP (Permanent Chasing Pennant) of anchor line #3 by rig crane and it was secured on the Karm fork. The rig’s crane was released, but the chaser’s collar slid on the anchor line towards anchor #3 and pulled the stern of the vessel to starboard, resulting in a bow side close approach to mooring line #2.

To stop this movement the Master activated the bow tunnel thruster, but the thruster did not start. As a result, the vessel bow had a close approach to mooring line #2. The Master immediately switched on all thrusters, obtained full manoeuvrability of the vessel, and the vessel pulled away safely.

A line drawing showing the AHTS vessel’s movement from anchor line #6 to anchor line #3

- Further review identified that the bow thruster electromotor was off. Machinery required for safe manoeuvring of the vessel had been disabled. The electromotors for the tunnel thrusters had been switched off by the chief officer to rest the machinery as the vessel was leaving the 500m zone. This fact had not been communicated to the Master;

- Ensured that critical vessel equipment is not switched off or its operational mode changed without the approval of the person in charge on the bridge;
- Manual transfer of vessel control to be followed by mandatory thorough checks of all propulsion relevant to the operation;
- Developed comprehensive work instructions for bridge transfer control.
