COBRA Bailout System: Various Issues – JFD Guidance Note

COBRA Guidance Note

21 March 2023

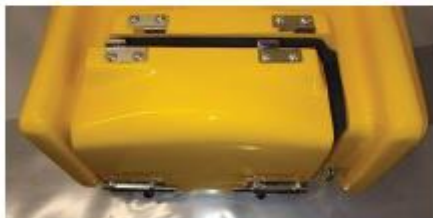
A number of back covers have been supplied with alternative hinges fitted. This causes the door to remove to the right, rather than the left. A number were also supplied with the hinges fitted upside down. Although this has no immediate effect on the functionality of the set, a potential problem exists if a spare door is required.

Figure 1 - Correct Orientation

All spare doors are supplied with a full set of hinges, so it will be possible to fit the replacement door in all cases.

For users wishing to standardise their sets, the correct hinge pt. no. DB5004141 is available from JFD on request.

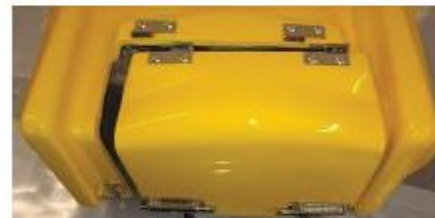
Figure 2 - Incorrect hinges and fitted upside down

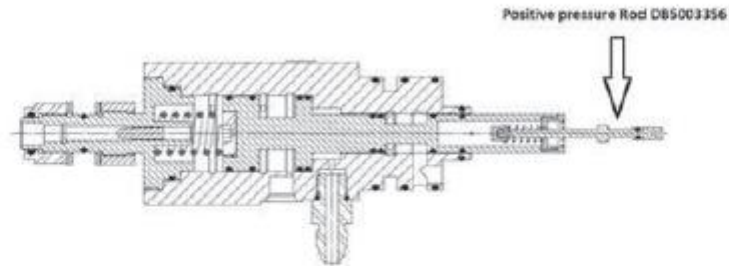
Figure 5 - Piston Assembly Showing Positive Pressure Rod

Various reports have been received relating to bending of the positive pressure rod DB5003356.

Likely reasons for bending to this rod are adjusting the demand valve setting via the diaphragm opening or manually purging the set to drain the cylinders more quickly. If either of these techniques is used, care must be taken to not damage the positive pressure rod.

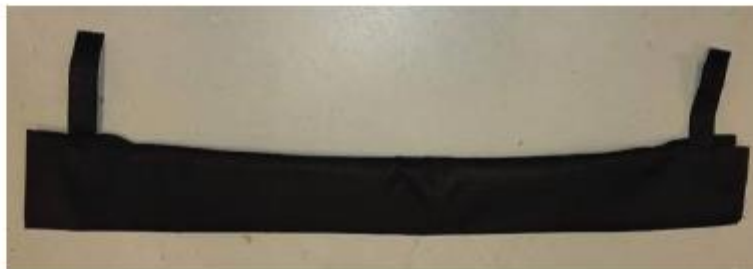
Figure 6 - Breathing Hose Cover, DB5002921

User requested additional protection for Breathing Hoses.

JFD can now provide Cordura covers for COBRA breathing hoses, pt. no. DB5002921

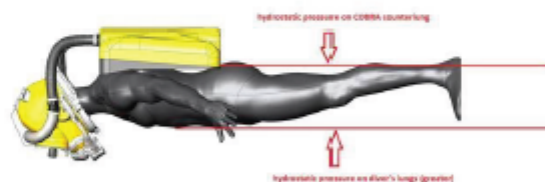
Users have reported increased breathing resistance when using COBRA in various orientations.

This is a well understood characteristic with all rebreathers. A proportion of the required breathing effort is caused by the pressure difference between the user's lungs and the current relative position of the rebreather counterlungs. For example, if a diver (using COBRA) is on his front, the counterlungs are higher in the water column i.e. at a lower pressure than the diver's lungs. The diver will have to work harder to fill his lungs with gas. Conversely, if the diver is on his back, the counterlungs will be at a higher pressure and the diver may well require extra effort to exhale. Other positions, of course, lie between these extremes.

Figure 10 - Diver Face Down, Easy Exhale, Harder Inhale

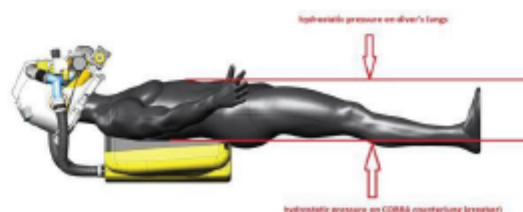
Figure 11 - Diver Face Up, Easy Inhale, Harder Exhale
