## **COBRA Breathing Hose Connection Issues – JFD Guidance Note**

## COBRA Guidance Note

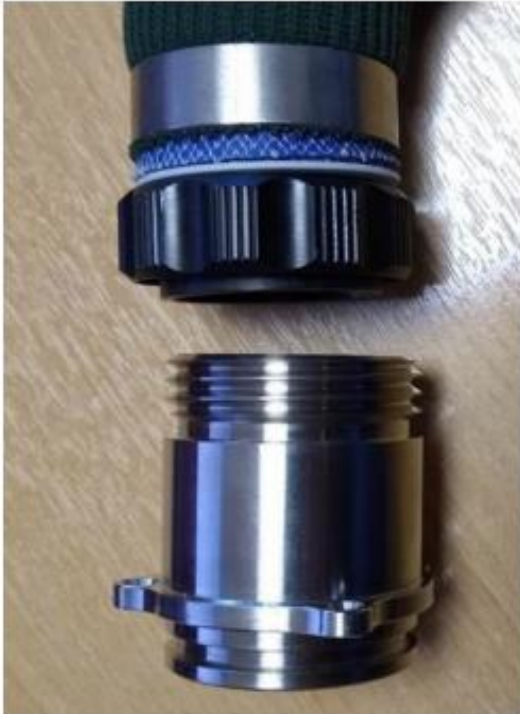
Figure 1 - Backpack Connector and Hose End

In all the reported cases, JFD believes that the hose nut was not fully engaged with the thread on the backpack / helmet connector. Due to the stowage / working arrangements in some bells, JFD understands that it is necessary to fit the breathing hoses to the backpack with the connectors facing away from the user. If this is the case, it is essential that the connection is properly inspected afterwards to ensure proper engagement.

The hose has a piston sealing arrangement. The hose nut should be fastened by hand, until it bottoms out and stops. At this point, the connection must be visually inspected to ensure full engagement. It is not necessary (nor is it recommended) to use any mechanical aid to tighten the hose nut. If the connection leaks with the hose fully inserted and the threads fully engaged, further tightening will not help rectify the leak. The connection should firstly be checked for correct engagement and then the o-ring and surface finish of the connector should be inspected for wear / damage.

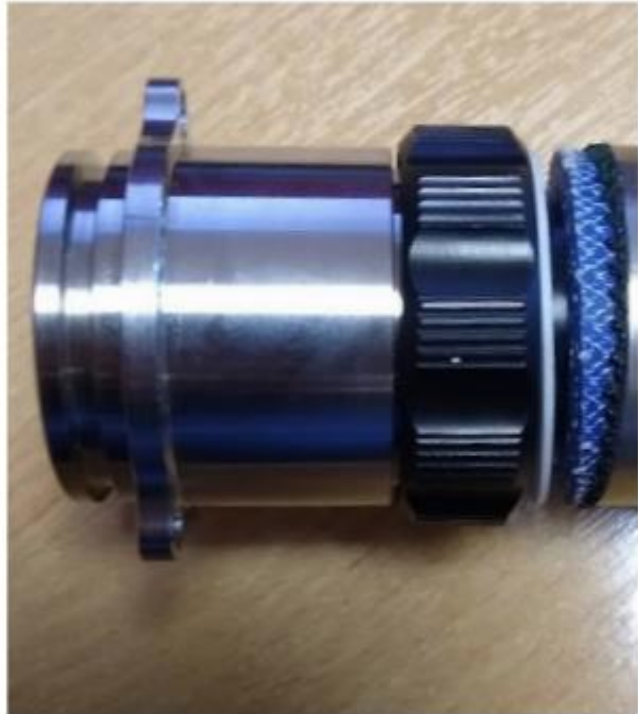
Figure 2 - Backpack Connection Correctly Made Up (no thread visible)

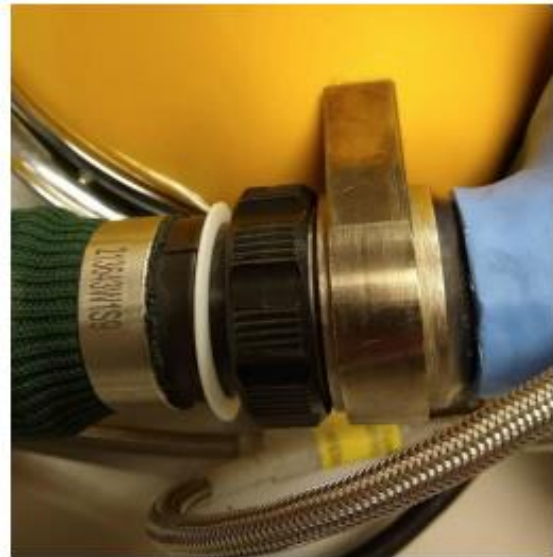
Figure 4 - Helmet Inhale Connection Correctly Made Up (no thread visible)

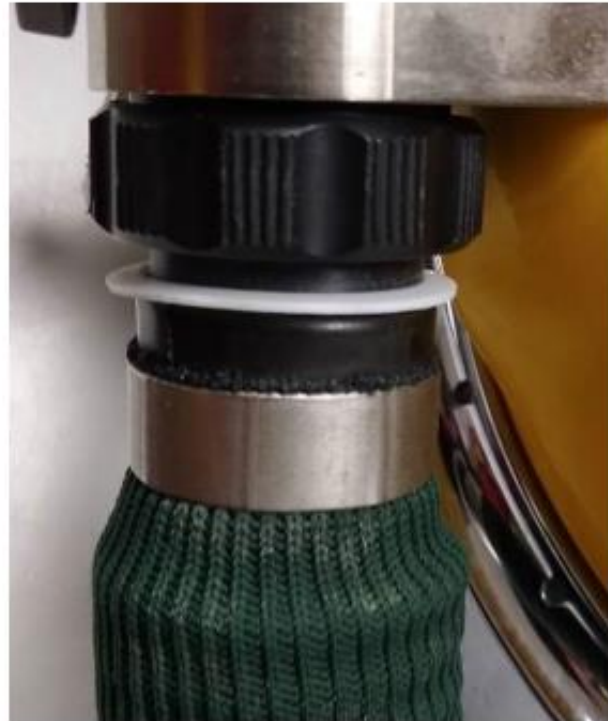
Figure 6 - Helmet Exhale Connection Correctly Made Up (no thread visible)
