The UK Marine Accident Investigation Branch has published [Safety Digest 1/2023](#), consisting of lessons from recent Marine Accident Reports. IMCA has reviewed the digest and here passes on for members interest, some but not all of the incidents in it.

1 MAIB: High pressure oil leak causes a fire in the engine room

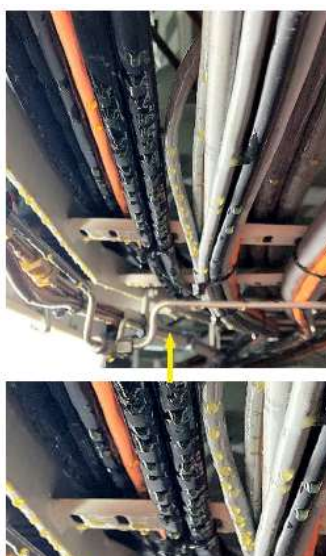
A recently built vessel was on passage when a gearbox temperature probe was ejected from its fitting by oil at 25 bar. A jet of gearbox oil sprayed a major part of the engine room including one of the running main engines.

The oil had saturated the main engine exhaust lagging, which had started to smoke. The oil-soaked lagging ignited but was quickly smothered in fire-fighting foam; subsequent small fires were similarly dealt with.

Figure 1: Oil dripping from engine room cables

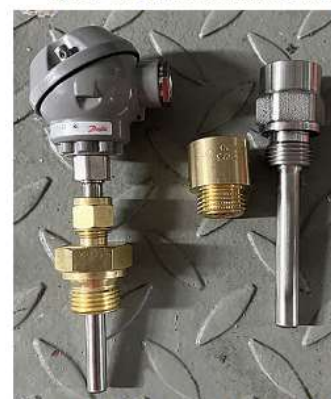
Investigation identified that the temperature probe was held in place by a pipe compression fitting that had not been fully tightened during the vessel build. Once the fitting slackened further, there was nothing to stop the oil pressure forcing the probe out of the gearbox.

Figure 3: The new temperature probe fitting

- There's always a "snag list" in a new vessel or after a dry dock. Some faults will only appear later. Monitor equipment much more closely at such times;
- Safety by design: the design of the probe fitting was insubstantial in terms of the operating environment and the consequences of it coming loose. Poorly designed equipment increases the risk of injury to the crew and can force them into undesirable workarounds. In this case, the manufacturer produced a redesigned fitting and probe housing that would prevent reoccurrence and allow the probe to be changed while the propulsion system was working.

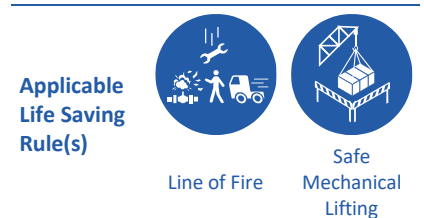
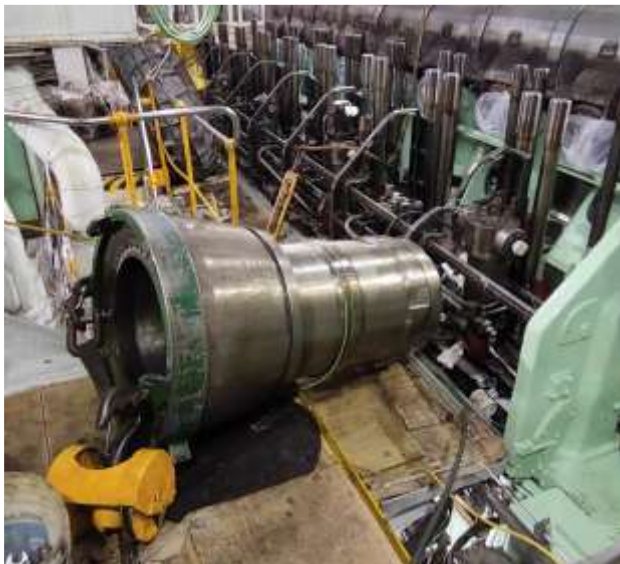
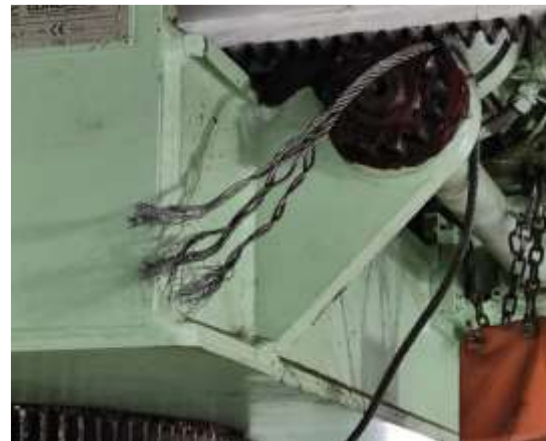
Engineers were overhauling a large diesel generator, using the engine room's overhead gantry crane to lift a 1200kg cylinder liner into position above the engine. This required the electric winch motor to raise the crane hook to its maximum lift height, at which point the crane's hoisting wire suddenly parted. The suspended cylinder liner fell onto the engine, causing damage to both pieces of equipment, and struck the left foot of an engine room fitter who was standing nearby. The crew member was treated in hospital for a broken toe.

Left: cylinder liner after wire parted. Above: parted hoisting wire

- The crew member was in the line of fire, near or under a suspended load;
- The failed hoisting wire had been recently renewed but was found to be 7m shorter than the wire length specified by the crane manufacturer. The shorter length wire affected the operation of the crane's hoist limit switch and prevented it from cutting power to the winch electric motor when the hook was raised to the maximum lift height; the winch motor was therefore able to overload the wire and cause it to fail;

- The cranes were all taken out of service for repair. Engineers conducted a full inspection of engine room hoisting devices and take necessary steps to ensure that all equipment meets manufacturer specifications;
- Test hoist limit switches before operating cranes.

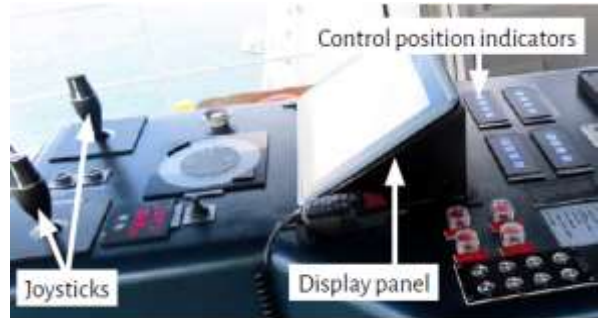
The vessel was fitted with a Voith Schneider Propeller. The system could be controlled from joysticks on one of three consoles on the port, starboard or centre of the bridge. Control was exchanged by pressing a command button at one of the consoles and confirmed by pressing the button a second time. An audible tone would indicate when there was misalignment between the joysticks of the two consoles and the transfer would not take place.

- The angle of the control display panels made it difficult to see which console was in control - previous modifications to the position of the display panels had inadvertently made it harder to see them;
- Confusion arose and neither the Master nor helmsman knew who was in control.

- Equipment:
 - With dual or other complex control systems, ensure there is a robust system for identifying which console has control at any time;
 - Control indications should be unambiguous and any modifications need to be carefully considered so that the fixing of one problem does not create another.
- Training and competence: When the equipment did not operate as expected it took time for the bridge team to regain control. This circumstance was in the manual – greater familiarity with procedure may have quickened the bridge team's response to the loss of control.

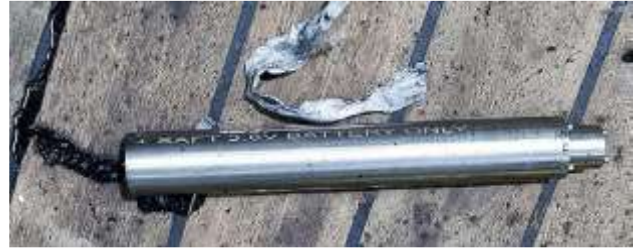
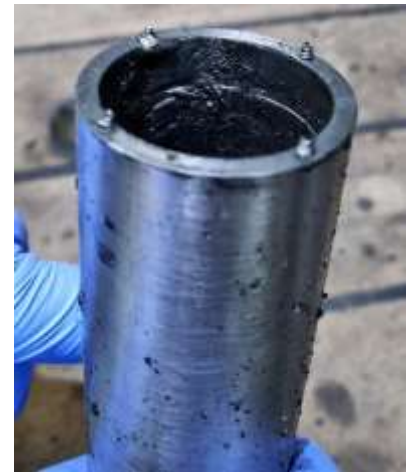
Sea water got into Lithium-ion batteries in equipment for use subsea, causing an explosion. Inspection of the equipment after a successful deployment identified a potential leak from one of the metal tubes. However, other work priorities meant that the technician in charge of the equipment decided to leave it in its storage area and delay the removal and further examination of the battery. Seven hours later, the vessel's bridge team heard a loud bang followed by a fire detection system warning for the deepwater equipment storage area. The attending crew members discovered a scorched and damaged metal battery tube lying on the deck. There were no injuries.

Examination of the battery tube indicated that sea water had leaked into the battery compartment and contaminated the Li-ion battery, which caused pressurised gasses to build up and self-combust and resulted in a brief explosion. The remaining battery tubes were removed to a secure storage area for further checks.

- Lithium-ion batteries are widely used in IMCA members' operations, and they are potentially very hazardous. A 1kg Li-ion battery can store the same amount of energy as a 6kg NiMH (Nickel metal hydride) or lead acid battery.
- Lithium-ion battery failures do occur; fires in Lithium-ion batteries can be difficult to extinguish.
- Lithium reacts intensely with water, which can corrode or damage the internal battery safety devices and cause it to overheat, ignite, rupture or leak. Some of the chemicals produced by burning Lithium-ion batteries can be very dangerous.
- A Li-ion battery that is found to be damaged or affected by water should not be used or charged. Remove the battery to a secure place where it can be monitored and potential spontaneous combustion can occur safely. In the event of a fire, use an appropriate fire extinguisher to put it out.
