1 Lifting chains parted – hydrogen embrittlement

2 Davit hook failures

3 Sheave became detached during lifting operations

4 Near Miss: personnel transfer basket hit structure

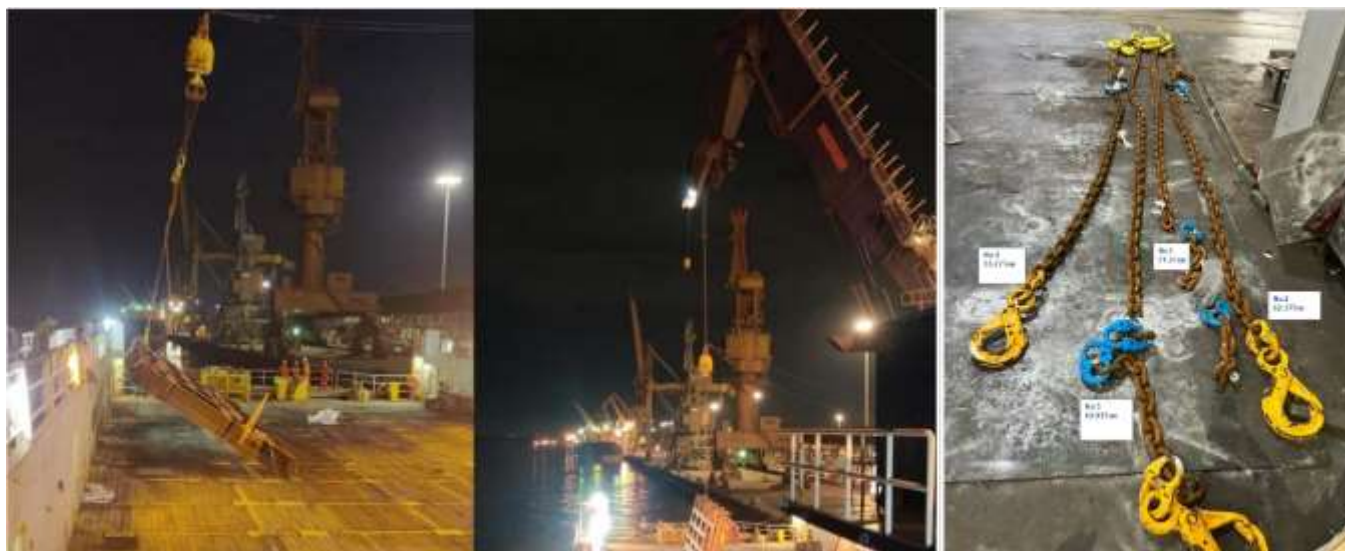
Three of four lifting chains on a load parted while the load was being lifted. The incident occurred in the last lift of sections of grillage from a vessel involved in project demobilisation. At the time of the incident, the grillage was suspended, above the deck, by approximately 4m. Following a discussion between the Deck Foreman and the Crane Operator, the grillage was slowly lowered down to the deck. There were no injuries.

Analysis by an independent third party, and the chain manufacturer, concluded that hydrogen embrittlement, causing pitting, exacerbated by the tensile load on the internal radius of the links caused surface corrosion cracking, leading to internal branch cracking and failure.

The rigging was changed from a four-way bridle arrangement to slings and shackles, and the lift was completed safely.

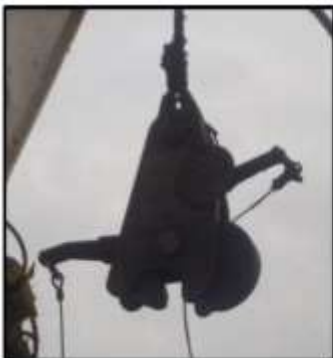
- Incident 1: During a weekly inspection of lifesaving equipment, the workboat davit hook on one vessel failed resulting in the hook releasing and dropping the workboat to the sea. No persons were in the workboat at the time and there were no injuries. However, the workboat itself was badly damaged.
- Incident 2: A subsequent inspection of similar davit hooks on a sister vessel found the top shaft screw had sheared on a life raft davit hook, with the nut having dropped to deck. The shaft remained in place, holding the hook in position.

Image 1 - Davit Hook failed, releasing and dropping the workboat (vessel 1)

- Halted all non-emergency launch and recovery operations using this type of hook until further notice;
- Inspected all similar davit hooks, paying particular attention to the top and bottom pin shafts and surrounding mounts, inspecting for cracks, deformation or fatigue. For this type of hook, the inspection included disassembly of the top shaft, loosening the securing screw, nut, shaft itself and the distance bush;

- Reviewed onboard maintenance regimes to ensure inspections of davit hooks include checks on the davit hook pins to identify any physical deterioration;
- Confirmed that the most recent annual inspection completed by the original equipment manufacturer (OEM) or third party included the opening of the hook and removal of the pin for inspection.

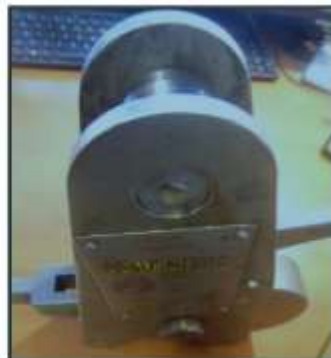
Image 2 - Davit Hook Top Shaft failed (vessel 2)

- Incident 1: The failure of the workboat hook remains under investigation. Further information will be distributed when the review has been completed;
- Incident 2: The failure of the life raft davit hook was suspected to have been the result of an undetected crack in the threaded section of the hook top shaft screw. This allowed environment conditions to cause deterioration, resulting in the top hook shaft threaded section to shear off the body of the pin. Examination of the shaft showed that the fracture had developed over time.

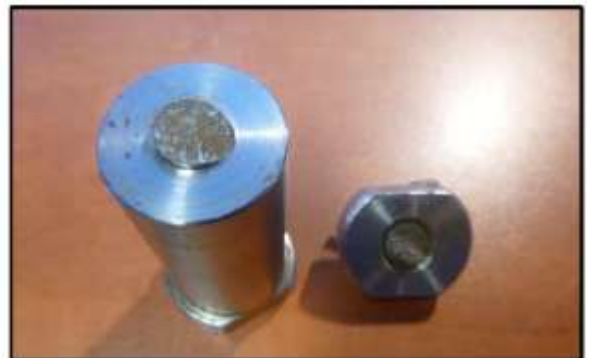
Image 3 - Failed Shaft (vessel 2)

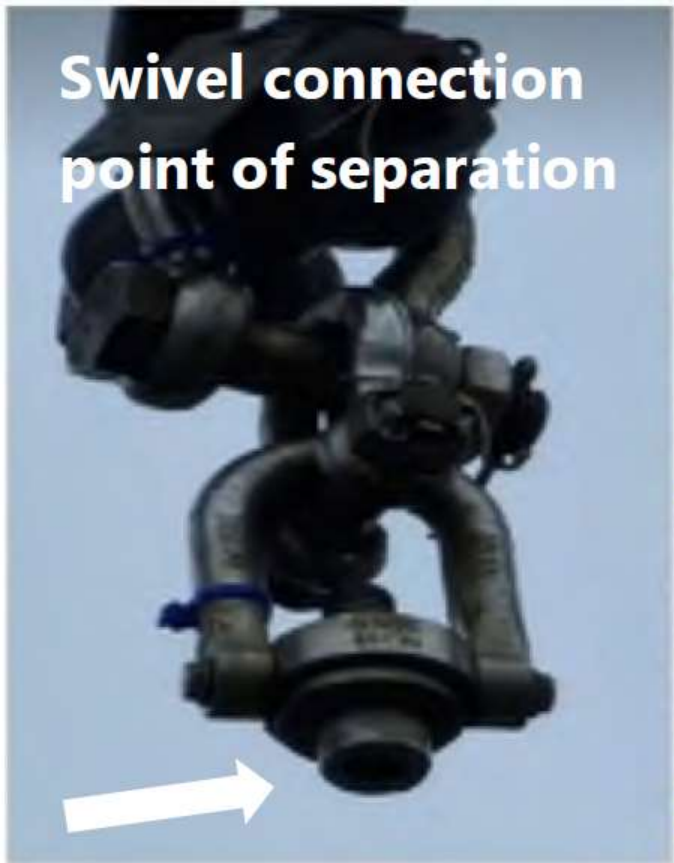
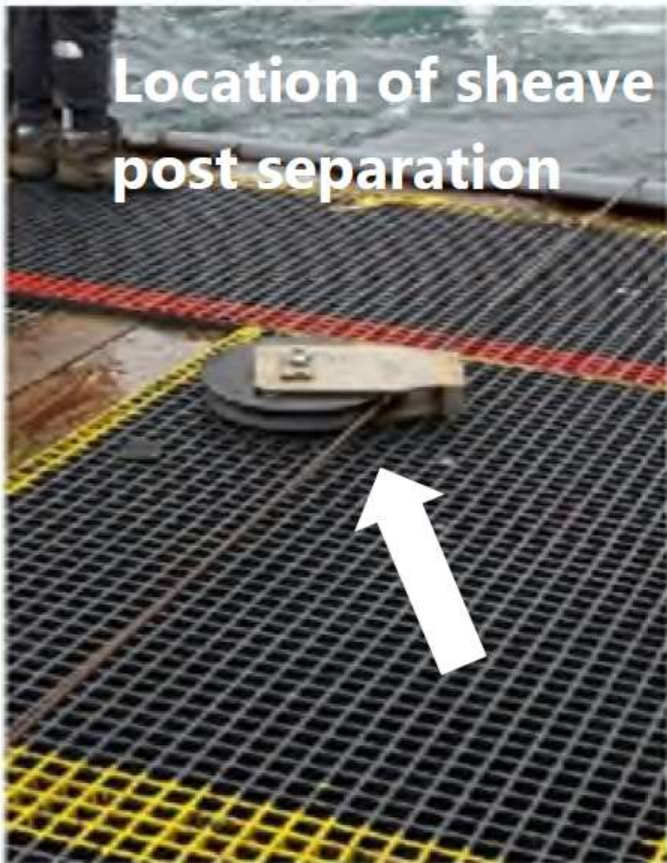
During recovery operations of marine geophysical sensors, a sheave parted from a swivel connection on the A-frame. The sheave fell approximately 6m to the deck below. No personnel were underneath the sheave, however had the sheave struck an individual, it could have caused serious injury.

- Investigation revealed that:
 - Installation of the sheave and introduction of new components had not been subject to a documented management of change;
 - There were no written installation instructions provided with the sheave, with nothing detailing the configuration of the sheave to the swivel connection;
 - The person installing the sheave relied on verbal instructions and an incorrect understanding of the previous installation;

- When the sheave was installed, the secondary retention (securing sling) was considered unnecessary and removed - there was no independent verification / quality check (QC) carried out;
- Prior to the incident, there had been numerous opportunities including one by an independent (third party) inspector to identify that the sheave was incorrectly installed;
- There was inadequate development and control of the lifting equipment records / register.

- **Equipment** - Design changes were made after the incident to remove the swivel connection and replace it with a pad eye thereby reducing the potential for incorrect connection;
 - Secondary securing slings were fitted to all sheaves. Additionally, a cable was installed between the A-frame legs to act as another barrier should primary and secondary retention fail. The sensor tow wire straddles this cable, so if the sheave falls it slides down the tow cable rather than drop (see image to the right).
 - Monitoring, tracking, inspecting, and provision of guidance for lifting equipment, accessories and rigging was improved.
- **Procedures** - Written installation and maintenance instructions should be provided with all equipment/sheaves.

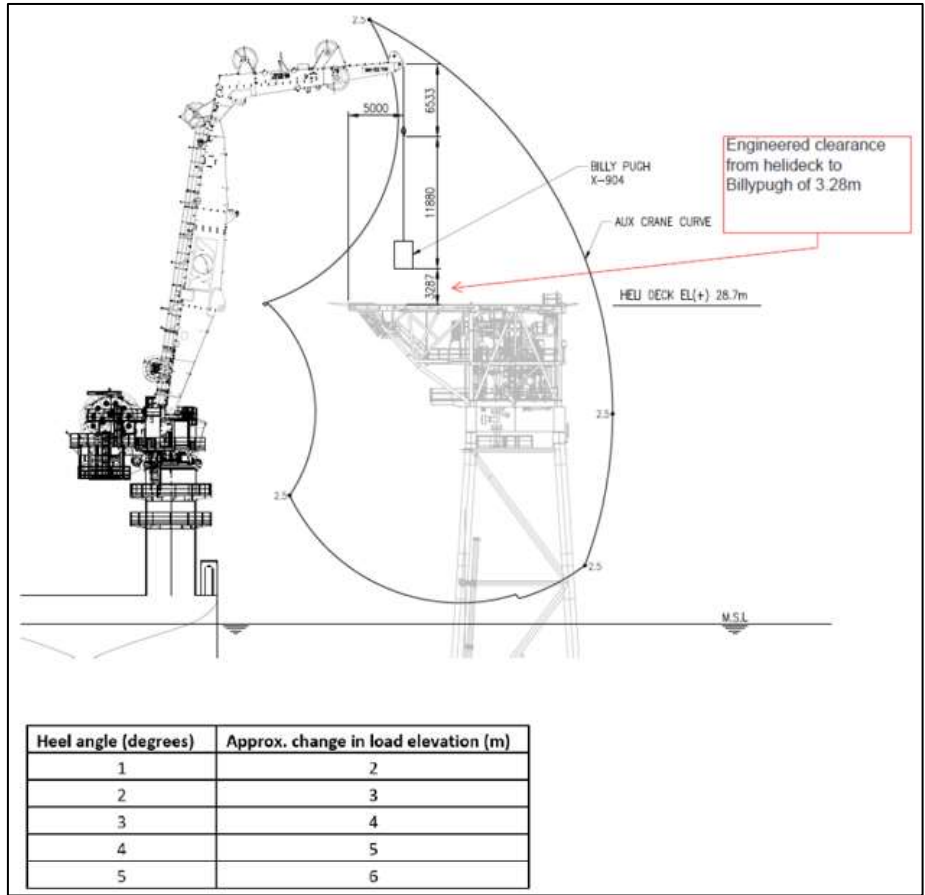
During a transfer of two personnel to a platform using the vessel crane, the base bumper of the personnel transfer basket came into contact with the helipad netting rail of the platform. At the time of the incident, an unexpected wave caused the vessel to roll and resulted in the subsequent vertical movement of the vessel crane tip.

- Detailed planning for personnel transfer operations had failed to recognise the potential – notwithstanding the sea state being within limits for such operations - for vessel roll and subsequent vertical movement of the crane and personnel basket;
- Engineering drawings did not provide vertical movement detail for the personnel basket as affected by environmental conditions.

Our member found that the root cause of the incident was insufficient detail in specified working limitations for the vertical movement of the basket when the vessel rolls, and that a minimum safe clearance height above the helideck had not been defined to avoid helideck contact whilst carrying out transfers within the operational limits of the crane.

Lift plan to include calculated basket vertical movements corresponding to vessel roll for crane operational limits. As per example drawing.

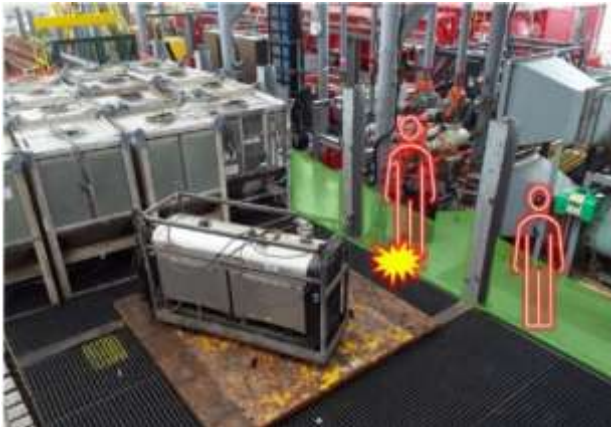
Figure 1: Worker entangled while moving toward a “Step Back Area”

- January 2023: While lifting a welding machine from the deck, a crew member moved into the Step Back Area (see Figure 1) and stepped into the coiled tagline and became entangled. The crew member was able to grab the tagline while entangled and was lifted up and swung with the load approximately 4m off the deck (Figure 2). The Signaller relayed the crane operator to stop the lift, and the rigger and load were lowered to the deck;

- Using hands-free tools instead of taglines whenever possible (e.g., push poles, etc.). If hands-free tools are not available, use taglines marketed as tangle-free or anti-tangle;
- Ensure your taglines are in adequate condition (e.g., free of knots, absent of frayed strands, etc.)

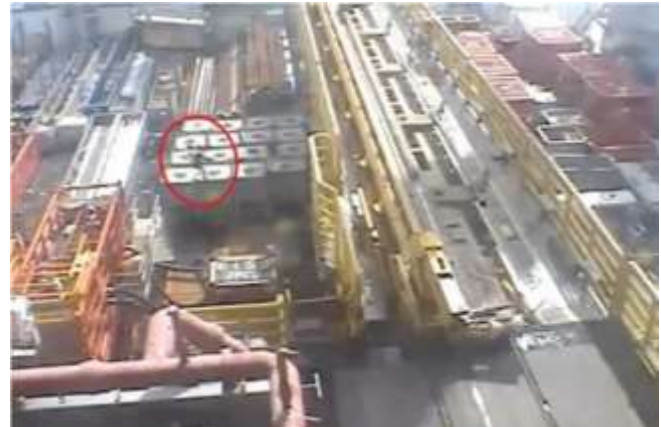
Figure 2: Worker lifted with load after becoming entangled
