IMCA Safety Flashes summarise key safety matters and incidents, allowing lessons to be more easily learnt for the benefit of all. The effectiveness of the IMCA Safety Flash system depends on members sharing information and so avoiding repeat incidents. Please consider adding safetyreports@imca-int.com to your internal distribution list for safety alerts or manually submitting information on incidents you consider may be relevant. All information is anonymised or sanitised, as appropriate.

1 Crew member in small boat slipped and dislocated shoulder

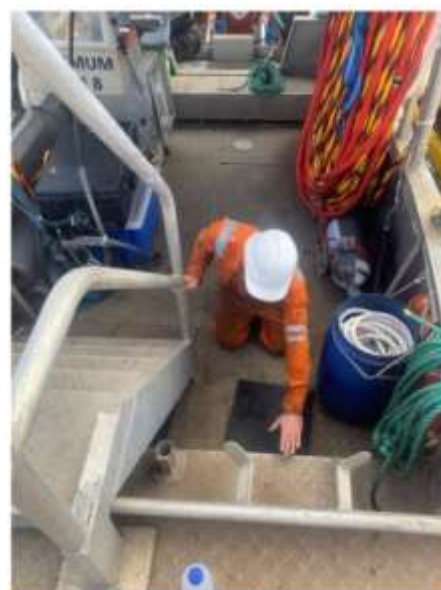
A person was kneeling down in a workboat and was injured when the boat moved suddenly as a result of the sea state. The boat (a small workboat used in diving operations) pitched forward and hit a Catenary Anchor Leg Mooring Buoy. The injured person automatically braced himself by placing a hand on the internal structure of the boat, however the impact on his arm resulted in him getting a dislocated shoulder.

The crew member, whilst he had earlier used some situational awareness to safely re-position himself, had not foreseen the new risks of sudden movement of the boat associated with where he was now working. Work was now being carried out in a location not covered in the risk assessment. He thought he would be safer, but he wasn't.

- Plan and consider human instinctual behaviour within risk assessments.

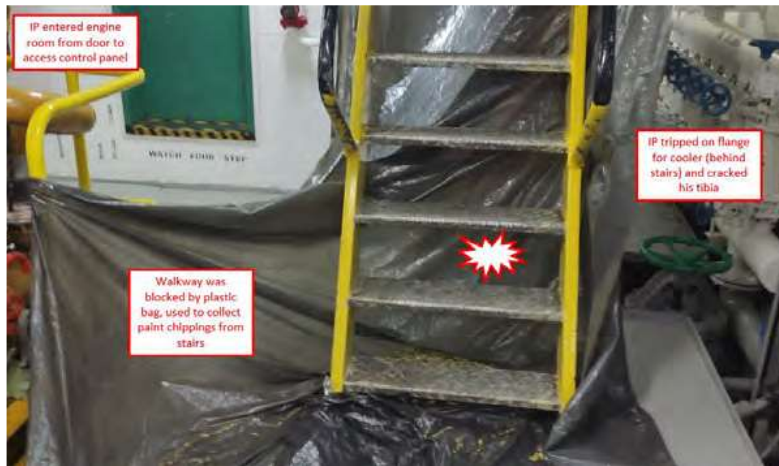
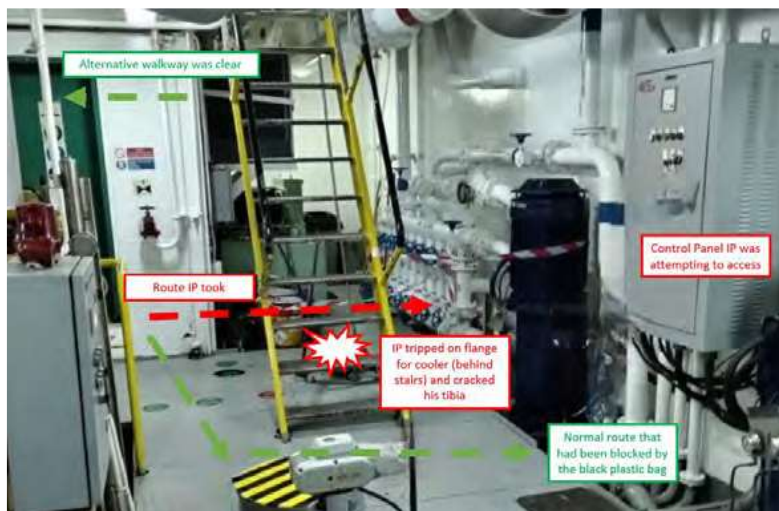
An engineer suffered a broken shin when he slipped taking a shortcut into the engine room. He went into the engine room down some stairs, in order to access a control panel, and found that access to the control panel was blocked by a plastic bag installed to collect paint chippings from maintenance work on the stairs. He took an alternative route behind the staircase, hit the stairs with his right shoulder, and lost his balance. He fell in such a way as to hit his ankle on a valve on the floor of the engine room, causing a cracked tibia (shin bone).

- No-one stopped to think:
 - Maintenance work created new, additional hazards – the crew conducting the maintenance work had blocked the walkway;
 - There were no barriers or controls in place to stop anyone from using the stairs being maintained, nor was the available alternative route highlighted;
 - The crew doing the maintenance work had not communicated what they were doing to the engineers;
 - The engineer took an unnecessary shortcut when there was an easily accessible walkway to the control panel.
- None of this was identified in any risk assessment or pre-job toolbox talk.

- Understand the need for thorough risk assessment that identifies all potential hazard including that which might arise from maintenance work;
- Ensure effective communication is in place between departments, shifts, crews etc especially with regard to blocked access, maintenance, and any simultaneous operations going on;
- Ensure proper signage and physical barriers are in place where required during maintenance work;

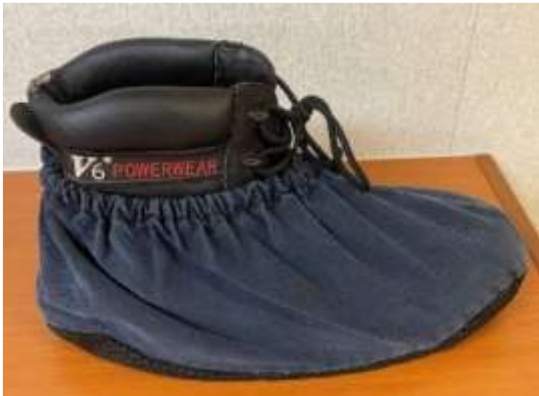
- The grip on the injured person’s cloth shoe covers had worn away over time;
- The person had not removed the cloth shoe covers upon exiting the accommodation area.

Safety shoe with reusable cloth shoe cover

- Inspect shoe covers before use to check the grip - and replace as necessary.

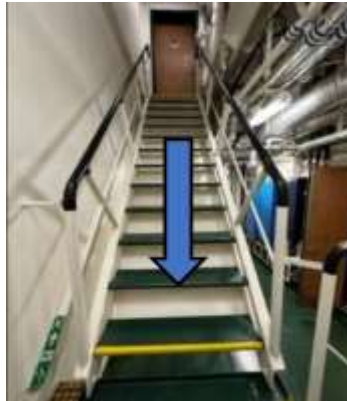
Looking up stairs

A person was making their way down a vessel staircase, wearing coveralls and safety boots with company approved shoe covers on. While descending the stairs, the person slipped down approximately four steps on the staircase. The person had a firm grip hand on the handrail at the time of the incident and thereby, further slippage was prevented. The strain of preventing a worse fall caused muscular pain on the left side of the person’s torso and their left shoulder.

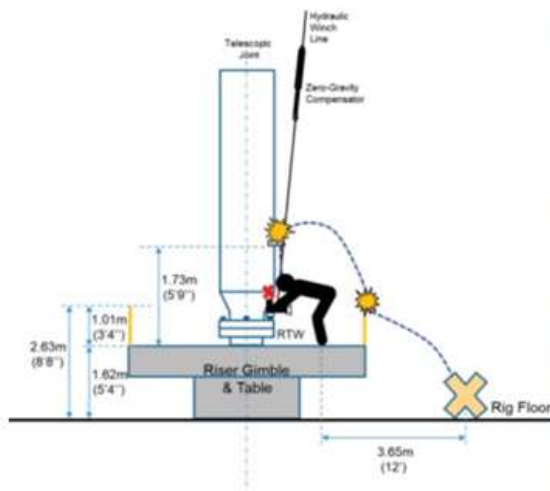
Figure 1. Floorhand Bolt Removal

The incident investigation found that the rig crew was using a hydraulic torque wrench to extract the bolts from a telescopic riser joint (TJ) flange. During the operation, the HTW T socket became stuck between the bolt head and the tapered edge of the TJ. After failing to manually dislodge the HTW using physical exertion, the rig crew utilized a hydraulic utility wrench (HUW) to supply upward force and applied tension to free the tool. After applying the upward force, the torque wrench became unstuck under tension and shot upwards leading to the crewmember being struck.

- Ensure Job Safety Analysis captures the *limitations* of the tools in use;
- Verify that all employees understand the Job Safety Analysis and have been formally trained on operating hydraulic or other power-driven tools;
- Emphasize the initiation of Stop Work Authority if an imminent danger is observed;
- Ensure supervisors and managers understand their responsibilities to monitor all aspects of jobs occurring in the areas over which they have control;
- Use tools that are compatible with, and specifically designed for use in, the particular work environment;
- Could a load indicator, or a similar design mechanism, be of use on such hydraulic wrench tools?

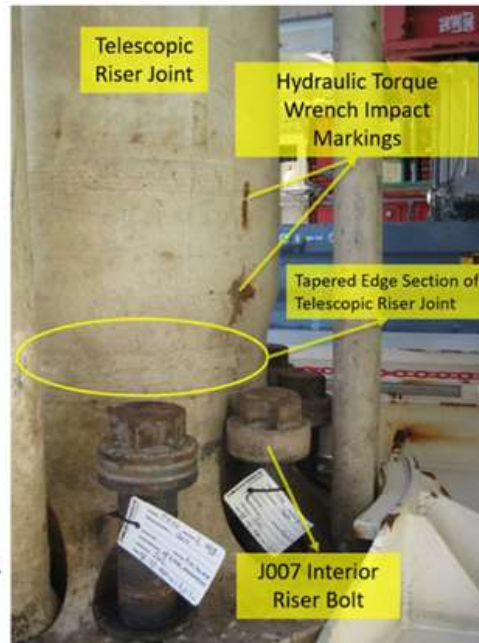
Figure 2. Riser Bolt and Telescopic Riser Joint

- The risk that the hydraulic torque wrench would get stuck on the TJ bevelled edge, was not recognised;
- There was no comprehensive understanding of the Task Risk Assessments associated with the riser pull.
- There was a failure to effectively communicate all learnings from the previous riser pulls;
- There was a lack of formalized training for the use of these hydraulic tools;
- The design of both tools was not optimal and may have contributed to the incident;
- Contributing Causes:
 - Failure to initiate Stop Work Authority;
 - Discrepancies in roles and responsibilities for the Drill Floor Observer (a supervisor).
