IMCA Safety Flashes summarise key safety matters and incidents, allowing lessons to be more easily learnt for the benefit of all. The effectiveness of the IMCA Safety Flash system depends on members sharing information and so avoiding repeat incidents. Please consider adding safetyreports@imca-int.com to your internal distribution list for safety alerts or manually submitting information on incidents you consider may be relevant. All information is anonymised or sanitised, as appropriate.

1 Restricted air supply to diver

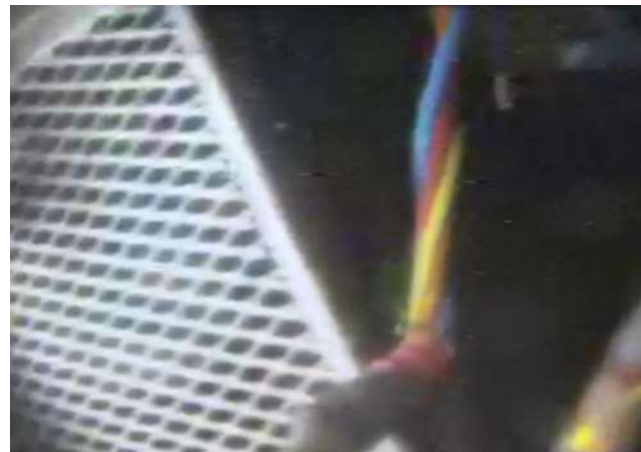
- **Human error:** Diver 2 moved his umbilical restriction from the handle of Basket-2 to the handle of Basket-1, leaving just 2m of slack between this connection and the ring on Basket-2 main wire. This led to his umbilical becoming strained between the baskets due to uneven recovery, causing a restriction in his main air supply;
- **Inadequate supervision:** The task plan for the drill lacked detailed and specific instructions, leaving gaps. That caused further issues when coupled with the umbilical placement, uneven recovery of the baskets, and communications issues;
- **Communication breakdown:** The placement of Diver 2 umbilical between the baskets was not apparent to the Diving Supervisor. The Diving Supervisor was unaware of the uncoordinated basket movement and there was inadequate communication between the divers and the diving supervisor, exacerbating the situation.

Subsea camera still of twisted umbilical

- **Improper umbilical management:** Prior to the recovery of the divers, Diver 2 moved his umbilical restriction from the handle on Basket-2 to the handle on Basket-1. Leaving Diver 2 with his umbilical connecting between Basket-1 and the ring on Basket-2 wire, causing a strain on his umbilical when Basket-1 raised before Basket-2. This led to a kink in the umbilical resulted in the loss of the main air supply to the diver;
- **Communication issues:** There were initial misunderstandings between the divers and the diving supervisor regarding the issues, resulting in delays in levelling the baskets to remove the strain from Diver 2's umbilical;

- **Coordination problems:** When the instruction was given to recover both baskets together, LARS-2 began lifting Basket-2 while Basket-1 was not lifted. This led to Diver 2 umbilical stretching between the two baskets as Basket-2 pulled it.

- **Communication:** Establish clear communication protocols before the operation and ensure all team members understand their roles and responsibilities. Ensuring that the crew understand their roles prevents misunderstandings and enhances overall coordination during operations;

- **Umbilical Management:** Proper umbilical management during all diving operations is critical. Poor umbilical management can lead to serious diver incidents and injuries;

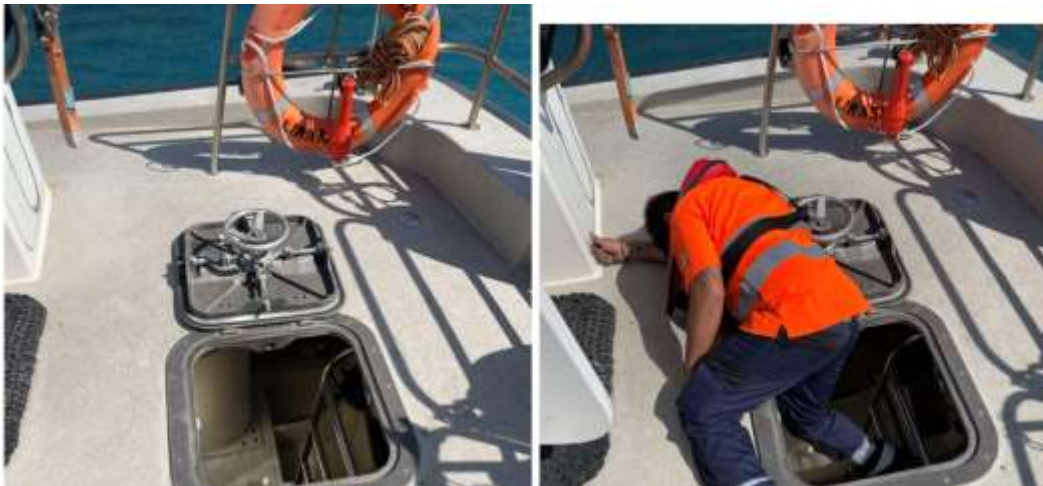
During mooring, a crew person was attempting to secure the rope on the aft section of the vessel. While performing this task, the person stumbled and fell into a hatchway which had been left open. The fall caused the individual to suffer three broken ribs, which led to a Lost Time Injury (LTI).

Right-hand image is a re-construction!

- Lack of communication: The engineer had failed to communicate the fact that the hatch was open and unprotected. No toolbox meeting had taken place to facilitate communication among crew members;
- There were no barriers nor warning signs;
- Inadequate hazard identification and risk management: No-one spotted this...crew members failed to identify and manage the risk. A toolbox meeting could have helped address this issue;
- Lack of toolbox meeting: Without a toolbox meeting, the crew couldn't discuss hazards, precautions, and communication strategies. Toolbox meetings should be considered essential for promoting safety awareness.

- Discuss requirements for using barriers and warning signs when hazards are present, such as open hatches or other potential risks. Make sure signage and equipment are readily available on board to facilitate these safety measures;
- Ensure toolbox meetings are held before starting work, and that they focus on task-specific hazards, safety measures, and crew member responsibilities. Encourage open communication and active participation from everyone involved.

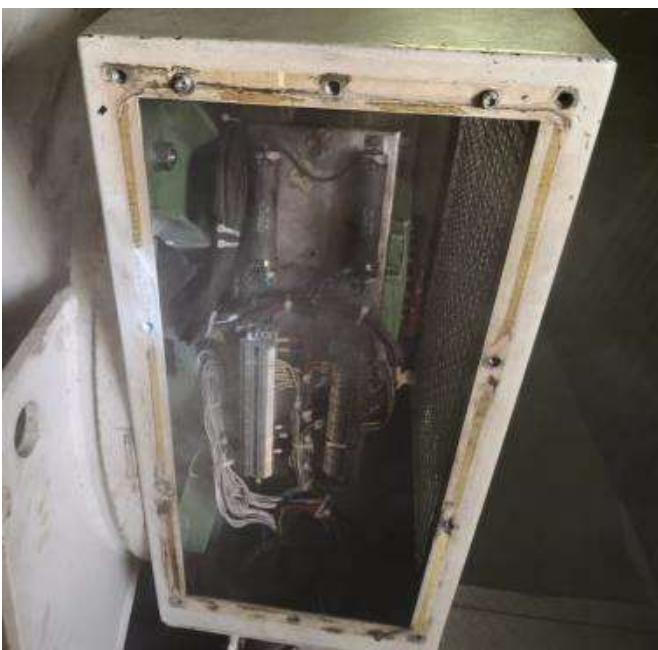
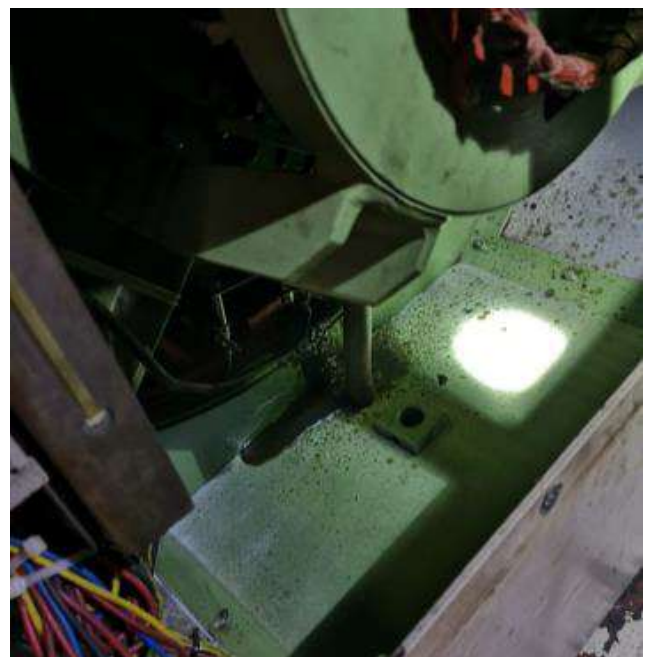
There was a small fire in the engine room on a vessel in port. The incident occurred when a diesel generator was being maintained by a third-party maintenance team. On completion of a change of alternator bearings, the generator was tested at idling speed, and no problem was found. But when the generator was tested at operational speed, after a few minutes fire came out of the non drive end excitors. The alarm was raised; the diesel generator was brought to an emergency stop and the fire was put out with an extinguisher.

There was a misalignment of the internal cover of the non drive end bearing. This misalignment caused friction against the shaft and subsequent sparking. The root cause was considered to be insufficient supervision of the third-party personnel conducting the maintenance.

- Whilst there was only a burnt alternator in this case, the potential was for the fire to have spread throughout the engine room;
- Ensure full and thorough supervision of the personnel of third-party contractors;
- Check carefully the status and readiness of any equipment after maintenance and test – in this case, it was as well that they tested it at operational speed rather than only when idling.

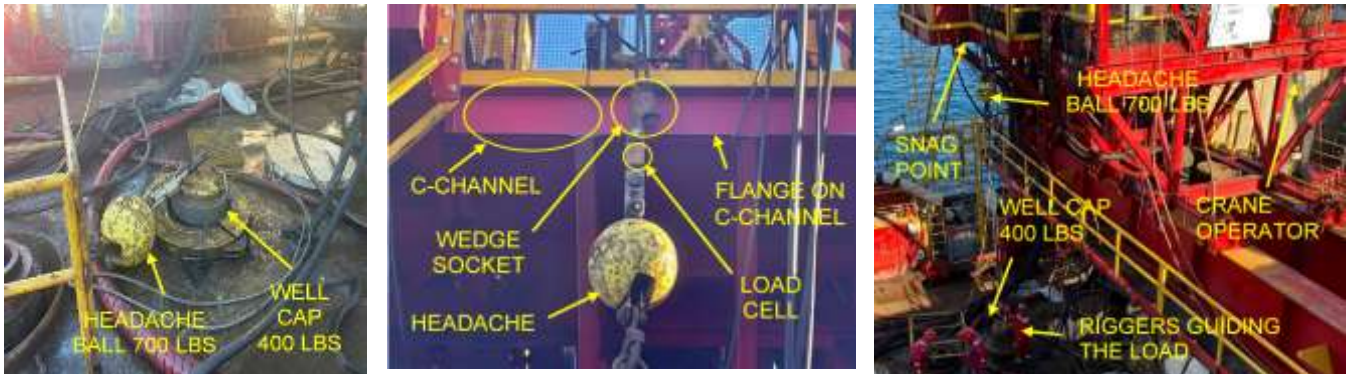
A crane was moving a 200kg (400 lb) well cap when a wedge socket on the auxiliary line snagged on the flange of a C-channel located at the edge of the platform’s rig deck. The lift required running the crane’s auxiliary line within centimetres of the edge of the platform. It was a “blind lift,” directed by a rigger using radio communications. The rigger was standing on the pipe deck and had a clear view of the load, line, pedestal crane, and crane operator. His location put him approximately 9m from the load line.

The wedge socket above the headache ball snagged on the C-channel flange that ran across the length of the edge of the deck. This snag temporarily held all the weight of the load and rigging, resulting in a false reading on the auxiliary winch - the load cell sending a weight signal to the operator was *below* the snagged wedge socket.

- The rigger and crane operator should have noticed the auxiliary winch was no longer detecting the weight of the load;
- The engineered controls (i.e., weight indicator) provided an inaccurate representation to the crane operator of the weight on the winch due to the wedge socket snagging *above* the load cell;
- The crane operator and rigger failed to recognize something was wrong after repeated requests to lower the load and after receiving the response that the line was being lowered and not seeing any movement in the load position;

- The rigger did not check the path of the auxiliary line for potential snags;
- The work team ought have noticed the potential hazards of working close to the C-channel at the edge of the platform rig, and should have recognized the potential snag points;
- No formal risk assessment was conducted. However, a review of the task was performed.

- Ensure a secondary device (e.g., weight indicator, camera) is accessible to detect any slack on the load line;
- Identify all potential rigging contact or snag points and include them in worksite instructions, risk assessments, and toolbox talks – particularly when working close to other equipment or structures;
- Ensure fully agreed, understood and practiced/tested communication between crane driver and rigging crew;
- Ensure a full and thorough lift plan is place before the job is started;
- What would **you** have done to avoid this situation? Discuss what key controls are in place to remove yourself and your team members from the potential “line of fire”.
