1 Caught between: unplanned movement of equipment leads to severe injuries

2 LTI – Person fractured pelvis in a fall from a ladder

3 Unplanned rotation of drilling machinery

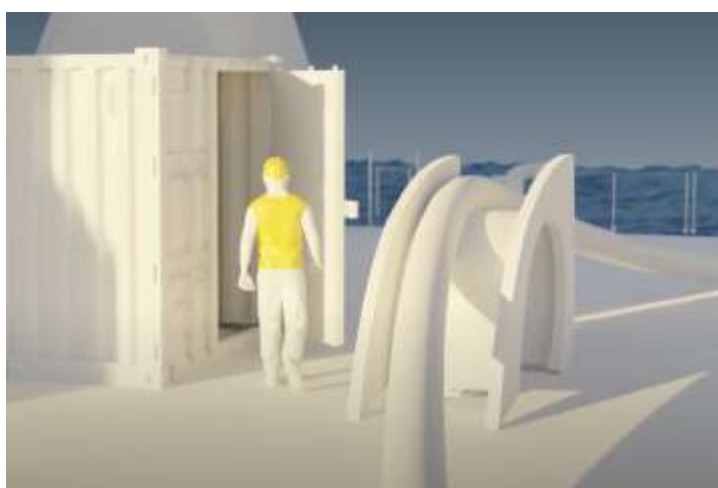
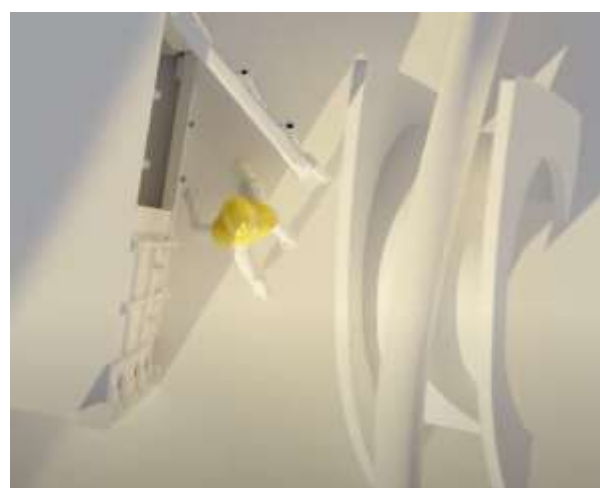
A mechanic was caught in the door of a freight container by a tipped-over hose saddle weighing 3 tonnes. The incident occurred when a team was performing maintenance works to a hydraulic spread on deck. A mechanic, who was not involved with these works, passed by the hose saddle, and entered a nearby container. At that moment the hydraulic hoses moved, causing the hydraulic saddle to tip over towards the container door, trapping the mechanic in between the container door and the frame. He sustained severe injuries for which he underwent surgery, and will be off work for more than 6 months.

- The hose saddle was not secured to the deck and due to its shape has a high centre of gravity, making it unstable;
- Because of the maintenance activities, the hose saddle was repositioned on deck, without a Management of Change (MoC) procedure being implemented;
- People working in the area were informed of the pressure tests on the hoses, but the mechanic was not there at that briefing. No Permit to Work was requested, nor was the area barricaded.

- The following causes were identified:
 - No “Safety By Design”: the hose saddle was top-heavy and was not sea fastened;
 - No risk assessment or management of change was done before repositioning the hose saddle;
 - There was no proper risk management of ongoing (simultaneous) activities, for example, Permit To Work, barricading of the area, and thorough communications to all stakeholders.

- Assessed the stability of all deck equipment;
- Sea-fastened all (unstable) deck equipment, also equipment which was in temporary locations;
- Reinforced the importance of procedural safety barriers such as the Management of Change process, last-minute risk assessment, and the Permit to Work system;
- Worked to improve safety coordination between all parties, including subcontractors.

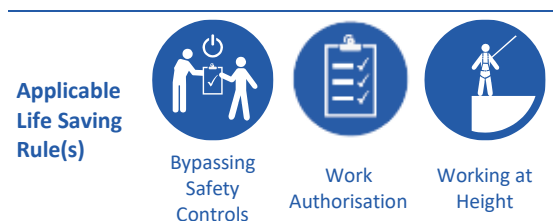
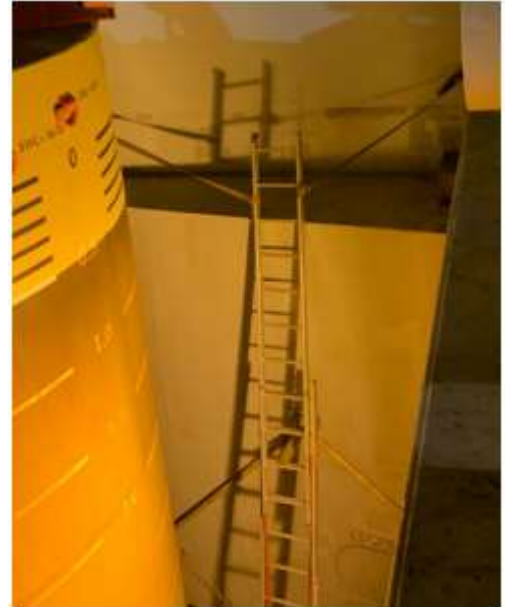
A crew person suffered a fractured pelvis falling 4-5 metres from a temporary access ladder onboard a cargo vessel. The ladder was installed at a previous equipment mobilisation following realisation that the permanent access / egress hatches to the cargo hold had been blocked. The ladder was secured to a small access platform off the ‘tween deck by means of ratchet straps. The platform edge was 5 metres in height with no handrails or fall prevention and the ladder could only be accessed by stepping over the ratchet straps at the exposed edge.

- Use of the ladder was not risk assessed and no working at height / fall protection mitigations were applied. There was no Management of Change applied when the ladder was installed. A work environment was created which influenced crew to use the ladder, creating a “routine violation”;

- Deck Drawings and review did not identify locations of access/egress hatches leading to them being blocked by mobilised equipment.

- Insufficient detail in Cargo Hold Drawing to create a safe load plan
- Design review did not assess safe cargo hold access/egress, stretcher routes and safe movement of personnel;
- Failure to conduct verification activities and ensure compliance.
- Poor risk perception / culture in that personnel did not carry organisational expectations onto a subcontractor worksite;
- Lack of basic operational control.

- Thorough engagement with management of sub-contractor to align HSE expectations:
 - Ensure thorough review of sub-contractor safety arrangements, documents and compliance;
 - Review of the sub-contractor’s load plans;
 - Conduct verification activities to ensure a safe working environment and practices prior to starting work (focus on the nine Life Saving Rules and pre-start work checklists);
 - Ensure robust worksite supervision and empower personnel to exercise ‘Stop Work Authority’.
- The ladder was removed from the vessel and safe access/egress was implemented.

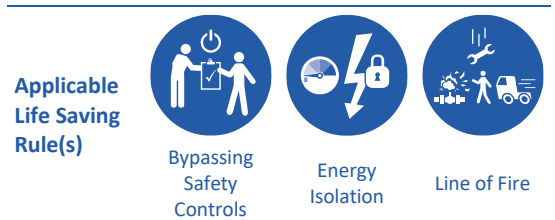
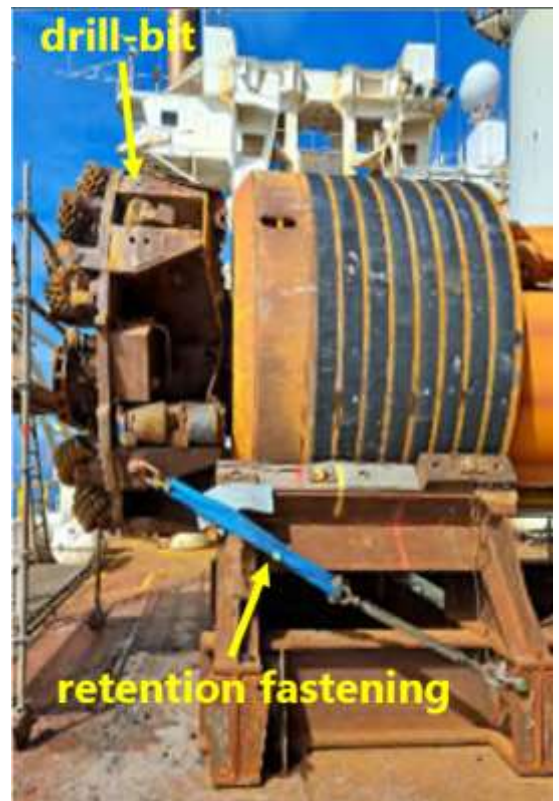
A large diameter subsea drill had completed drilling operations and was returned to the vessel's deck for planned maintenance. Part of the maintenance programme required the drill support system to be energized. As the system was energized, the drill bit unexpectedly started rotating for around 40 seconds. The retention fastenings, used to secure the drill during maintenance, parted, tangling in the rotating drill-bit. Nobody was in the vicinity at the time and there were no injuries.

- Operating procedures were not fully followed by the drilling team, which led to the operating console drill-bit rotation switch being left in the 'on' position;
- There was no warning that the system was "live" and that the bit would turn;
- There was no engineering barrier, such as an automatic interlock system which would have prevented inadvertent operation;
- Shift handover was not adequate and did not ensure all safety practices were followed;
- The control measures identified during the task risk assessment and subsequently included in the operating procedure, placed too great a reliance on individuals being aware of the situation (e.g. being aware of the position of control switches etc.) and also a reliance on following administrative controls / check sheets.

- Following an equipment design review, an isolation interlock was integrated into this equipment;
- Additional procedural steps requiring operator intervention (switching off) were now included in improved operating procedures;
- Improved monitoring of compliance and communication within work teams;
- The importance of engineering controls over and above administrative controls has been reiterated.

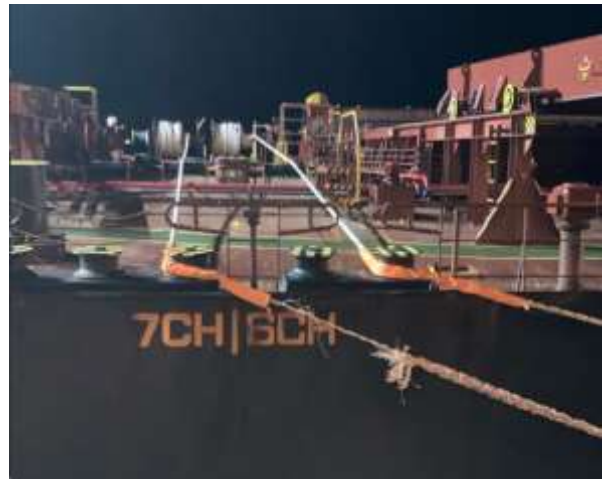
CHIRP – the Confidential Human Factors Incident Reporting Programme – has shared an event in which the careful vigilance of vessel crew prevented a mooring incident. A long, low-amplitude swell was causing a steady yawing and rolling motion of up to around 1.2m from the wharf on a 93,000-tonne deadweight bulk carrier alongside. During this time, a forward spring line running over the edge of the shipside roller fairlead began interacting with another mooring line causing significant abrasion damage.

It was observed by CHIRP that *“the design of the roller fairleads was not optimised to prevent contact with the sheer strake. Additionally, like many vessel spring lines, they can be susceptible to abrasion when environmental conditions at the port result in excessive movement.”*

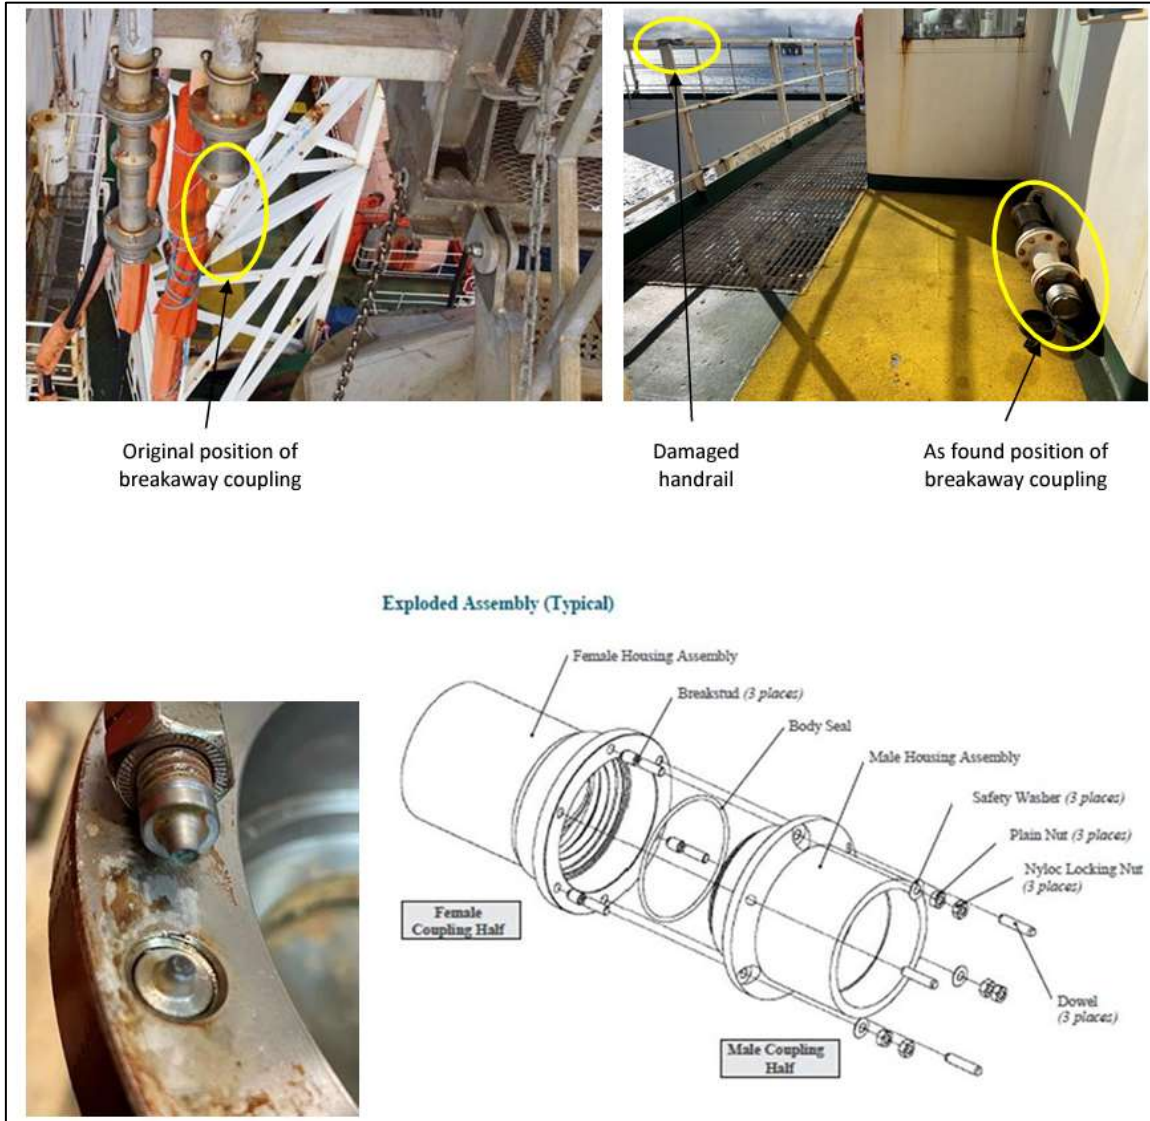
A breakaway coupling became a dropped object. It fell unnoticed to deck on a semi-submersible accommodation vessel. Later investigation identified where the breakaway coupling had fallen from. Another coupling was found with early signs of failure, with one of the breakaway studs found loose and able to be moved around freely.

The MSF notes that planned maintenance of the couplings was not aligned with OEM guidelines - it was found that the breakaway studs had been in place for longer than OEM recommendations. Also, the vessel was in lay-up and there was no reason for the couplings to be in place during layup. The couplings should have been removed at end of contract to remove any risk of a dropped object.

- Amend planned maintenance system to reflect OEM requirements and recommendations;
- Amend procedures to ensure hoses and couplings are not left *in situ* at height, when this is not required;
- Review potential use of drop net / secondary restraint.

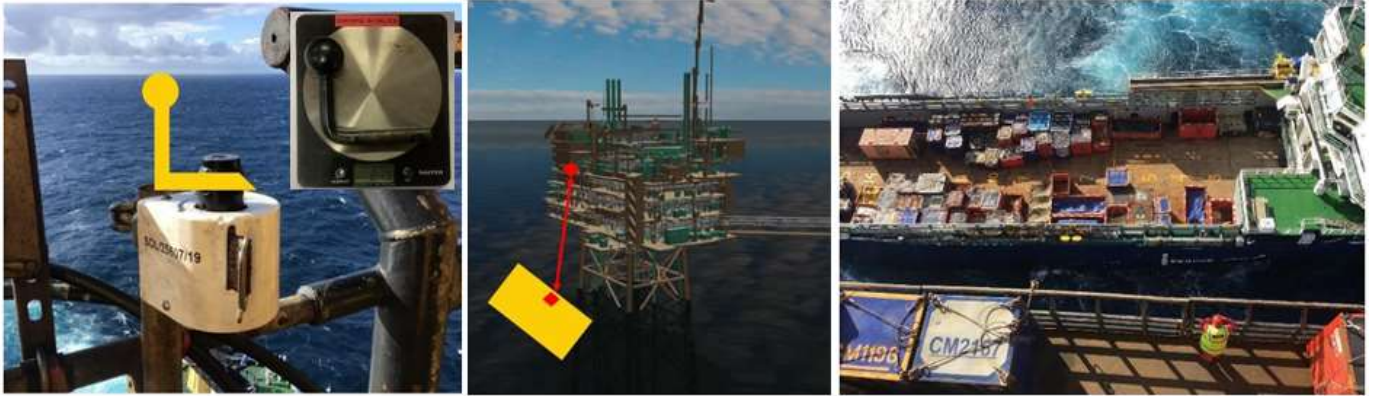
A barrier tape mechanism handle weighing 278g fell 45m from an offshore platform onto the deck of a supply vessel. During routine supply vessel operations, a deck crew person on an offshore platform was establishing barriers for safe lifting of cargo onto the platform's weather deck. On extraction of the fixed barrier tape the handle was seen to eject from the mechanism and fall, eventually landing **45m below** onto the deck of a supply vessel. Whilst nobody on the supply vessel was on the deck at the time, this had the potential to have been a fatality.

This type of barrier tape was only used by the offshore platform deck crew and was all fixed to the outboard handrails near laydown areas. The handle was fastened with a grub screw to a round shaft with no keyway or secondary retaining mechanism. The design is such that as the tape spools out the handle spins; this provided the lateral force to allow the handle to eject out over the handrail and down onto the supply vessel deck. A review of other new and older mechanisms onboard found similar loose moving handles but none that would readily fall out.

- Check if similar barrier tape mechanisms are used and check integrity of handle fixtures;
- Consider relocation away from handrails to remove the potential for rotating mechanisms to fail and fall to levels below, the sea or supply vessels.
