22/23 - September 2023

1 Fatality due to fire incident and fall from height

2 Fall from pilot ladder

3 Finger Injury while setting up pipe cutting operation

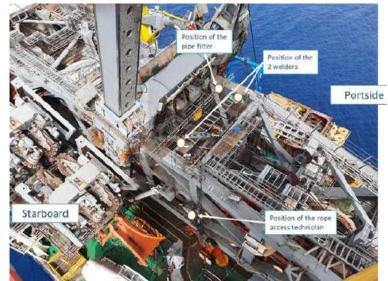
permits to work, following the vessel's safety management system's requirements. The rope access technician was doing work consisting of chipping, brushing and painting. To clean the area before painting, the worker decided to bring a bucket of thinners (solvent). At the same time, another group of workers were engaged in tack welding activities at the top of the tower. Some of the welding particles fell from the welding location and ignited the bucket of thinners. The heat produced by the fire melted the rope access technician's body harness resulting in a fatal fall from the height of approx. 8.5m.

- The potential conflict between the two activities was not properly evaluated;
- Sparks were coming down from the welding location above because of incomplete protection of the area with fire blankets;
- Thinners (solvent) were taken from the paint store without authorization and its use was not foreseen for the specific activity;

- Permits to Work should correctly identify all salient aspects of the job before starting any activity, including:
 - All hazards and precautions to be taken by the working team
 - The precise location of the work
 - The exact activities for which it has been issued

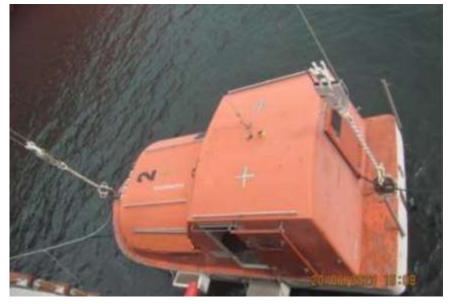
A Chief Officer slipped and fell from a pilot ladder onto a lifeboat, suffering minor bruising. The incident occurred on a vessel which was coming to the end of ten days spent alongside in a shipyard. The crew were performing a last pre-departure mandatory drill, which was a man overboard recovery with the lifeboat afloat, combined with the periodic over-boarding sea trial of the lifeboat itself. A Pilot ladder has been rigged to join the lifeboat which was already lowered into the water. The Chief Officer climbed down the ladder, and as he did so it suddenly slid downward. He let go of the ladder immediately for fear of getting his hands caught between the sliding ladder and the hull and fell about 2m directly onto the lifeboat.

Person climbing down Pilot Ladder

The Pilot Ladder was not properly secured.

- Work Preparation always rig the Pilot Ladder securely, ensuring that it is properly attached to the vessel's side and positioned at the correct distance from the waterline. The installation of the pilot ladder should be checked by an officer, who is responsible for ensuring it is correctly installed and complies with the required safety standards
- Training Familiarization ensure the crew responsible for rigging and handling the Pilot Ladder are properly trained and familiar with the proper procedures for deploying, securing, and stowing the ladder.

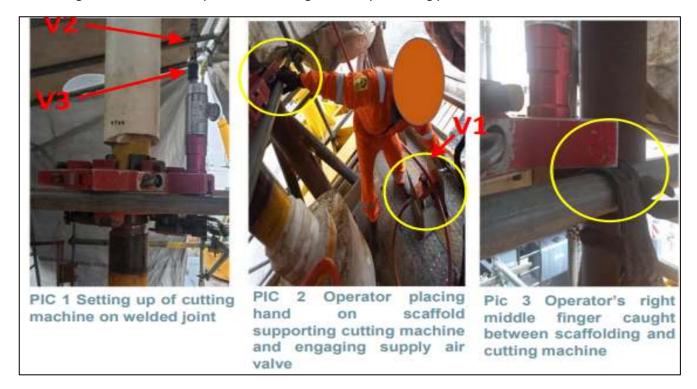
and suddenly the equipment moved. The crew member got their right middle finger trapped in between the scaffolding tube and the lower part of the cutting machine protruding part.

One of three valves in the machine was found to be defective during post-incident simulation. Company standing instructions required that the machine be turned manually during the setup validation or readiness check (to confirm its proper setup *before* energizing it). This was not done.

The crew member intended to perform a setup validation check by energizing the equipment. He closed the Inlet valve (V2 in photo), and then must have opened the Supply valve (V1 in photo) to perform the check. Due to the fault on the inlet valve (V2), as the Supply valve (V1) was opened, the inlet valve (V2) allowed air to pass and energized the machine causing it to rotate. As the machine rotated, it trapped his finger that was placed on the scaffold tubes.

- Don't take short-cuts equipment operating procedures and manuals are thee for a purpose and should be followed:
- Check that you all of you is **out of the Line of fire**. Always ensure body parts are kept away from moving or rotating parts;
- Our member:
 - Improved toolbox talks to increased awareness of unsafe positioning in this cutting operation and other tasks;
 - Refreshed training in the use of this equipment for the operators;
 - Improved procedures to make the task safer;
 - Developed and implemented pre-use checklist to cover inspection of cutting machine and accessories (air supply hoses and valves).
