1 Near miss: dropped object during lifeboat testing

2 Serious LTI - Person struck in rigging accident

3 Fire extinguisher fails during pressure testing

4 Fire-fighting equipment in poor condition

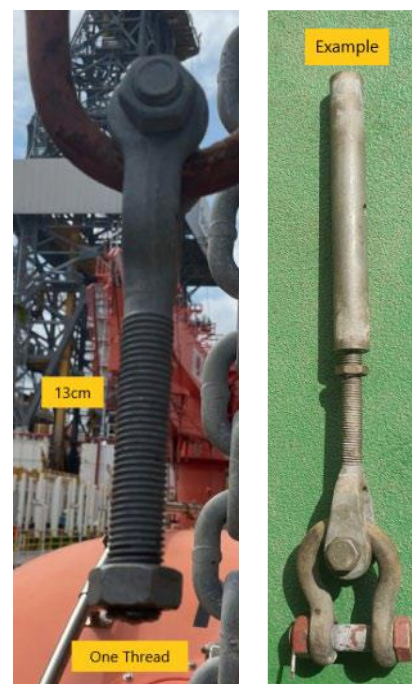
There was a mechanical failure – the turnbuckle was of a “closed” design that did not allow visual inspection of the thread engagement through the buckle. The threaded end of this turnbuckle was just 13cm and had one thread securing it into the buckle (see location of nut in illustration) on the threaded end. The bottom end was lost at sea.

- The lifeboat was secured to the falls and the area cleared before it was lifted;
- The remaining maintenance pennant turnbuckles were removed from the other lifeboats, and the threaded end measured was 17-18cm with plenty of thread though the buckle;
- Similar turnbuckles on other vessels in this fleet were examined carefully;
- Arrangements were made to replace “closed” turnbuckles with “open” turnbuckles that can be properly inspected;
- Company arranged with the lifeboat OEM to source appropriately specified open type turnbuckles from their supplier;
- Procedures revised to include thorough DROPS inspection of turnbuckles and other rigging overhanging the lifeboats before launch.

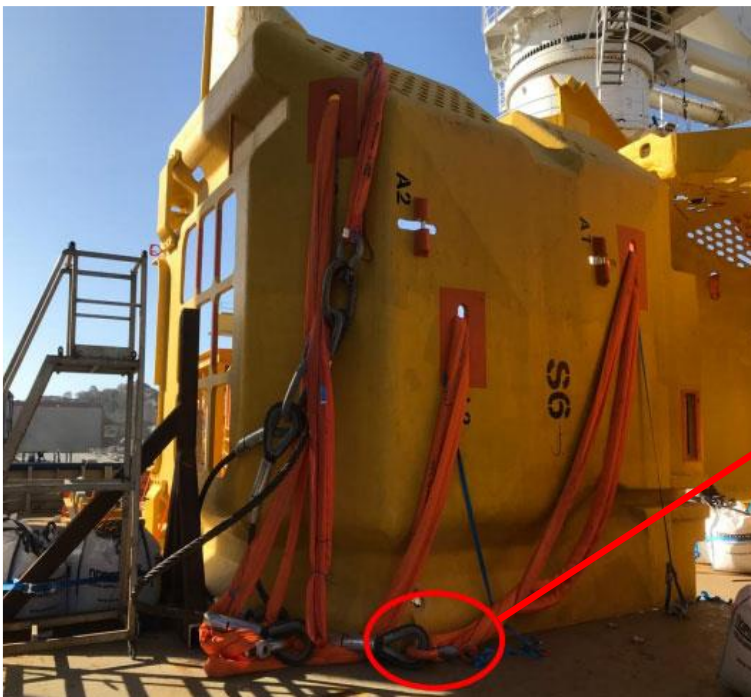
The hatch cover was safely landed on deck. However, during the lowering of the lift rigging to enable the crane to be disconnected, a slack leg of the lifting bridle, which would only come into use during deployment subsea, came to rest on the top flat section of the hatch cover. Instructions were given by the banksman to 'stand by' whilst the crane manoeuvred to free and lower the slings to deck. The volume on the injured person's radio had previously been turned down due to feedback from other users' radios, and subsequently he missed the safety command from the banksman. The rigger approached the load and within 5 seconds of doing so the rigging suddenly fell from the top of the cover and struck him. The rigger sustained multiple injuries including a fractured and dislocated right clavicle, fractured spine in several places, broken ribs and bruising to the lung.

Lift rigging fell from flat top section of hatch cover

- The design of the cover allowed objects to come to rest on top;
- The rigging design was overly conservative and too big and heavy for the job in hand;
- Misleading rigging drawing did not show slack sling;
- There was a breakdown in verbal communication (radio interference, terminology, understanding);
- The rigger acted without thinking deeply – “fast thinking” and entered the line of fire;
- There were missed opportunities to use existing safety mechanisms (such as the toolbox talk, task risk assessment, the stop work authority, the management of change process).

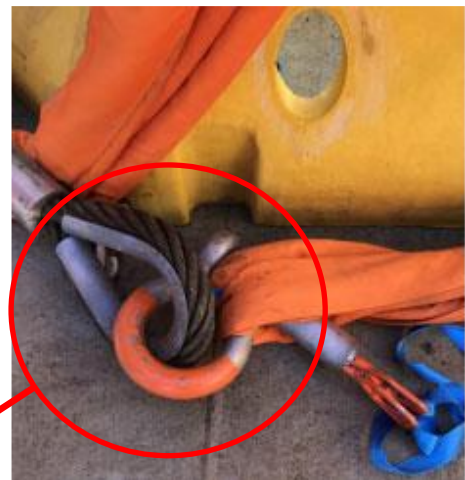
55Te ROV shackle and wire sling

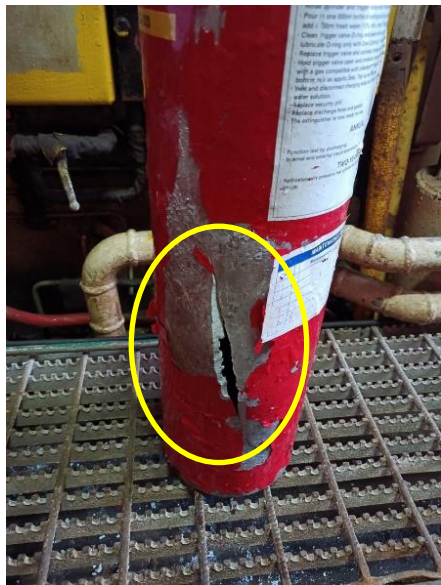
A member reports a recent incident involving the failure of a 5kg CO₂ fire extinguisher during hydrostatic pressure testing. The extinguisher, rated to 200bar, was being tested to a pressure of 300bar. The incident occurred when the test pressure reached 196 bar. The extinguisher was 13 years old. No-one was harmed.

- The main body of the extinguisher failed. Our member noted the following points:
 - **General Wear and Tear:** Over time, fire extinguishers are subjected to various environmental factors and conditions that can lead to wear and tear. This wear and tear may include corrosion, stress, or weakening of materials due to exposure to temperature fluctuations and external elements. It is essential to regularly inspect and maintain fire extinguishers to ensure their integrity;
 - **Age of the Extinguisher:** The extinguisher in question was manufactured in July 2010, making it over a decade old at the time of the incident. As fire extinguishers age, their components, including pressure vessels and seals, can deteriorate. Over time, the ability of the extinguisher to withstand high-pressure testing may diminish, increasing the risk of failure.

- Our member took the following actions:
 - Reviewed the current inspection and maintenance program to ensure it is implemented correctly and is rigorous enough for inspection and maintenance of fire extinguishers;

- Considered the age of fire extinguishers when planning hydrostatic tests. Older extinguishers may require more frequent testing or replacement to ensure their safety and reliability;

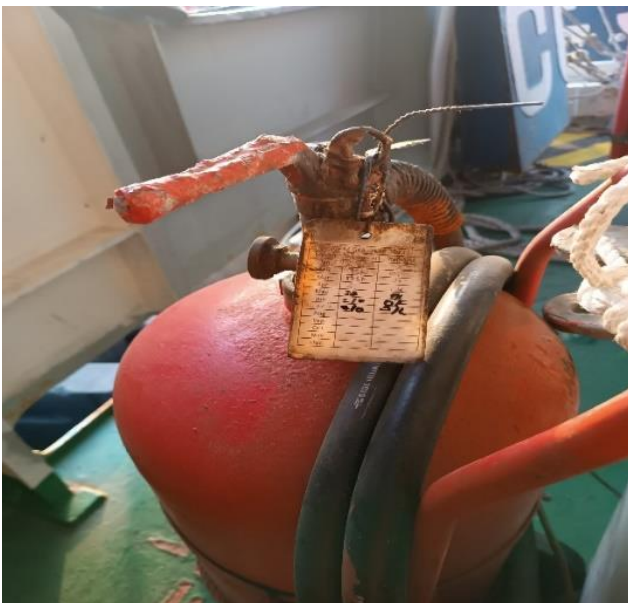
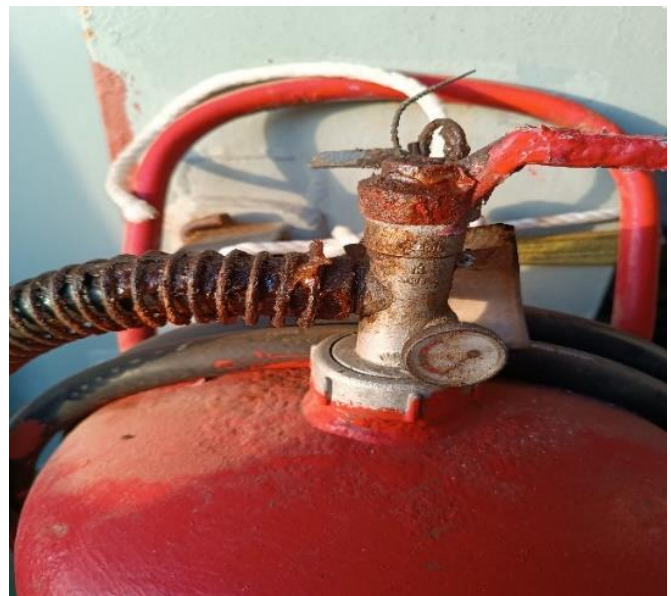
Several 50kg wheeled dry powder fire extinguishers on board a vessel were found to have low pressure and heavy signs of corrosion. This was discovered during an audit walk-around by shore-based personnel.

- There had been a regular monthly inspection of the firefighting equipment onboard, but the person inspecting the equipment had not highlighted its poor condition;
- The crew were unaware of the detail and quality required in planned inspection of firefighting equipment.

- Thorough and comprehensive inspection of all fire extinguishers and fire fighting equipment on board/site to ensure all are in sound workable condition;
- Removal and quarantine of defective fire extinguishers and other safety critical equipment not in safe and usable condition, and relevant repairs or replacements ordered;
- Additional control measures to be put in place until replacements /repairs implemented;
- Regular maintenance: Monthly visual inspection of fire fighting equipment by crew and annual service by authorized third party provider;
- Crew Training: Conduct regular awareness sessions to ensure sufficient knowledge of relevant crew members on how to conduct quality visual inspections of firefighting equipment as well as to emphasize the importance of timely reporting of any safety concerns.

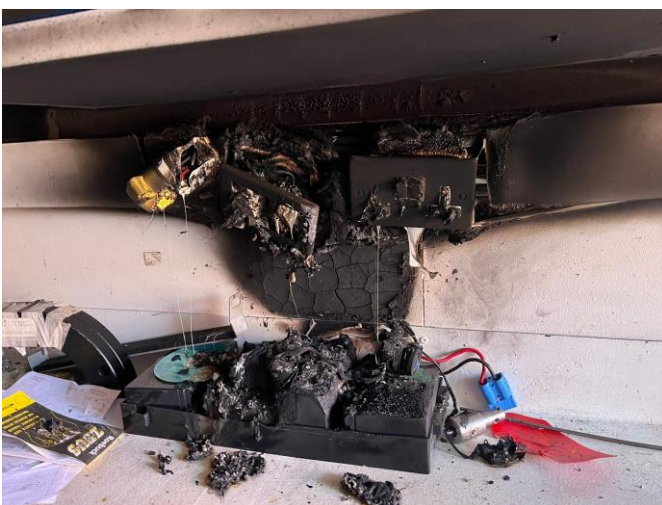
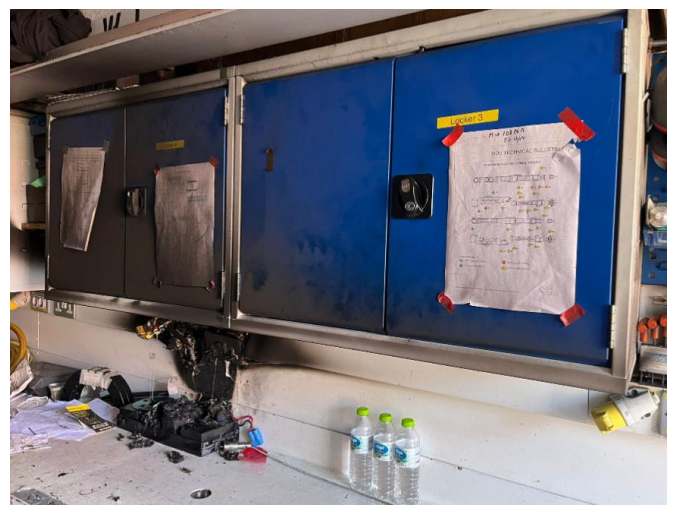
A crew member noticed smoke coming from the ROV workshop and reported a fire.

- A rechargeable headset flashlight was left on charge unsupervised, also on a UPS supply.

- The importance of checking the condition of all personal electrical equipment;
 - All electrical appliances should be sourced from a reputable supplier and should be in good working condition;
 - Plug sockets and extension leads should be used correctly and not overloaded;
 - Charger cords for all electronic devices should be in good working condition (with no exposed wiring) prior to being brought offshore, and likewise, sourced from a reputable supplier;
- Charging devices should not be left on surfaces that are potentially flammable or that can promote heat build-up;
 - Avoid leaving charging cables or portable electronic devices on bedding;
 - Remove electronic devices from chargers and outlets once fully charged;
- Include information about the hazards of charging portable devices during orientations and post relevant signage in living quarters.

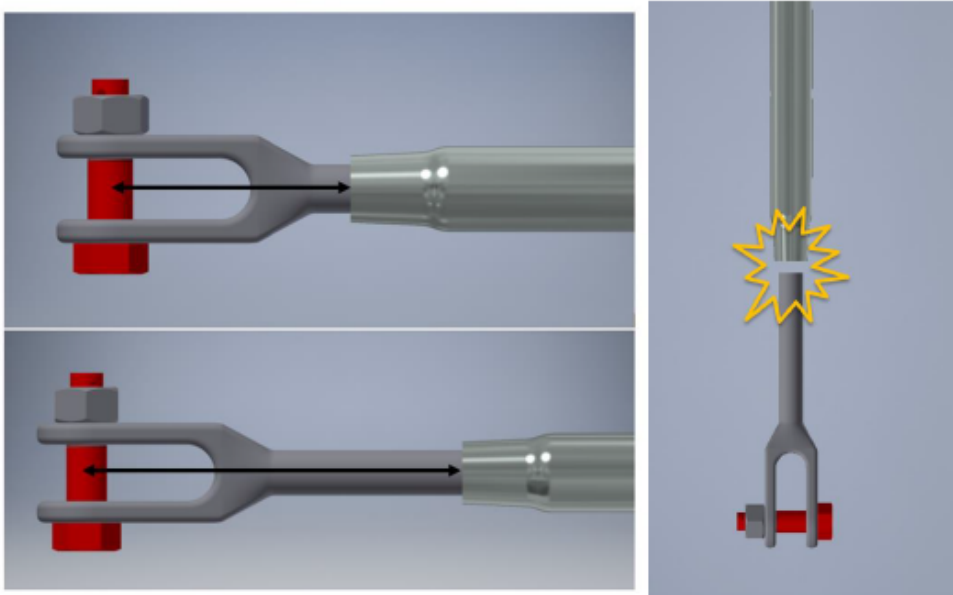
Issue relates to the use of the turnbuckle meant for hanging off during maintenance. As informed, this turnbuckle being of a closed type, it makes it hard for the user to see the amount of thread used or remaining thread available, and resulting in its potential release.

Fig.2: Closed turnbuckle and thread movement

- We recommend to use the optional hang-off unit only for maintenance purpose and not to be used as a component during lifeboat drills.
- We recommend to mark the thread to show its limits and or remaining thread available to the user
- In the case the closed type is no longer preferred, please contact your nearest VIKING office for its replacement for an open type turnbuckle.
- To replace the system with a fixed length wire sling, with the length of the sling to be determined based on actual on-site measurements.
- Hanging-off to be used only in conjunction with maintenance activities.
