1 High potential near miss: Crane part fell to deck

2 High potential near miss: Dropped Paraguard stretcher during drill

3 Failure of AHC cylinder causing oil leak to deck

4 Vehicle incident – driver tiredness

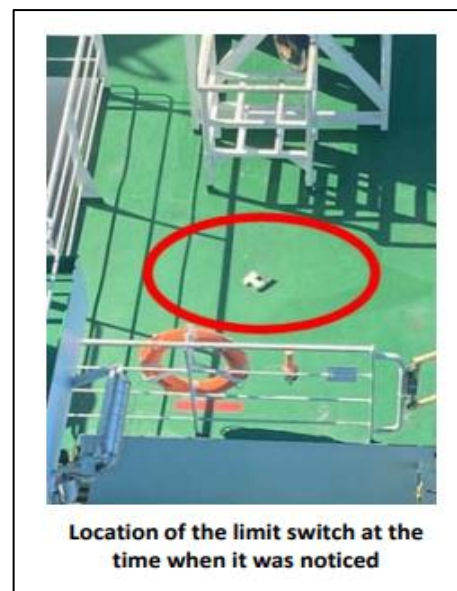
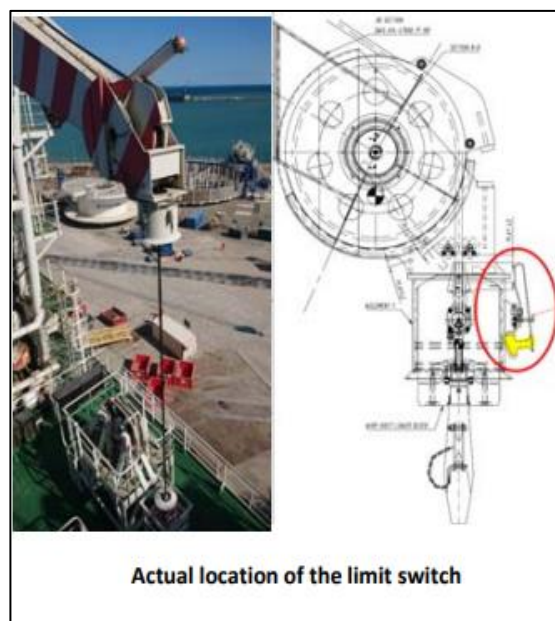
During a vessel transit during which the crane was unused in its boom rest, a crew member observed a piece of metal debris lying under the crane boom tip. It was discovered that one of the three Crane Whip Line Block Catcher Limit Switches (3.6kg) had fallen off and had fallen 6.5m to the deck. There were no injuries.

- Inadequate design verification - the cross-sectional area of the broken plate was not sufficient to bear the stress applied to the limit switch;
- The bolt spring was acting as a strong point and was creating unbalanced forces on the limit switch plate;
- There was insufficient preventive maintenance or inspection of this area.

- The equipment was not being used as it was originally designed;
- The maintenance schedule recommended by the crane manufacturer, was not adequate.

- Work with the crane manufacturer on a new design of the limit switch plate;
- Amend preventive maintenance schedule and inspection program to include more frequent assessment;

- Look at other vessel cranes for any signs of potential weak points on the limit switches.

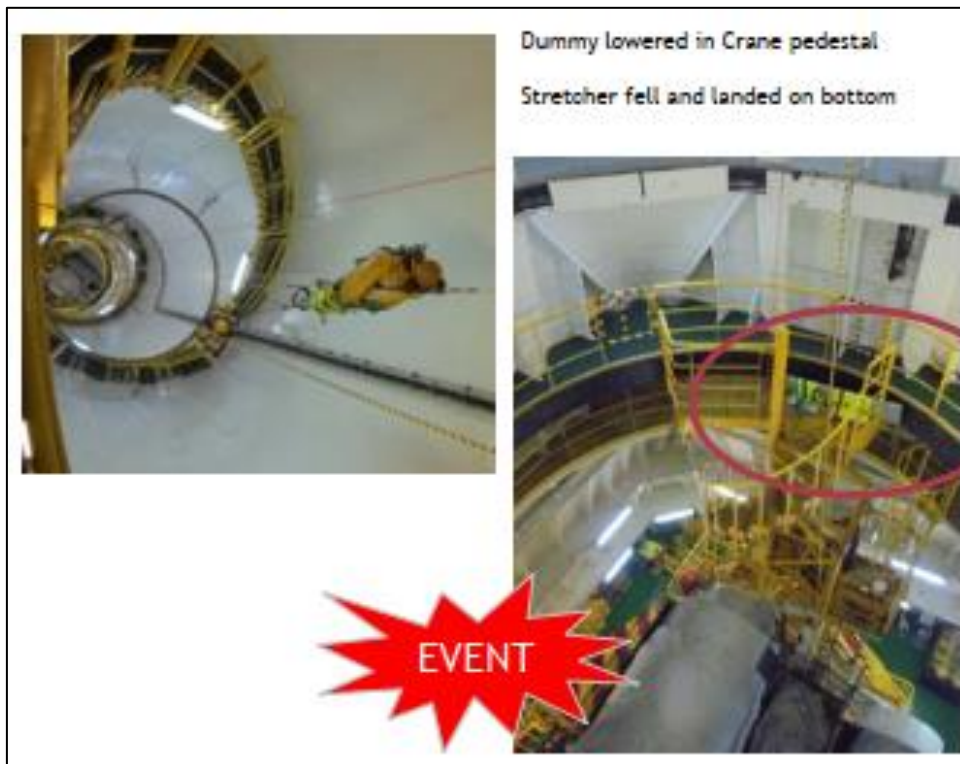
During a rescue from height /evacuation drill within the top of the main crane pedestal, a Paraguard stretcher (12kg) slipped out from the dummy and fell approx. 50m to the crane winch room below. The incident occurred just as the descent was starting. The area below the drill was a restricted access area; there were no injuries.

For the first transfer through the top hatch, using the tripod, the lifting point on the stretcher itself was correctly used. However, after the transfer to the descending davit, the descending cable was attached to the Dummy harness, **not** to the stretcher lifting point. This led to the stretcher and dummy not being secured to each other, and the stretcher slipping during the descent.

- The rescue plan was too generic and did not address specifically the process by which the injured person in a stretcher would be lowered;
- Despite the presence of several rescue team members, nobody noticed that the rope was connected to the wrong attachment point.

- Review the rescue plan in this case to
 - Ensure that suitable rescue equipment is used (if space is limited, the use of a stretcher can pose additional hazards and use of a harness may be an acceptable alternative);

- Incorporate more specific details on the process of lowering the casualty.

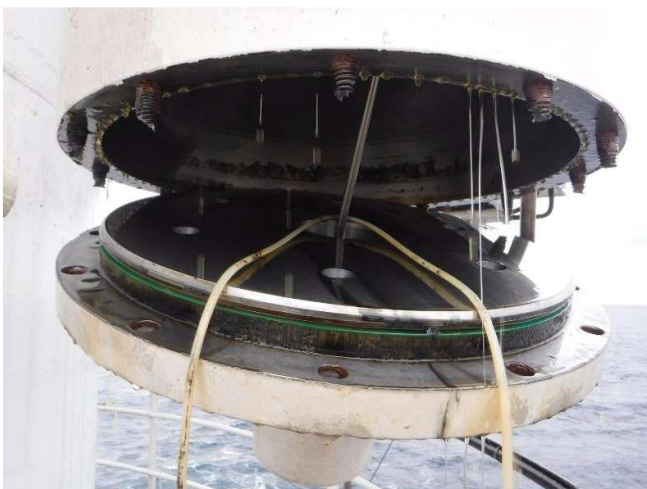
*The bottom of the AHC cylinder
before the work started on a temporary repair
to seal it*

The low pressure seals became worn. This allowed oil to leak past the piston into the vacuum side. At the time of the incident the seal had failed so badly that the leak oil choked the drain lines and oil built up in the vacuum space behind the piston. The vessel then rolled; the piston began to travel compensating the hook wire. As the piston moved down the cylinder, it hit the wall of built-up oil, this transferred the force through the incompressible oil onto the small surface area of the cylinder end cover, shearing the bolts and blowing the oil out onto deck. The cylinder is not designed to take any pressure on this side of the piston.

- Crane manufacturer to incorporate pressure sensor with alarm in crane computer to highlight a leaking seal before unplanned breakdown occurs;
- Crane manufacturer to review manuals and incorporate new maintenance for an inspection of the low pressure seal, check of return filters and overhaul time for the AHC cylinder.

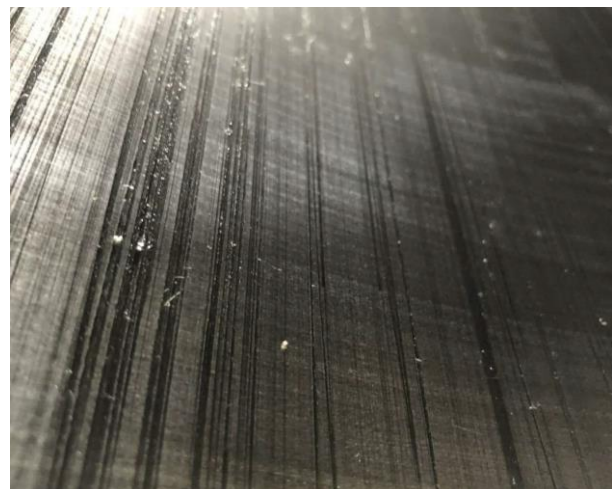
Scoring seen inside the cylinder

Investigators believe that at some point, contaminated oil has passed through the cylinder causing damage to the seal and scoring the cylinder. The source of this contamination could have been during an overhaul of other components and has entered the oil and found its way to the active heave cylinder. It was not known at what point in the cylinder's lifetime this damage was sustained because the cylinder had never been inspected inside. In its lifetime the piston and seals have travelled many thousands of kilometres inside the cylinder as the active heave will move every time the ship is rolling during crane use.

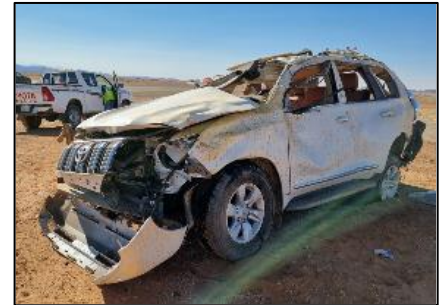
Prior to reaching the rest stop the vehicle gradually drifted onto the hard shoulder and crashed into the back of a stationary police vehicle. The driver and third party (the policeman in the stationary car) were not injured, however the passenger, who had an open laptop computer on his knees and was using his phone, sustained a fractured arm and broken nose when the airbag deployed during the crash.

- Documented procedures and controls were not strictly followed in terms of fatigue management;
- Though they could have swapped over, the driver did not initiate a driver change when he felt tired;
- Unsecured cargo or luggage including laptop computers can cause serious injury if not stowed away and secured;

- Effectively manage journeys and speak up when circumstances change and /or we experience fatigue;
- Recognising your own tiredness and be aware of your limitations;
- As a passenger, be aware of your surroundings and keep a reasonable lookout for unsafe driver habits and conditions;
- Stow and secure luggage and/or equipment including laptop computers in designated compartments / pockets or the trunk or boot before starting journeys;
- As a passenger in a car, don't be using a laptop computer while the vehicle is moving;
- Make use of dashcams.

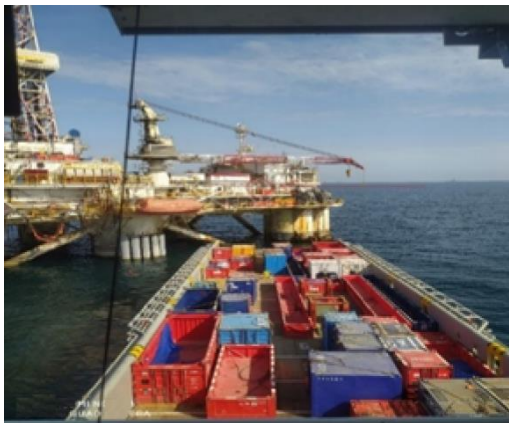
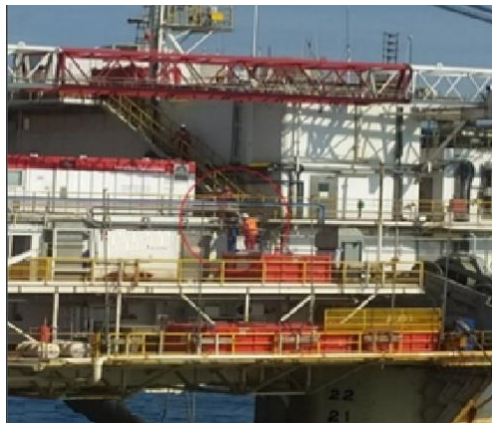
During fuel transfer operations alongside a semi-submersible rig, the officer on watch on the supply vessel PSV observed welding work being undertaken on the deck of the rig. The vessel bridge immediately communicated this information to the rig control room using VHF, challenging why bunkering and hot work activities were being carried out simultaneously. Stop Work authority was applied; the vessel stopped fuel transfer.

Hot work observed by crew (orange figure on deck, circled, right)
